# Access Compliance Report Public Rights-of-Way (Curb Ramps)

Main Street: BEACH\_POINT Cross Street: BUSHWOOD\_CIR Location: NW

ADA ID: RPRK211104135212 Ramp Type: Type 4 - Parallel Initial Pass/Fail: Fail Overall Compliance: No Severity Score: 16

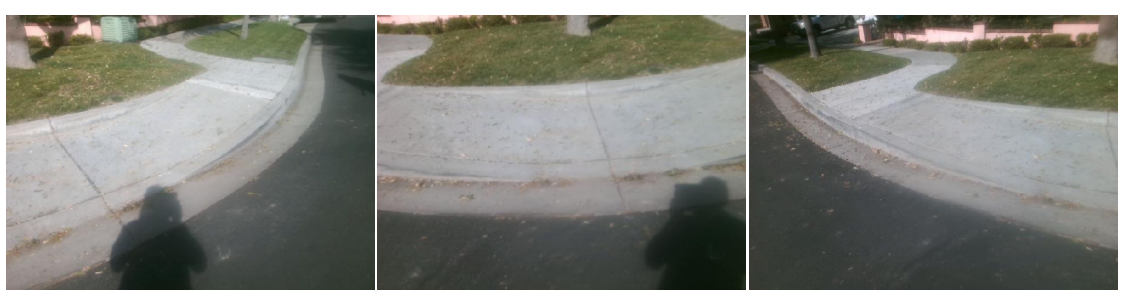
| Compliance | Description | Data | Compliance | Description | Data |
|---|---|---|---|---|---|
| Yes | Ramp Run Slope LT (%) | 3.5 | No | Ramp Run Slope RT (%) | 9.7 |
| No | Ramp Cross Slope LT (%) | 3.2 | No | Ramp Cross Slope RT (%) | 3.9 |

Possible Solutions:  
**Remove & Replace Curb Ramp With Two New Directional Ramps or Equivalent.**
