# Access Compliance Report Public Rights-of-Way (Curb Ramps)

| Main Street: N_SELLAS_RD | | Cross Street: SIENNA_PKWY | | Location: | SE |
| ADA ID: RPRK211109130159 | Ramp Type:Type 1 - Perpendicular | Initial Pass/Fail: Fail | Overall Compliance: No | Severity Score: | 15 |

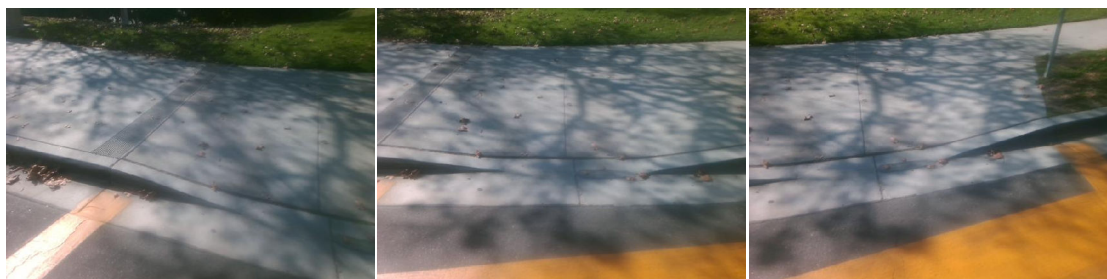
| Compliance | Description | Data | Compliance | Description | Data |
|---|---|---|---|---|---|
| No | Ramp Run Slope (%) | 9.4 | N/A | Flare Slope LT (%) | N/A |

**Remove & Replace Entire Ramp.**
