Access Compliance Report Public Rights-of-Way (Curb Ramps)

Main Street: CARLISLE_CT **Cross Street:** LANGFORD_RD **Location:** S

ADA ID: RPRK211111115523 **Ramp Type:** Type 4 - Parallel **Initial Pass/Fail:** Fail **Overall Compliance:** No **Severity Score:** 30

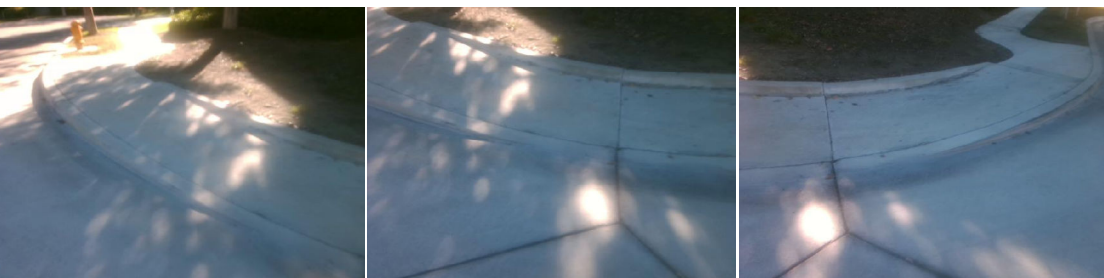
Compliance	Description	Data	Compliance	Description	Data
Yes	Obstructions Present?	No	N/A	Utilities Present?	No
	Obstruction Types	N/A		Utility Types	
	Obstruction Dimensions	N/A			N/A
