# Access Compliance Report Public Rights-of-Way (Curb Ramps)

| Main Street: S_SELLAS_RD | | Cross Street: SIENNA_PKWY | | Location: | SE |
| ADA ID: RPRK211111134109 | Ramp Type: Type 1 - Perpendicular | Initial Pass/Fail: Fail | Overall Compliance: No | Severity Score: | 15 |

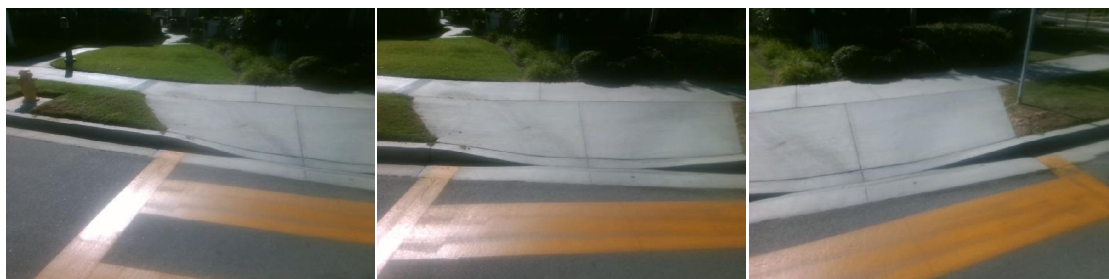
| Compliance | Description | Data | Compliance | Description | Data |
|---|---|---|---|---|---|
| No | Ramp Run Slope (%) | 11.8 | N/A | Flare Slope LT (%) | N/A |

Remove & Replace Entire Ramp.
