# Access Compliance Report Public Rights-of-Way (Curb Ramps)

| Main Street: SENDERO WAY | | Cross Street: ASCENSO_AVE | | Location: | E |
| ADA ID: RPRK211117153248 | Ramp Type:Type 1 - Perpendicular | Initial Pass/Fail: Fail | Overall Compliance: No | Severity Score: | 16 |

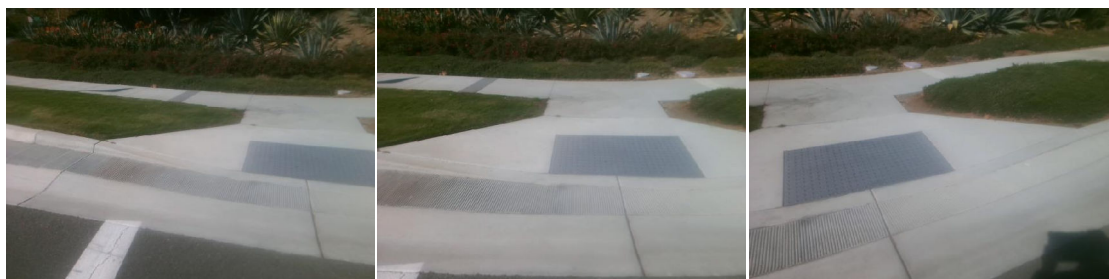
| Compliance | Description | Data | Compliance | Description | Data |
|---|---|---|---|---|---|
| N/A | Ramp Length (in) | 60 | N/A | Flare Type LT | |
| Yes | Ramp Width (in) | 60 | | | N/A |
| No | Ramp Run Slope (%) | 9.8 | N/A | Flare Slope LT (%) | N/A |
| No | Ramp Cross Slope (%) | 2.2 | N/A | Flare Traversable LT | N/A |

Remove & Replace Entire Ramp.
