# Access Compliance Report Public Rights-of-Way (Curb Ramps)

| Main Street: RIBERA_RD | | Cross Street: BRIOSO_ST | | Location: | SW |
| ADA ID: RPRK211118125254 | Ramp Type:Type 1 - Perpendicular | Initial Pass/Fail: Fail | Overall Compliance: No | Severity Score: | 15 |

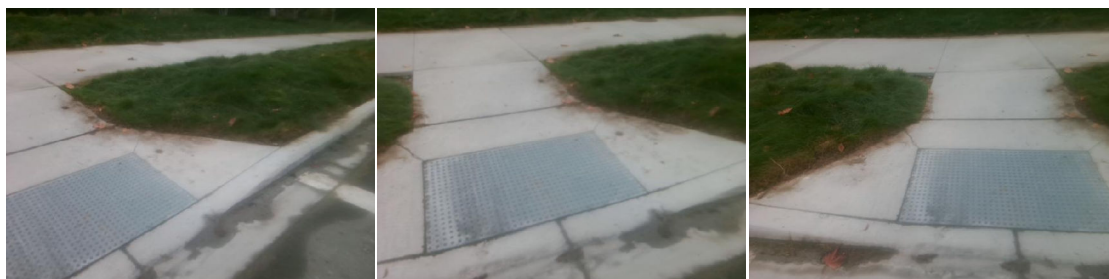
| Compliance | Description | Data | Compliance | Description | Data |
|---|---|---|---|---|---|
| No | Ramp Run Slope (%) | 9.2 | N/A | Flare Slope LT (%) | N/A |

Remove & Replace Entire Ramp.
