# Access Compliance Report Public Rights-of-Way (Curb Ramps)

| Main Street: CADENCIA_ST | | Cross Street: LIGADO_ST | | Location: | W |
| ADA ID: RPRK211119120651 | Ramp Type: Type 4 - Parallel | Initial Pass/Fail: Fail | Overall Compliance: No | Severity Score: | 15 |

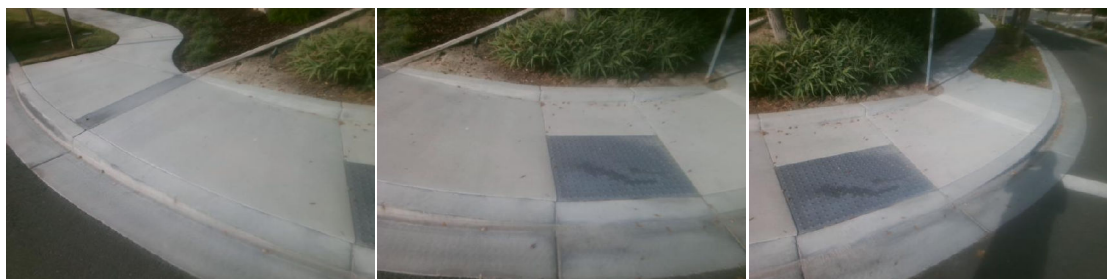
| Compliance | Description | Data | Compliance | Description | Data |
|---|---|---|---|---|---|
| N/A | Ramp Length LT (in) | 94 | N/A | Ramp Length RT (in) | 69 |
| Yes | Ramp Width LT (in) | 65 | Yes | Ramp Width RT (in) | 65 |
| No | Ramp Run Slope LT (%) | 11.9 | Yes | Ramp Run Slope RT (%) | 2.6 |

**Remove & Replace Curb Ramp With Two New Directional Ramps or Equivalent.**
