# Access Compliance Report Public Rights-of-Way (Curb Ramps)

| Main Street: ESENCIA_DR | | Cross Street: SUERTE_ST | | Location: | N |
| ADA ID: RPRK211124140943 | Ramp Type: Type 1 - Perpendicular | Initial Pass/Fail: Fail | Overall Compliance: No | Severity Score: | 2 |

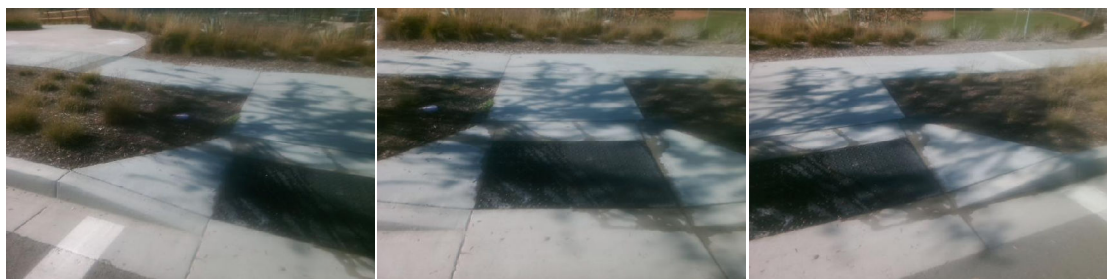
| Compliance | Description | Data | Compliance | Description | Data |
|---|---|---|---|---|---|
| N/A | Ramp Length (in) | 106 | N/A | Flare Type LT | |
| Yes | Ramp Width (in) | 60 | | | N/A |
| Yes | Ramp Run Slope (%) | 5.2 | N/A | Flare Slope LT (%) | N/A |
| No | Ramp Cross Slope (%) | 2.1 | N/A | Flare Traversable LT | N/A |

**Remove & Replace Entire Ramp.**
