# Access Compliance Report Public Rights-of-Way (Curb Ramps)

Main Street: ESENCIA\_DR Cross Street: ANDAZA\_ST Location: NW

ADA ID: RPRK211129123014 Ramp Type: Type 1 - Perpendicular Initial Pass/Fail: Pass Overall Compliance: No Severity Score: 6

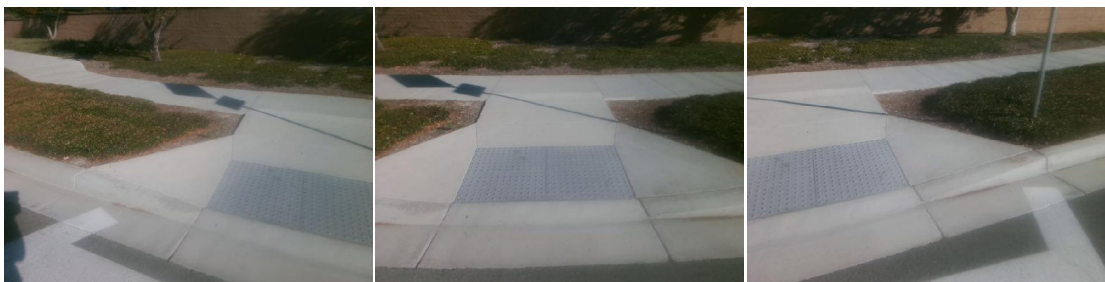
| Compliance | Description | Data | Compliance | Description | Data |
|---|---|---|---|---|---|
| Yes | Overall Surface Condition: Acceptable | | Yes | Perp Joint Present | Yes |
| | Cross Gutter Present? | No | | Spandrel Present? | No |

Remove & Replace Curb Slope. Remove & Replace Gutter.
