# Access Compliance Report Public Rights-of-Way (Curb Ramps)

| Main Street: ESENCIA_DR | | Cross Street: FAUNA_DR | | Location: | S |
| ADA ID: RPRK211201125450 | Ramp Type:Type 1 - Perpendicular | Initial Pass/Fail: Pass | Overall Compliance: No | Severity Score: | 5 |

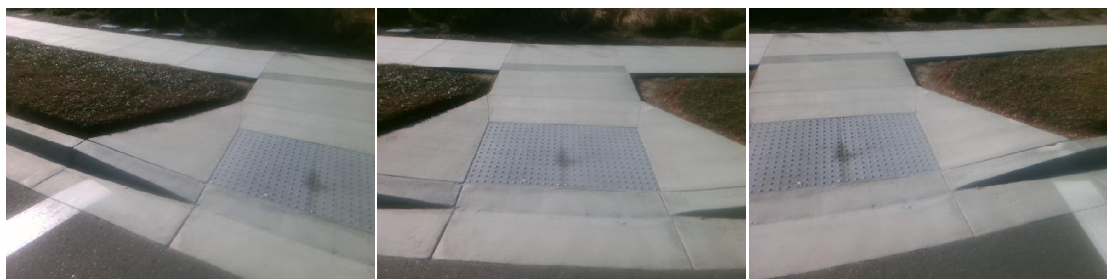
| Compliance | Description | Data | Compliance | Description | Data |
|---|---|---|---|---|---|
| Yes | Overall Surface Condition: Acceptable | | Yes | Perp Joint Present | Yes |

Remove & Replace Entire Ramp.
