# Access Compliance Report Public Rights-of-Way (Curb Ramps)

| Main Street: CHRISTY_LN | | Cross Street: COPA_DE_ORO_DR | | Location: | SW |
| ADA ID: RPRK211207133233 | Ramp Type:Type 1 - Perpendicular Diagonal Initial Pass/Fail: Fail | | Overall Compliance: No | Severity Score: | 2 |

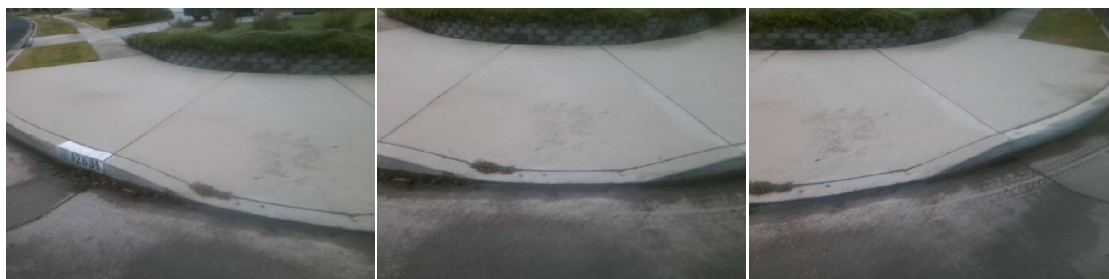
| Compliance | Description | Data | Compliance | Description | Data |
|---|---|---|---|---|---|
| N/A | Ramp Length (in) | 136 | N/A | Flare Type LT | |
| Yes | Ramp Width (in) | 48 | | | N/A |
| Yes | Ramp Run Slope (%) | 4.3 | N/A | Flare Slope LT (%) | N/A |

**Remove & Replace Curb Ramp With Two New Directional Ramps or Equivalent. Grind Gutter Lip.**
