# Access Compliance Report Public Rights-of-Way (Curb Ramps)

| Main Street: VILLA_PARK_RD | | Cross Street: LEMON_ST | | Location: | NW |
| ADA ID: RPRK211222141925 | Ramp Type:Type 1 - Perpendicular | Initial Pass/Fail: Fail | Overall Compliance: No | Severity Score: | 15 |

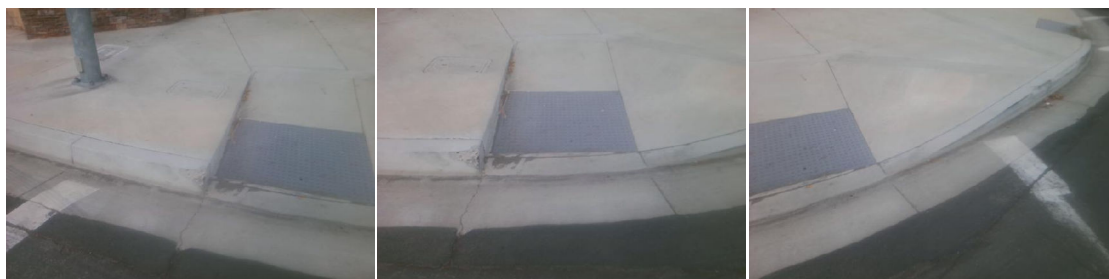
| Compliance | Description | Data | Compliance | Description | Data |
|---|---|---|---|---|---|
| Yes | Overall Surface Condition: <b>Acceptable</b> | | Yes | Perp Joint Present | Yes |

**Remove & Replace Entire Ramp.**
