# Access Compliance Report Public Rights-of-Way (Curb Ramps)

| Main Street: TREASURE_LN | | Cross Street: ARROYO_AVE | | Location: | S |
| ADA ID: RPRK220125140822 | Ramp Type: Type 1 - Perpendicular Diagonal Initial Pass/Fail: Fail | | Overall Compliance: No | Severity Score: | 60 |

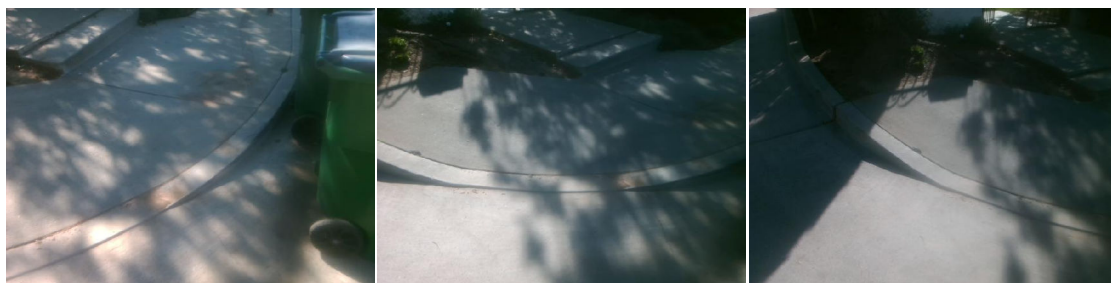
| Compliance | Description | Data | Compliance | Description | Data |
|---|---|---|---|---|---|
| No | Ramp Run Slope (%) | 13.8 | N/A | Flare Slope LT (%) | N/A |

**Remove & Replace Curb Ramp With Two New Directional Ramps or Equivalent. Grind Gutter Lip.**
