Access Compliance Report Public Rights-of-Way (Curb Ramps)

Main Street: YORBA_ST **Cross Street:** E_ROMELLE_AVE **Location:** NE

ADA ID: RPRK220126121408 **Ramp Type:** Type 1 - Perpendicular Diagonal Initial Pass/Fail: Fail **Overall Compliance:** No **Severity Score:** 15

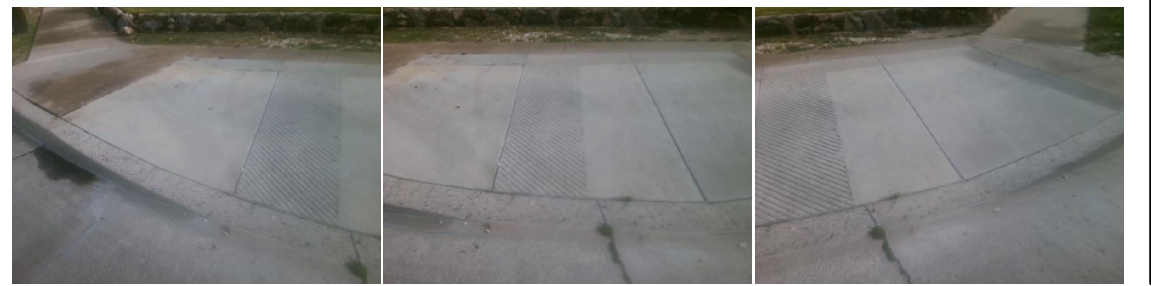
| Compliance | Description | Data | Compliance | Description | Data |
|---|--|---|---|---|---|
| No | Ramp Run Slope (%) | 10.8 | N/A | Flare Slope LT (%) | N/A |

Possible Solutions:
Remove & Replace Curb Ramp With Two New Directional Ramps or Equivalent.
