# Access Compliance Report Public Rights-of-Way (Curb Ramps)

| Main Street: MCFADDEN_AVE | | Cross Street: VAN_BUREN_ST | | Location: | S |
| ADA ID: RPRK220202120214 | Ramp Type: Type 4 - Parallel | Initial Pass/Fail: Fail | Overall Compliance: No | Severity Score: | 16 |

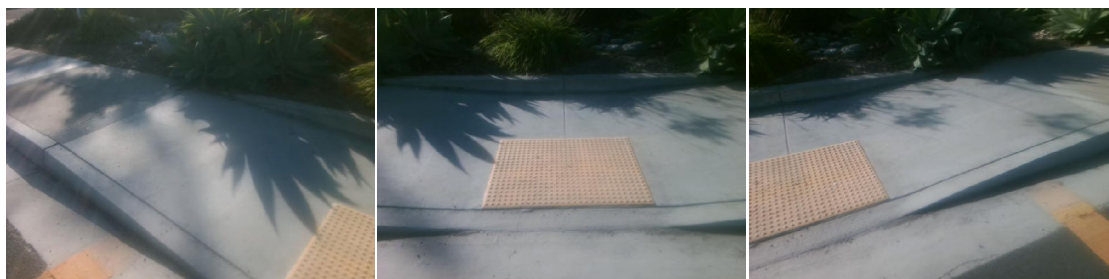
| Compliance | Description | Data | Compliance | Description | Data |
|---|---|---|---|---|---|
| N/A | Ramp Length LT (in) | 118 | N/A | Ramp Length RT (in) | 120 |
| Yes | Ramp Width LT (in) | 83 | Yes | Ramp Width RT (in) | 83 |
| No | Ramp Run Slope LT (%) | 9.3 | No | Ramp Run Slope RT (%) | 9.1 |

Remove & Replace Entire Ramp.
