# Access Compliance Report Public Rights-of-Way (Curb Ramps)

| Main Street: EMBARCADERO_PL | | Cross Street: DANA_POINT_HARBOR_DR | | Location: | SE |
| ADA ID: RPRK220208154928 | Ramp Type:Type 1 - Perpendicular | Initial Pass/Fail: Fail | Overall Compliance: No | Severity Score: | 2 |

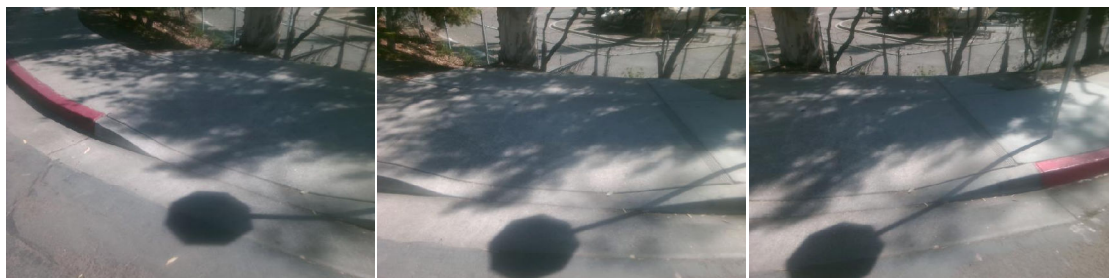
| Compliance | Description | Data | Compliance | Description | Data |
|---|---|---|---|---|---|
| No | Ramp Cross Slope (%) | 2.1 | N/A | Flare Traversable LT | N/A |

Remove & Replace Entire Ramp.
