# Access Compliance Report Public Rights-of-Way (Curb Ramps)

| Main Street: EMBARCADERO_PL | | Cross Street: DANA_POINT_HARBOR_DR | | Location: | SW |
| ADA ID: RPRK220208155140 | Ramp Type:Type 1 - Perpendicular | Initial Pass/Fail: Fail | Overall Compliance: No | Severity Score: | 16 |

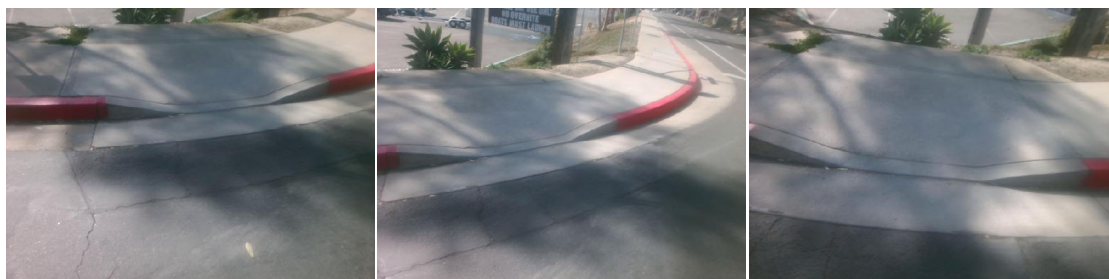
| Compliance | Description | Data | Compliance | Description | Data |
|---|---|---|---|---|---|
| No | Ramp Run Slope (%) | 11.2 | N/A | Flare Slope LT (%) | N/A |
| No | Ramp Cross Slope (%) | 4.9 | N/A | Flare Traversable LT | N/A |

**Remove & Replace Entire Ramp.**
