# Bridge Inspection Records Information System

**Bridge Inspection Report**

**Name : SANTIAGO CREEK**

Description of Structure : Continuous four span CIP/RC T-beam (5 each) with RC single column bents and RC open end seat abutments, all supported upon spread footings.

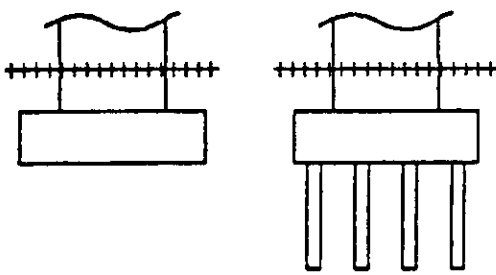
| | | <u>CALCULATED SCOUR DEPTH</u> | <u>ACTION NEEDED</u> |
|---|---|---|---|
| A | Above top of footing | | None - indicate rating of 8 for this item |

| <u>Code</u> | <u>Description</u> |
|---|---|
| 8 | Bridge foundations determined to be stable for assessed or calculated scour conditions, calculated scour is above top of footing. (Example A) |

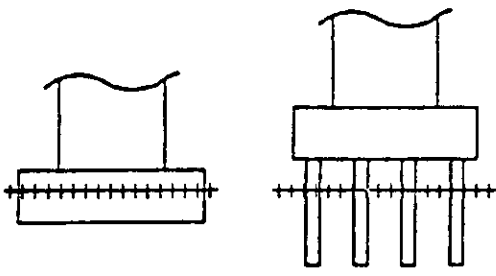
| | | <u>CALCULATED SCOUR DEPTH</u> | <u>ACTION NEEDED</u> |
|---|---|---|---|
| B | Within limits of footing or piles | | Conduct foundation structural analysis |

| <u>Code</u> | <u>Description</u> |
|---|---|
| 5 | Bridge foundations determined to be stable for calculated scour conditions, scour within limits of footing or piles. (Example B) |
| 3 | Bridge is scour critical, bridge foundations determined to be unstable for calculated scour conditions.<br>- Scour within limits of footing or piles. (Example B)<br>- Scour below spread-footing base or pile tips. (Example C) |

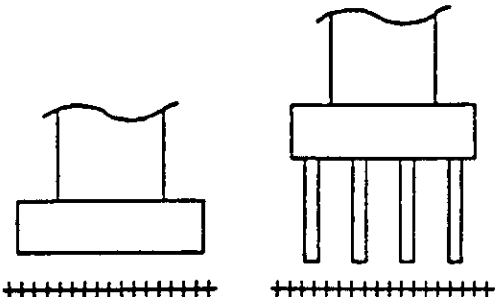
| | | <u>CALCULATED SCOUR DEPTH</u> | <u>ACTION NEEDED</u> |
|---|---|---|---|
| C | Below pile tips or spread-footing base | | Provide for monitoring and scour countermeasures as necessary |

+++++ = Calculated scour depth

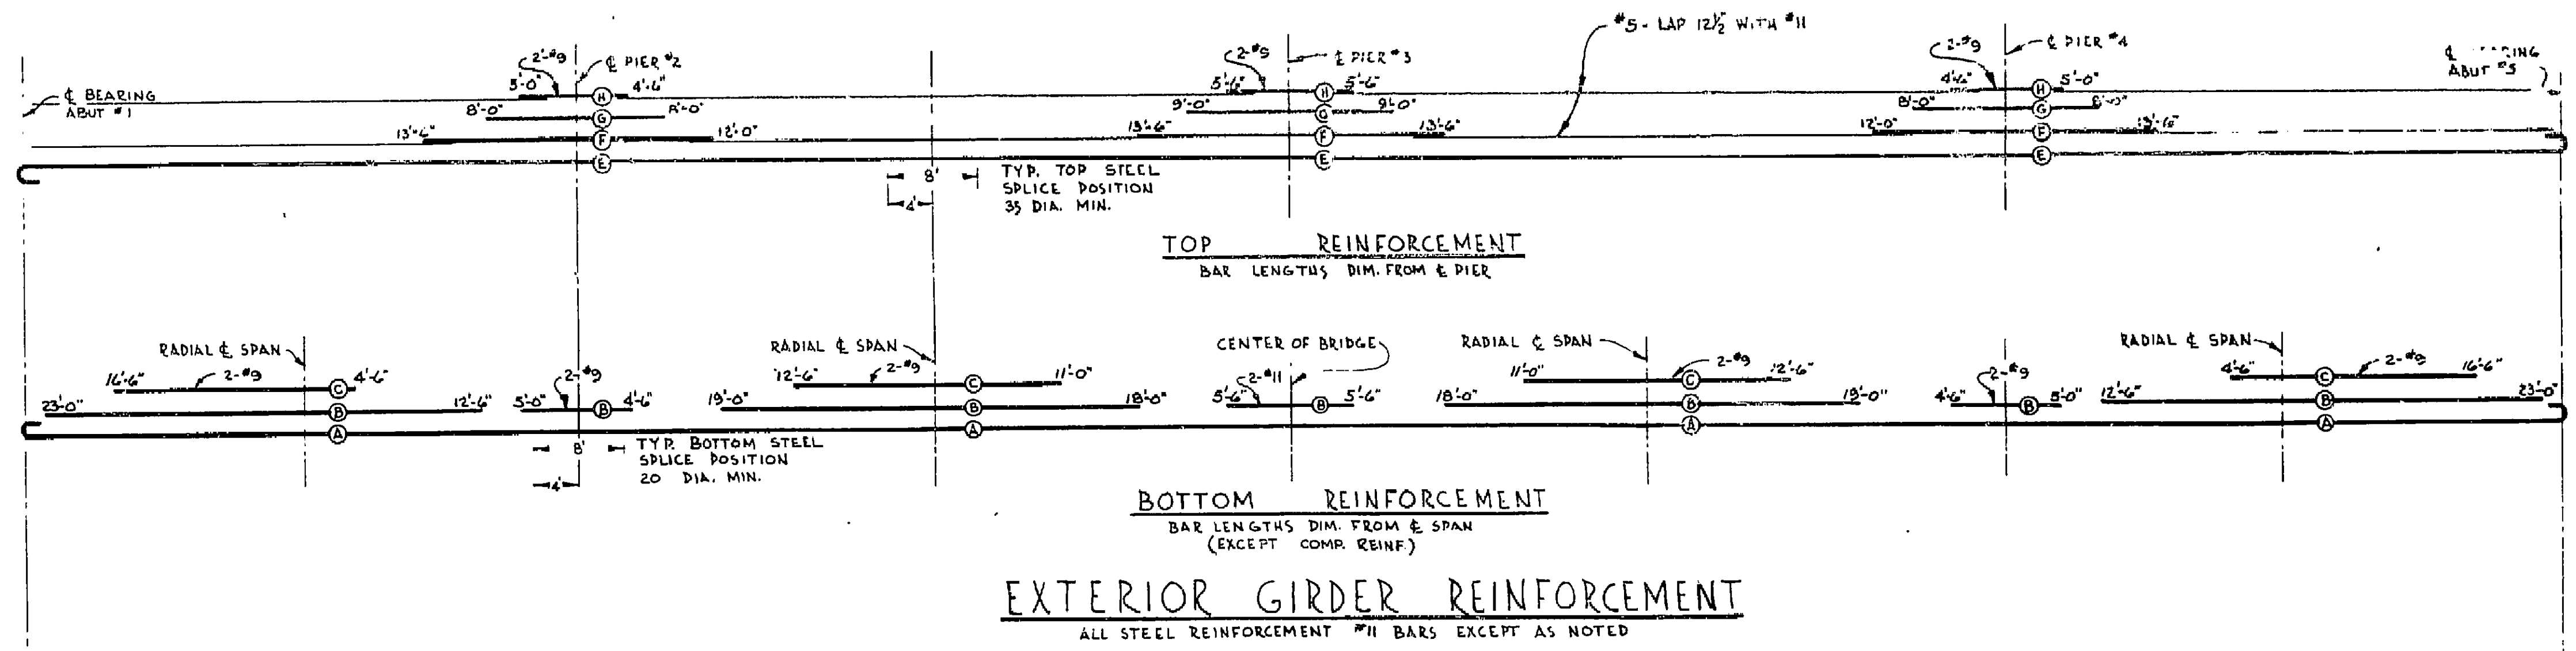
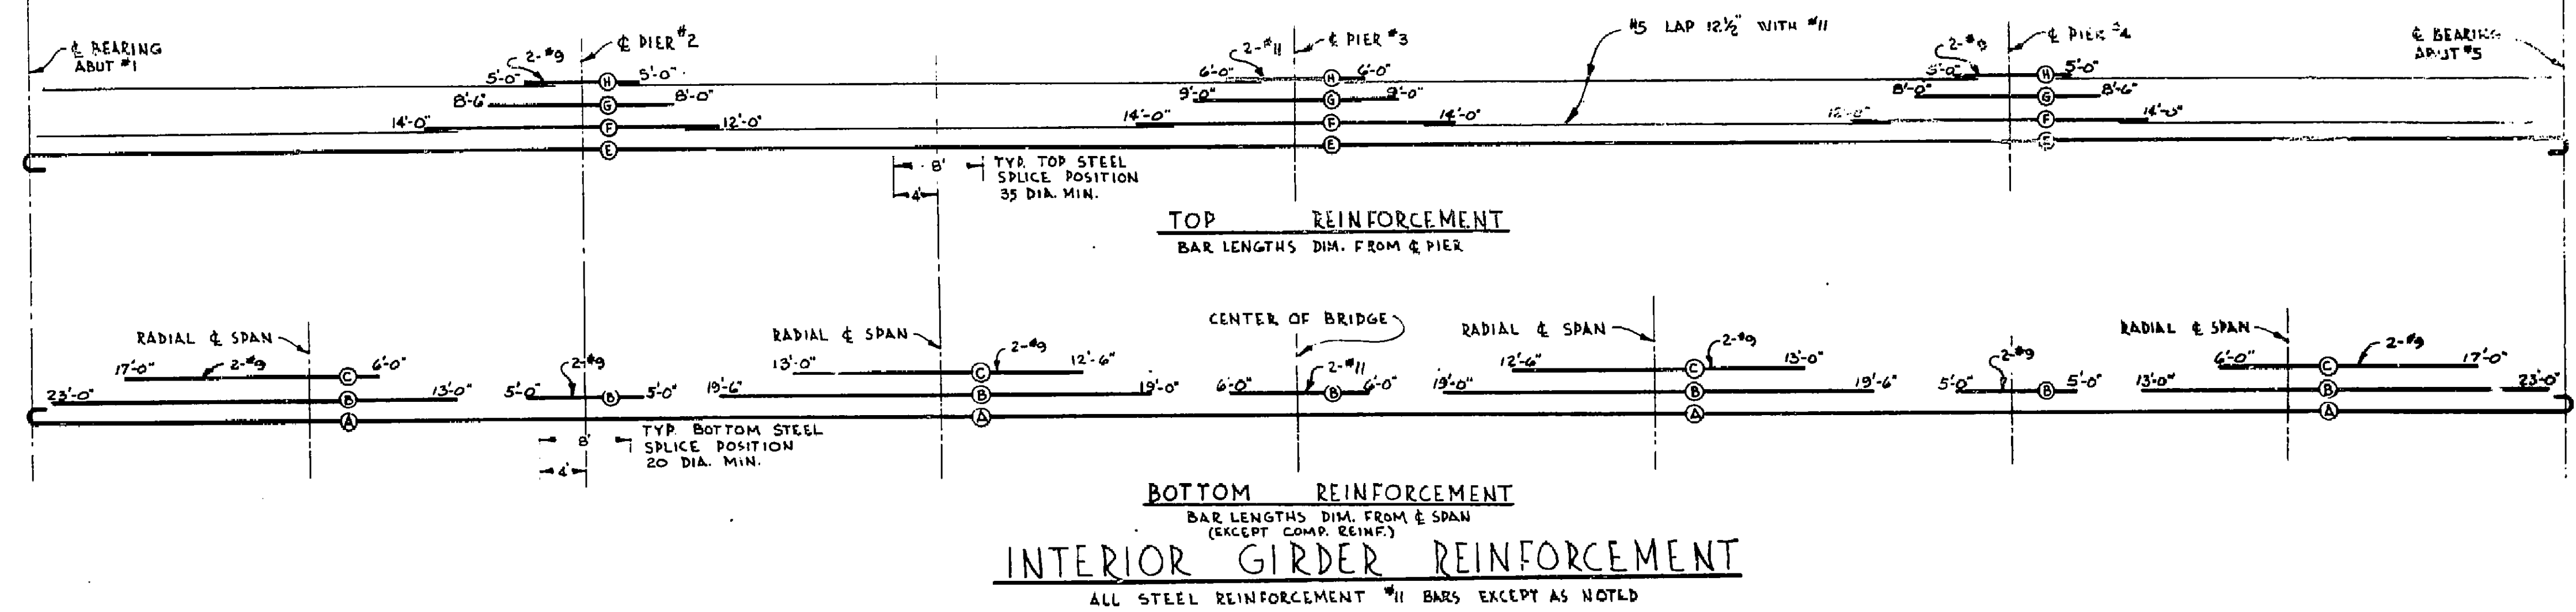
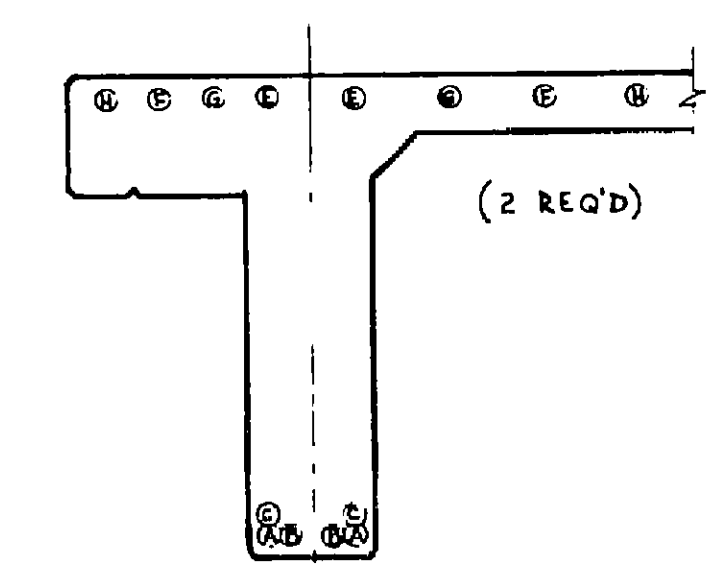
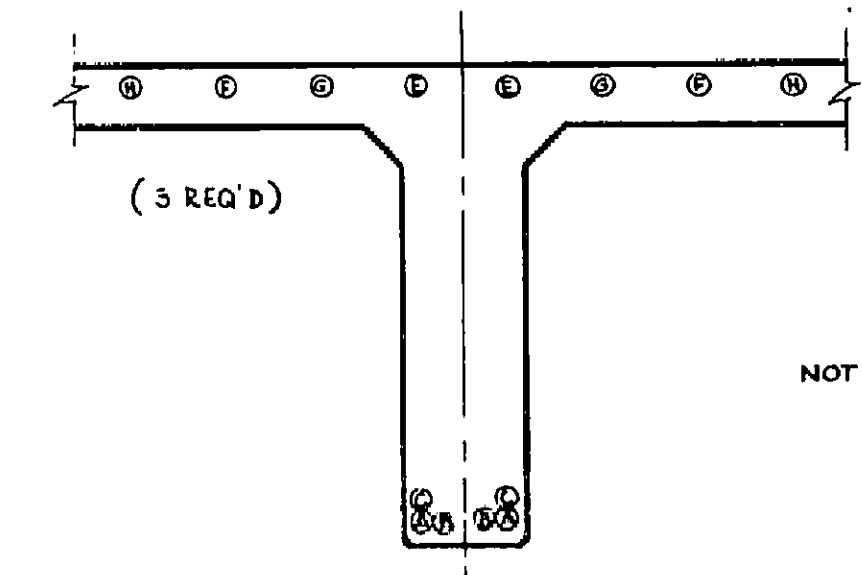
C-55C38-7  
 ORANGE COUNTY HIGHWAY DEPARTMENT  
 SANTIAGO CANYON  
 BRIDGE SC-9  
**GIRDER REINFORCEMENT**  
 SCALE 3/4" = 1'-0" SHEET 20 OF 28

NOTE:  
 LETTERS DENOTE POSITION,  
 NOT SIZE OF REINF. BAR.

NOTE: (A), (B) AND (C) BARS ARE BUNDLED

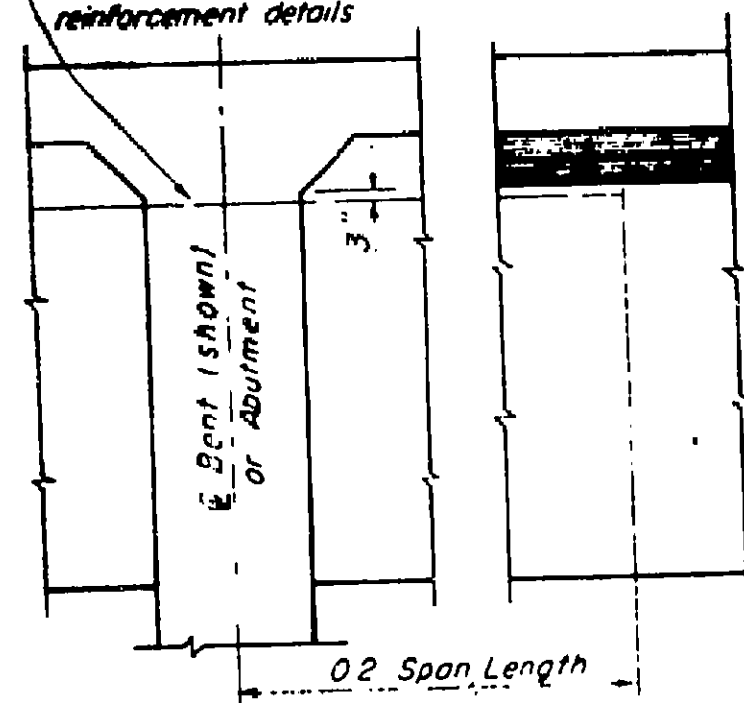
REINFORCEMENT  
DETAIL J-1

2" #8 in all bents and abutments. At bent locate between the 0.2 point of one span and the 0.2 point of the next span. At the abutments locate from the back face of abutment to the 0.2 point of the adjacent span. For any exceptions, see the reinforcement details.

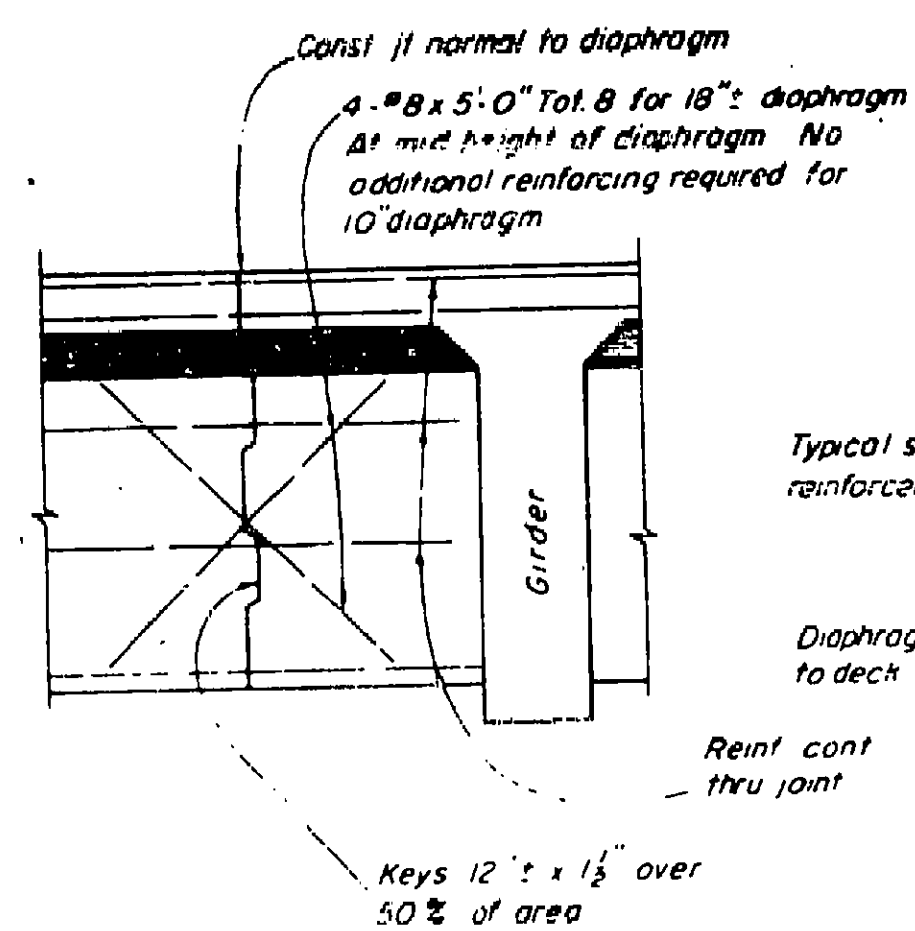
LONGITUDINAL CONSTRUCTION JOINT  
DETAIL J-4

Note: Longitudinal construction joints in slab, if required, are to be located at edge of traffic lanes except as approved by the Engineer.

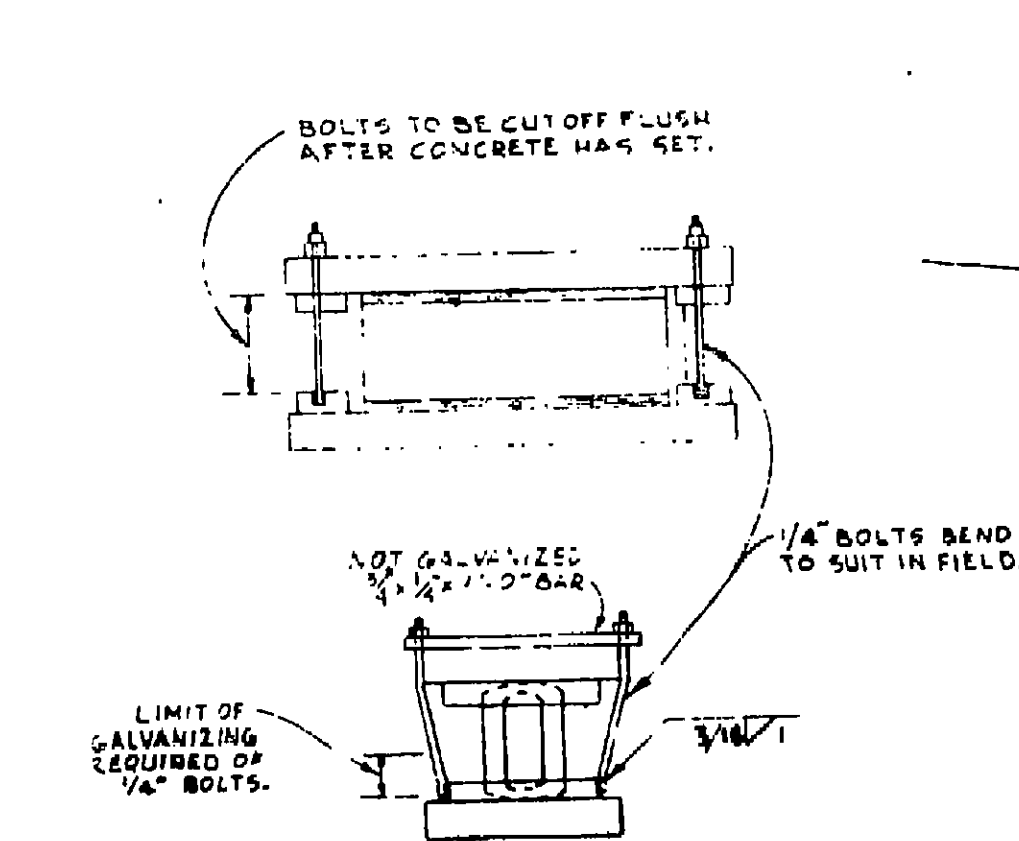
INTERMEDIATE  
DIAPHRAGM SECTION  
DETAIL D-1

DETAIL OF ERECTION BOLTS  
SCALE: 1 1/2" = 1'-0"

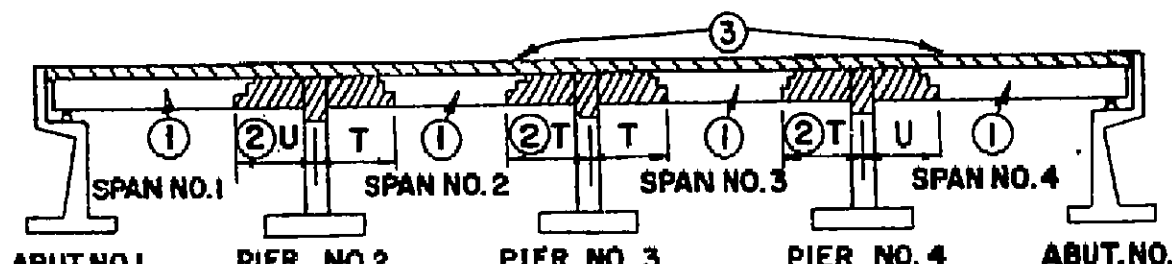
TEE BEAM SUPERSTRUCTURE PLACING DIAGRAM

NUMBERS (1) AND (2) INDICATE SEQUENCE OF PLACING GIRDER STEM CONCRETE  
 (2) MAY BE PLACED SIMULTANEOUSLY WITH (1) WHEN APPROVED BY THE ENGINEER, AND PROVIDED THAT THE (1) SECTIONS ARE PLACED IN ADJOINING SPANS.  
 TOP SLAB CONCRETE (3) SHALL BE PLACED SEPARATELY FROM (1) AND (2).  
 (3) MAY BE PLACED CONTINUOUSLY OR IN PARTS AS APPROVED BY THE ENGINEER, HOWEVER THE ONLY JOINTS PERMITTED SHALL BE LOCATED WITHIN 2'-0" OF THE GIRDER JOINTS BETWEEN (1) AND (2).  
 T = 1/5 SPAN LENGTH  
 U = 1/4 SPAN LENGTH  
 FOR ANY DEVIATION FROM THE ABOVE THE CONTRACTOR SHALL SUBMIT A DIAGRAM TO THE ENGINEER.

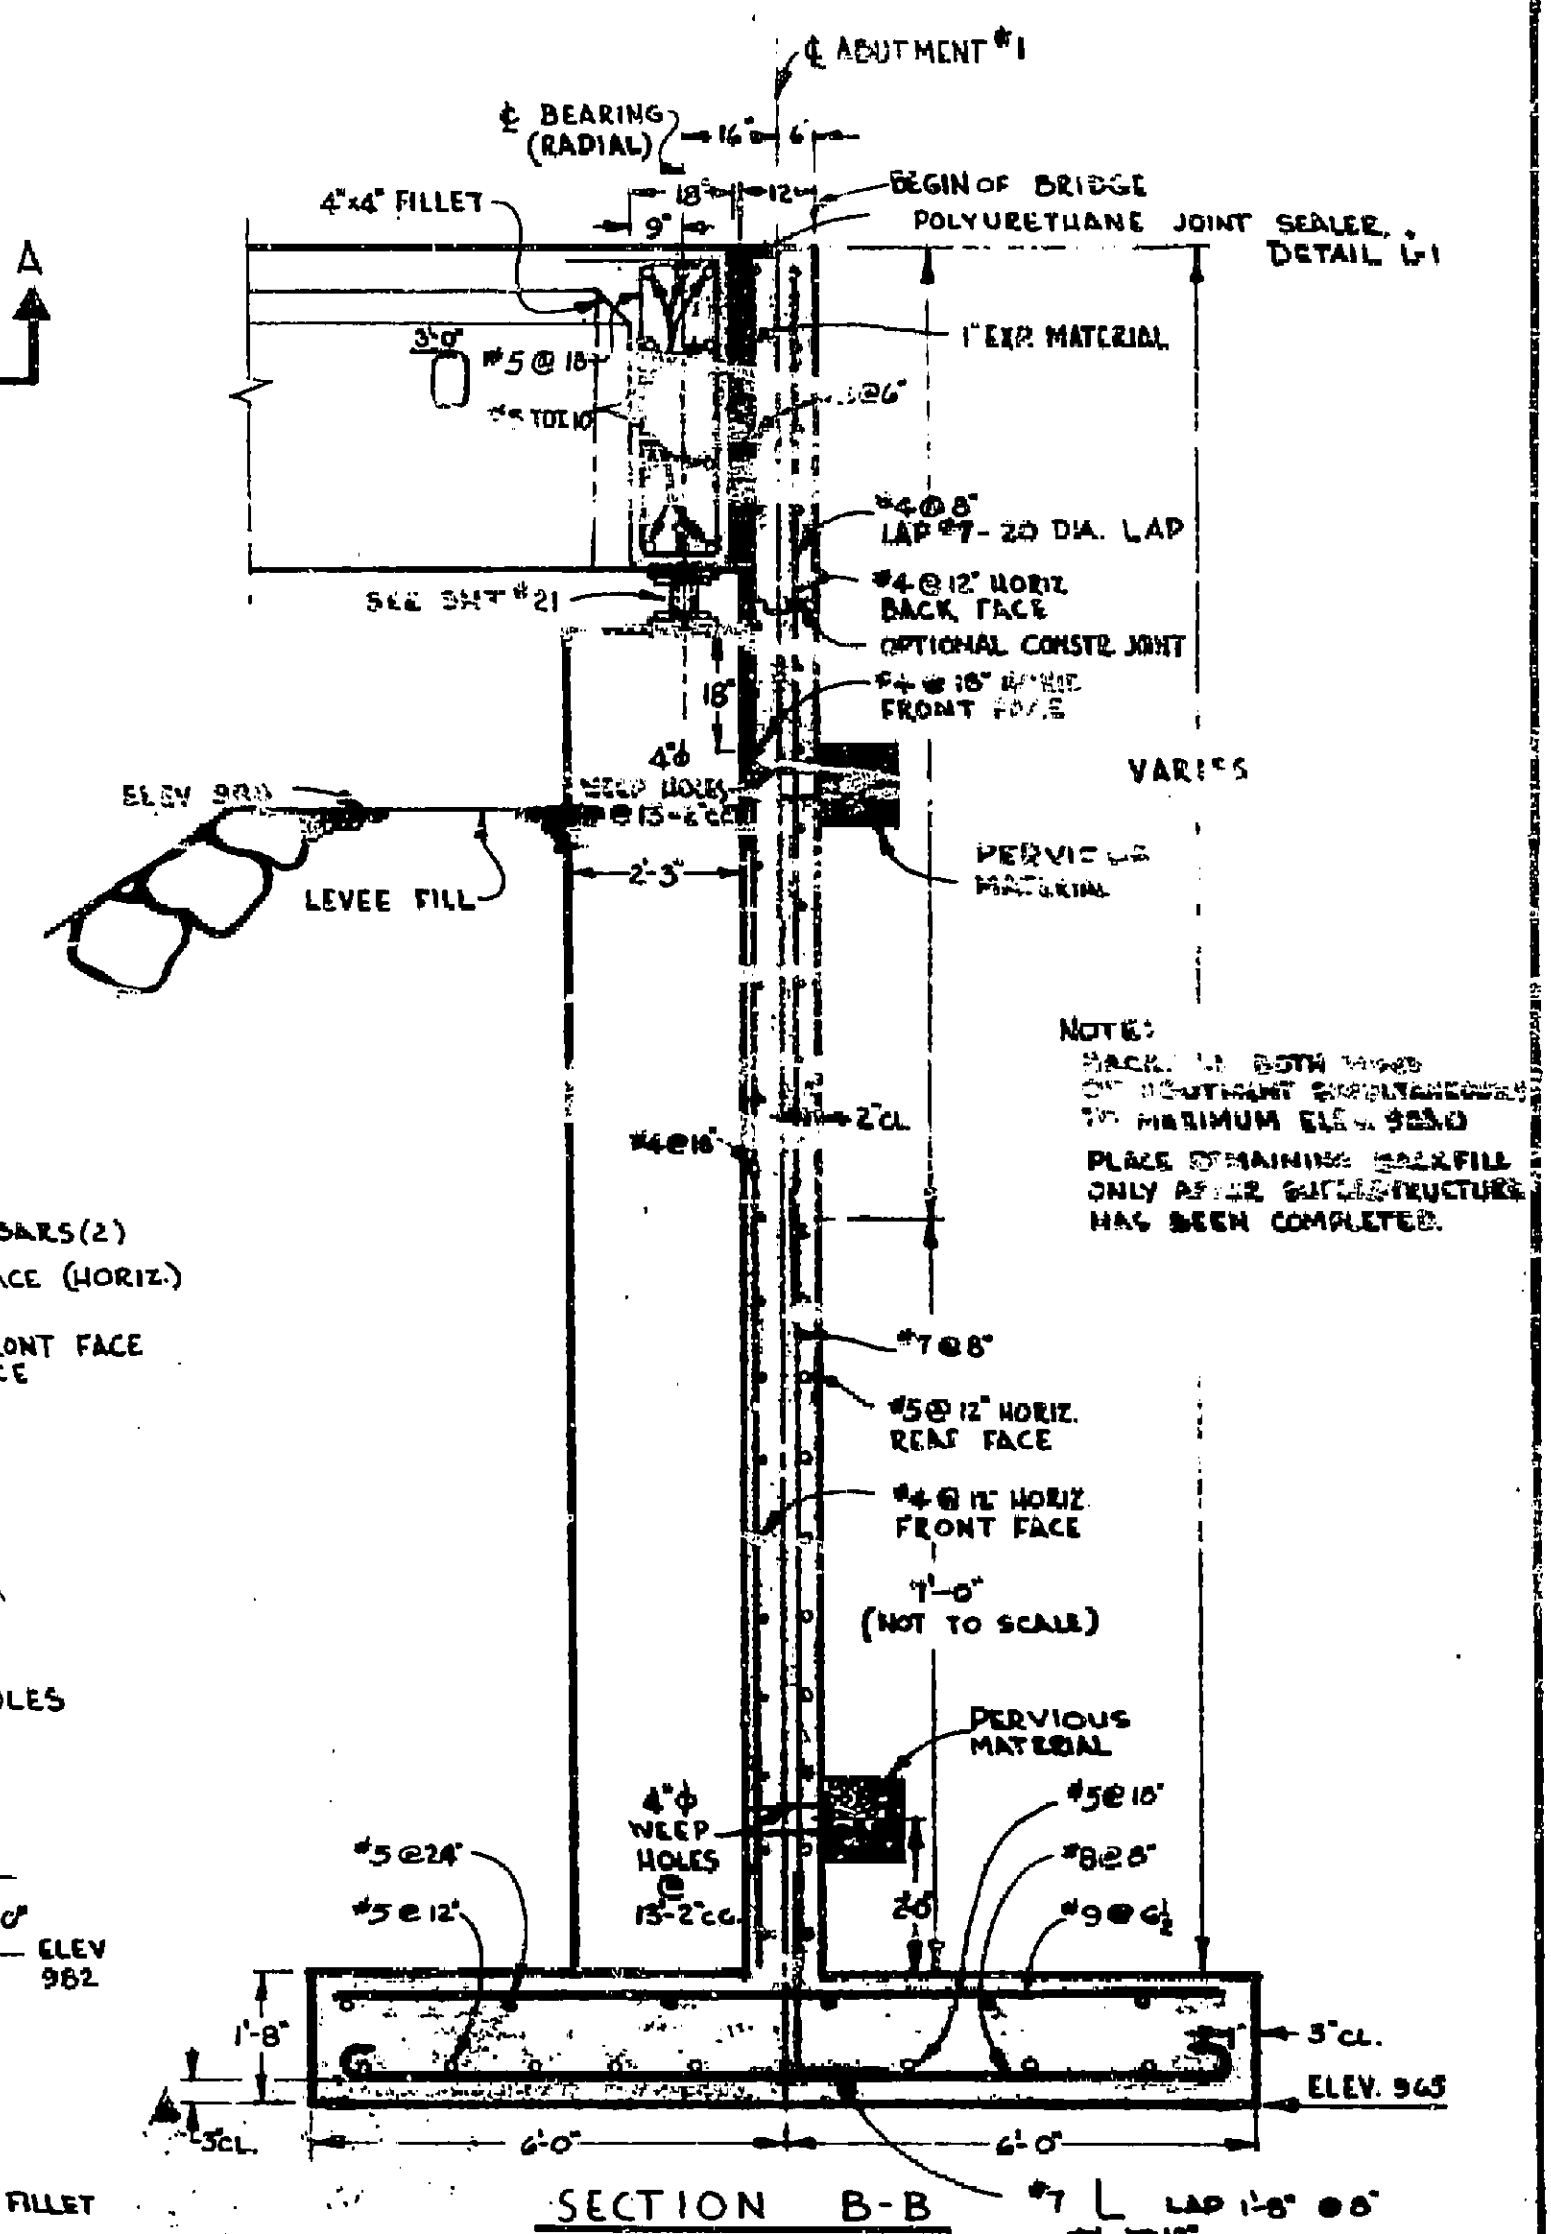
SECTION B-B

NOTE:  
 BACK OF BOTH WINGS  
 OF ABUTMENT DISCONTINUED  
 TO MINIMUM ELEV. 955.0  
 PLACE REMAINING BACK FILL  
 ONLY AFTER OUTLETS/STRUCTURE  
 HAS BEEN COMPLETED.
