Bridge Inspection Records Information System

Bridge Number : 55C0175
Facility Carried: SILVERADO CYN RD
Location : 2.2 MI E OF SANTIAGO RD
City :
Inspection Date : 29-MAY-01

Bridge Inspection Report

Name : LADD CANYON

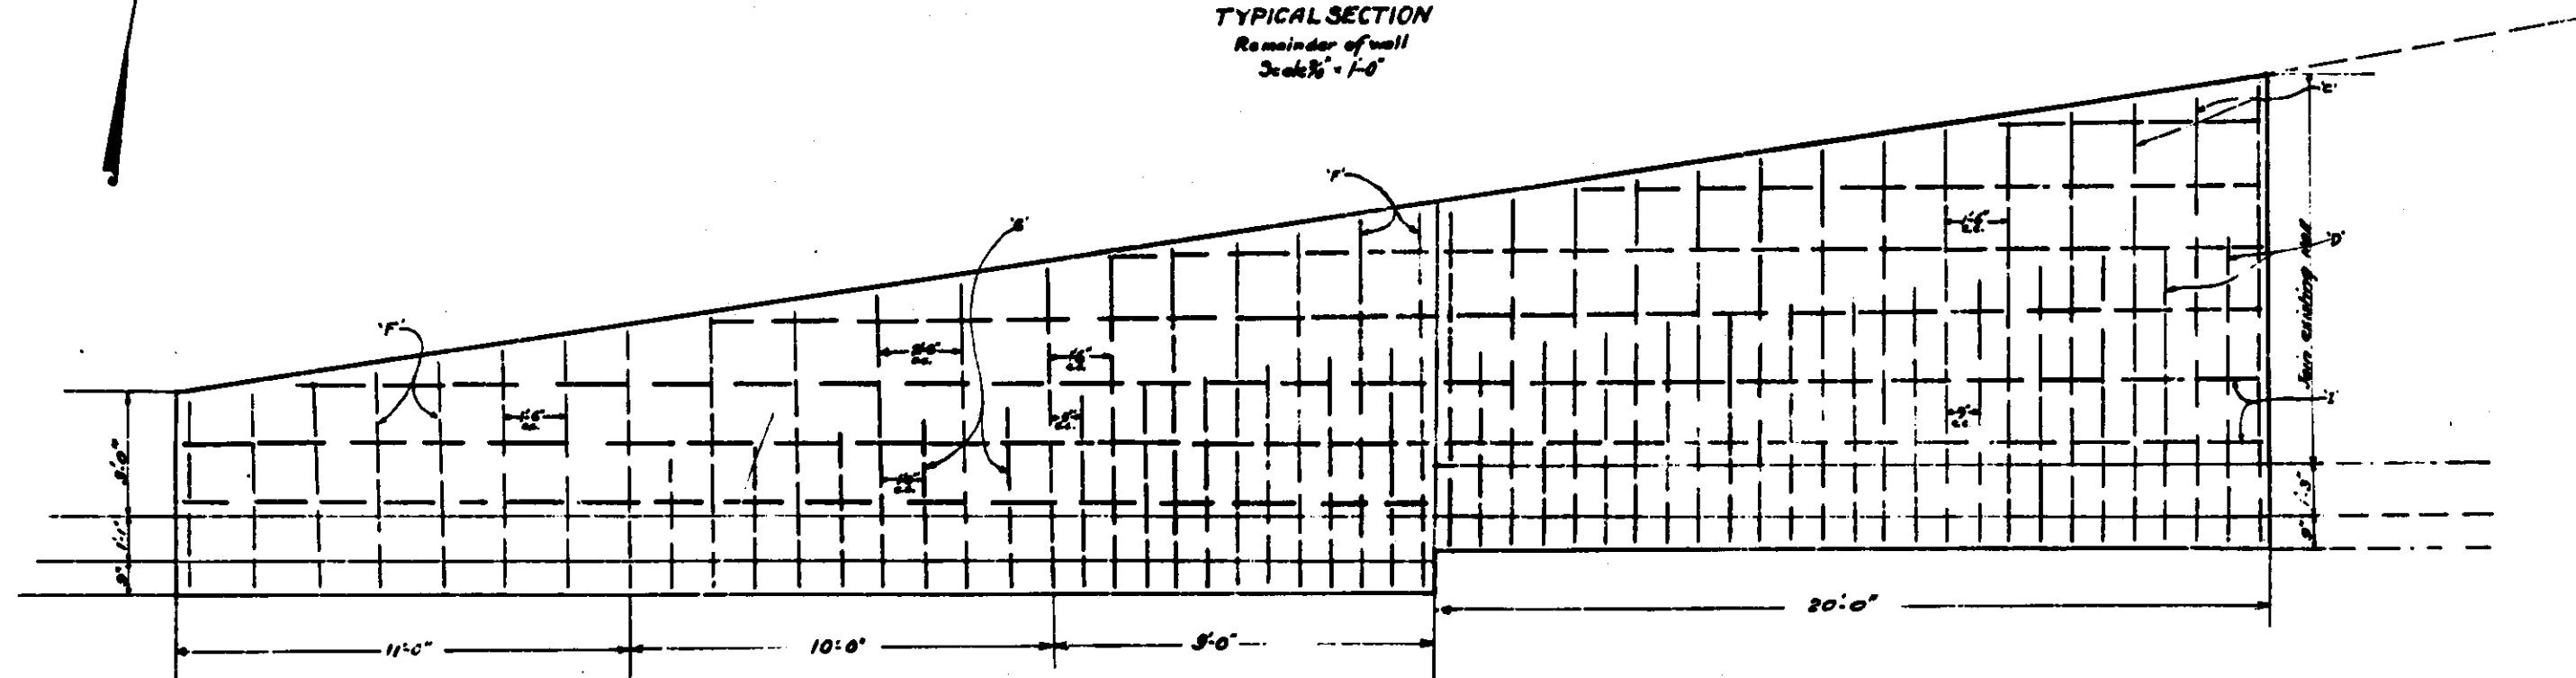
ELEVATION
Scale 3/8" = 1'-0"

ORANGE COUNTY HIGHWAY DEPT.
REINFORCED CONCRETE
RETAINING WALL
LADD CANYON BRIDGE S.V. 8
FEB. 1947 SCALE AS SHOWN
