# Bridge Inspection Records Information System

**Bridge Inspection Report**

**Name : SUNSET CHANNEL**

Description of Structure : Simply supported 4-span CIP/RC deck slab with RC pile bents and pile bent abutments.

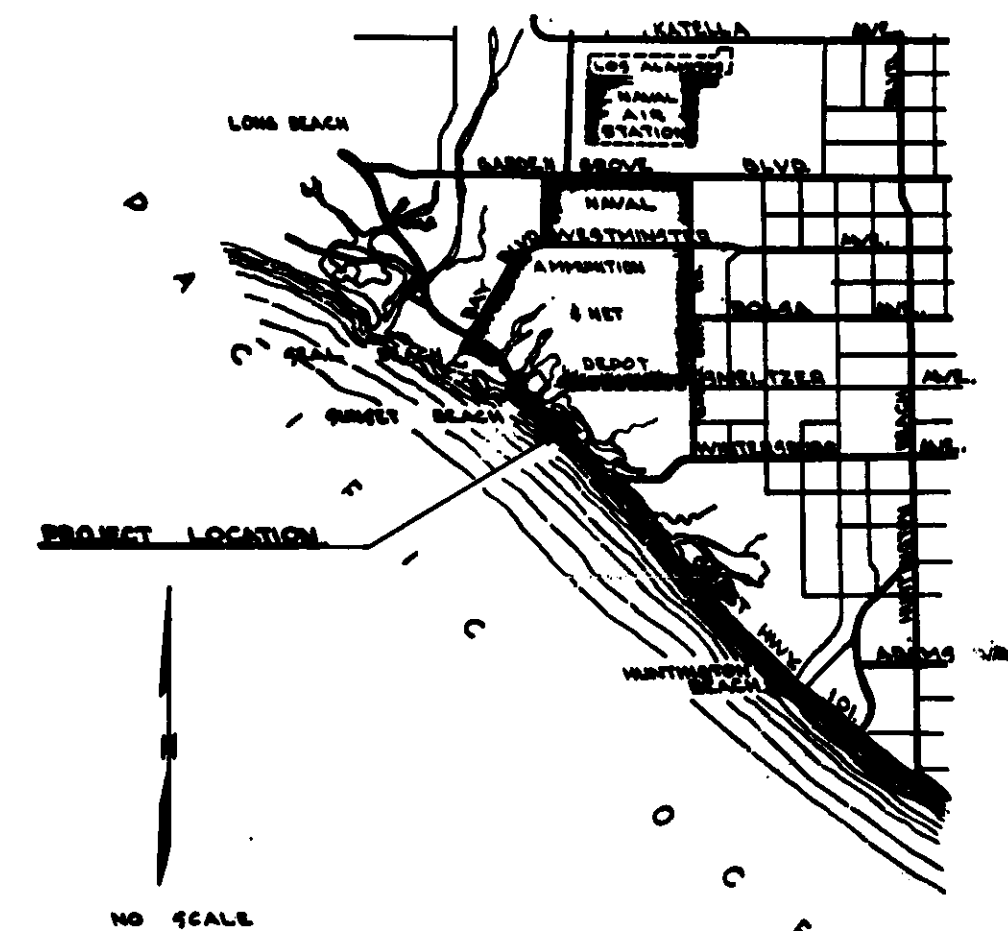
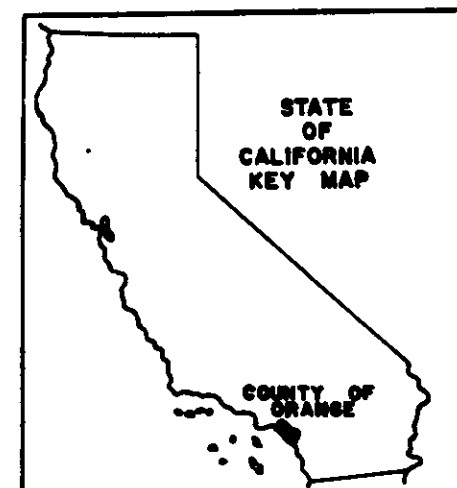
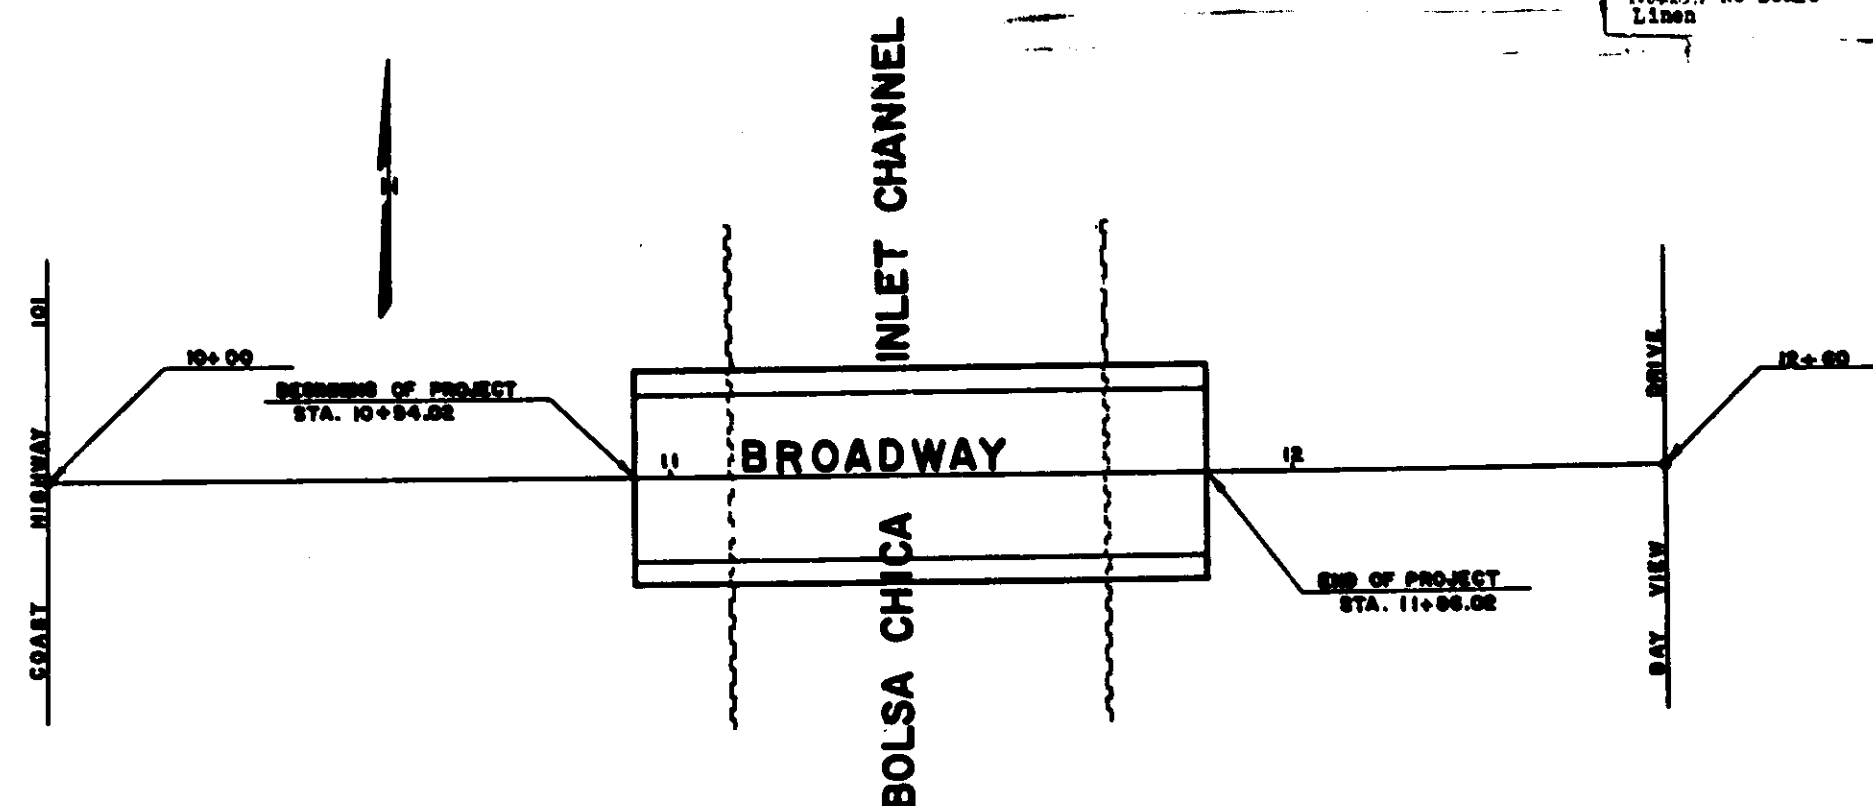
Bridge #AN-2  
Broadway Bridge  
Across Bolsa Chica Inlet  
Channel  
Sheet 1 of 7  
Plans / No Scale  
Linen

FROM STATION 10+94.02 TO STATION 11+86.02

TOTAL LENGTH 0.0174 MILES

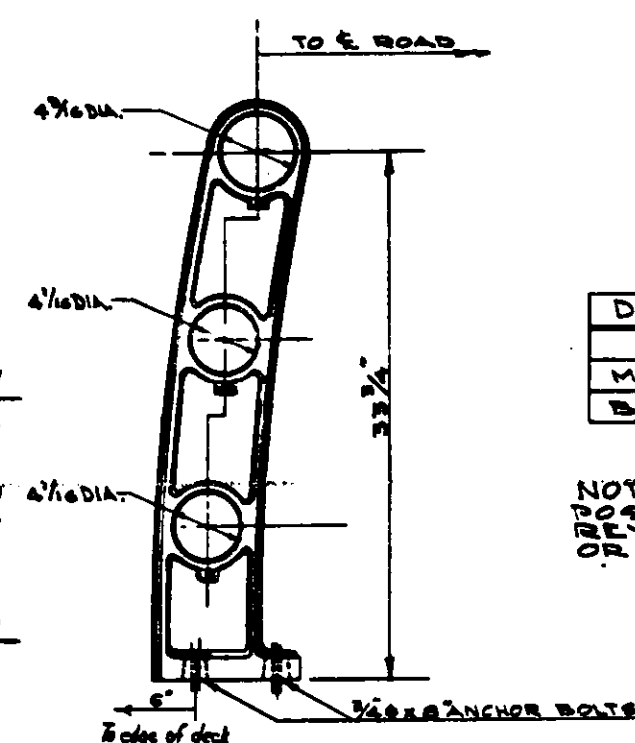
- 1- RAILINGS NOT SHOWN
- 2- SET ANCHOR BOLTS TO MATCH FABRICATED RAILING.

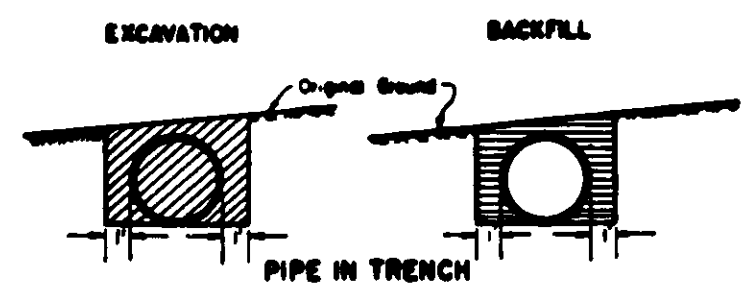
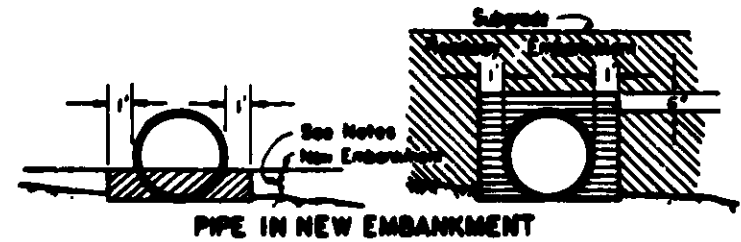
**PIPES, RODS & DEADMEN**  
 Except Underdrains & Dose-drains

Height of Top of Embankment Before Excavating For Pipe  
 Shall Be As Follows:-  
 For pipe 24" or less dia. 6" above top of pipe  
 For C.M.P. over 24" to 30" dia. 30" above bottom of pipe  
 For C.M.P. over 30" dia. 1/3 point of dia. above bottom of pipe  
 For R.C.P. over 24" dia. 30" above bottom of pipe  
 For hand excavated pipe culvert 1/3 point of dia. above bottom of pipe  
 Structure Backfill 6" Above Top of Pipe

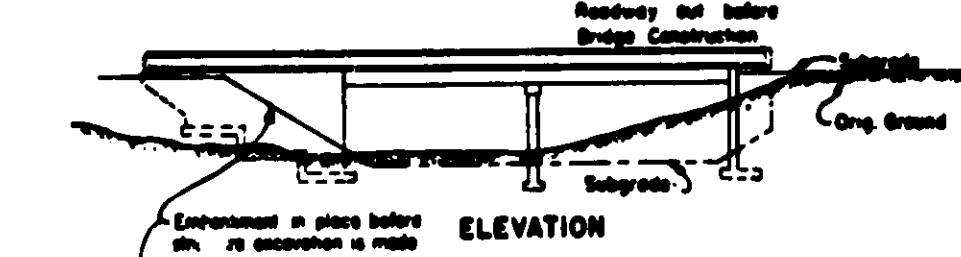
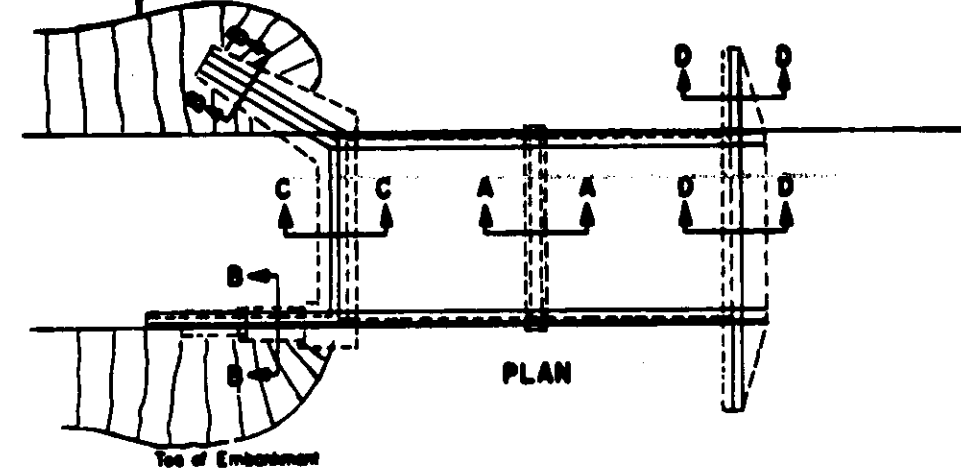
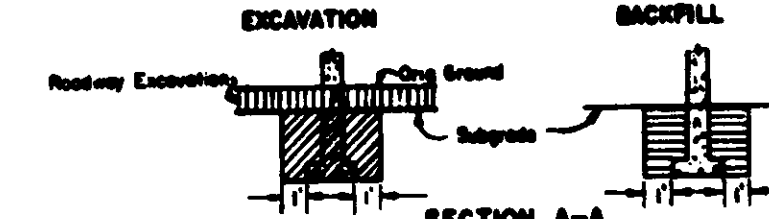
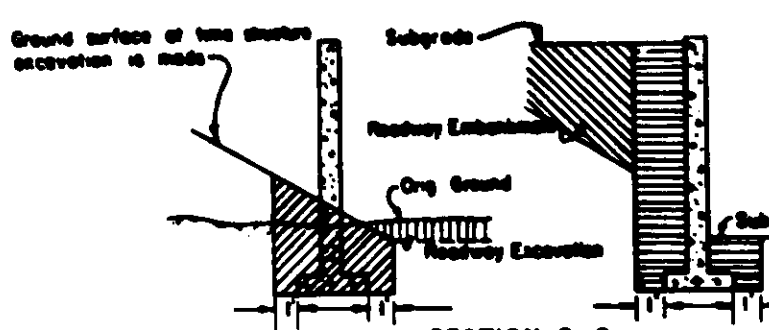
**MONOLITHIC CONCRETE SLOPE PAVING; RIPRAP**

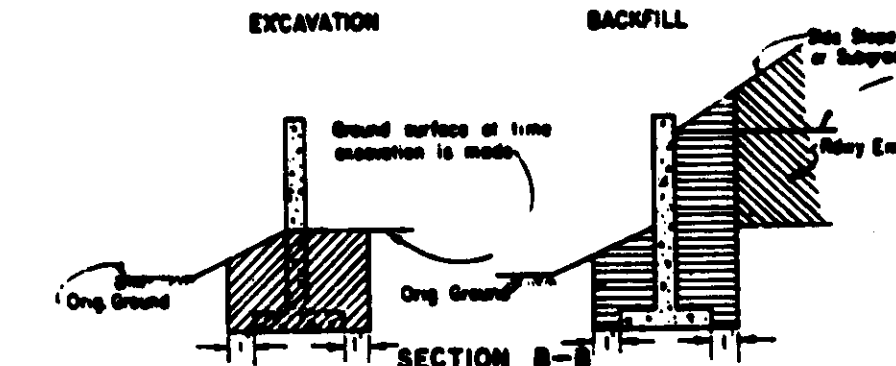
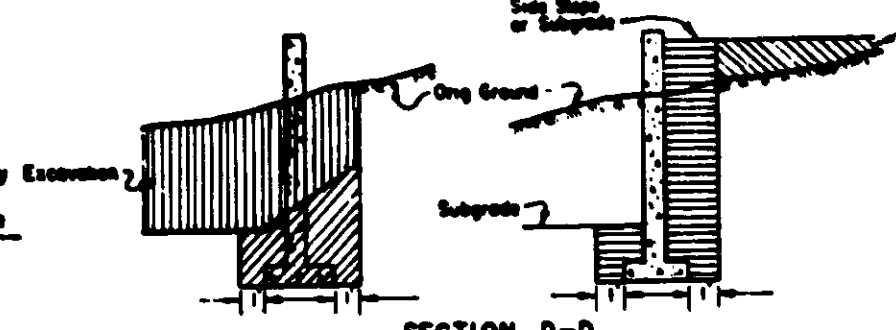
**BRIDGE ABUTMENTS & ADJOINING WING WALLS**

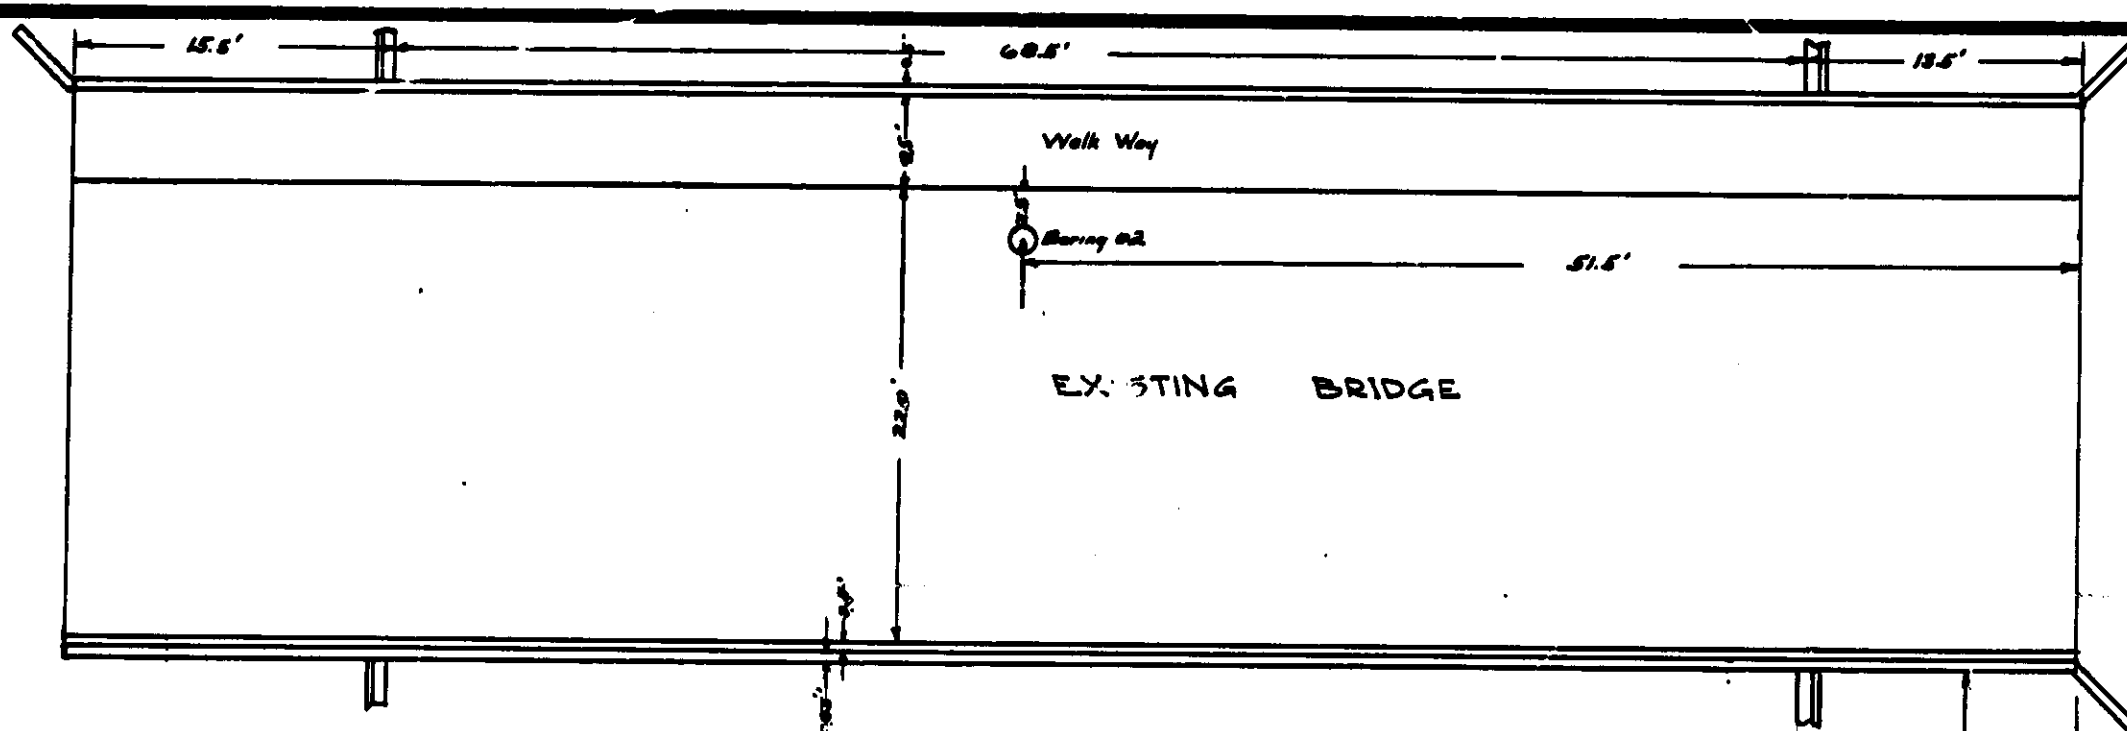
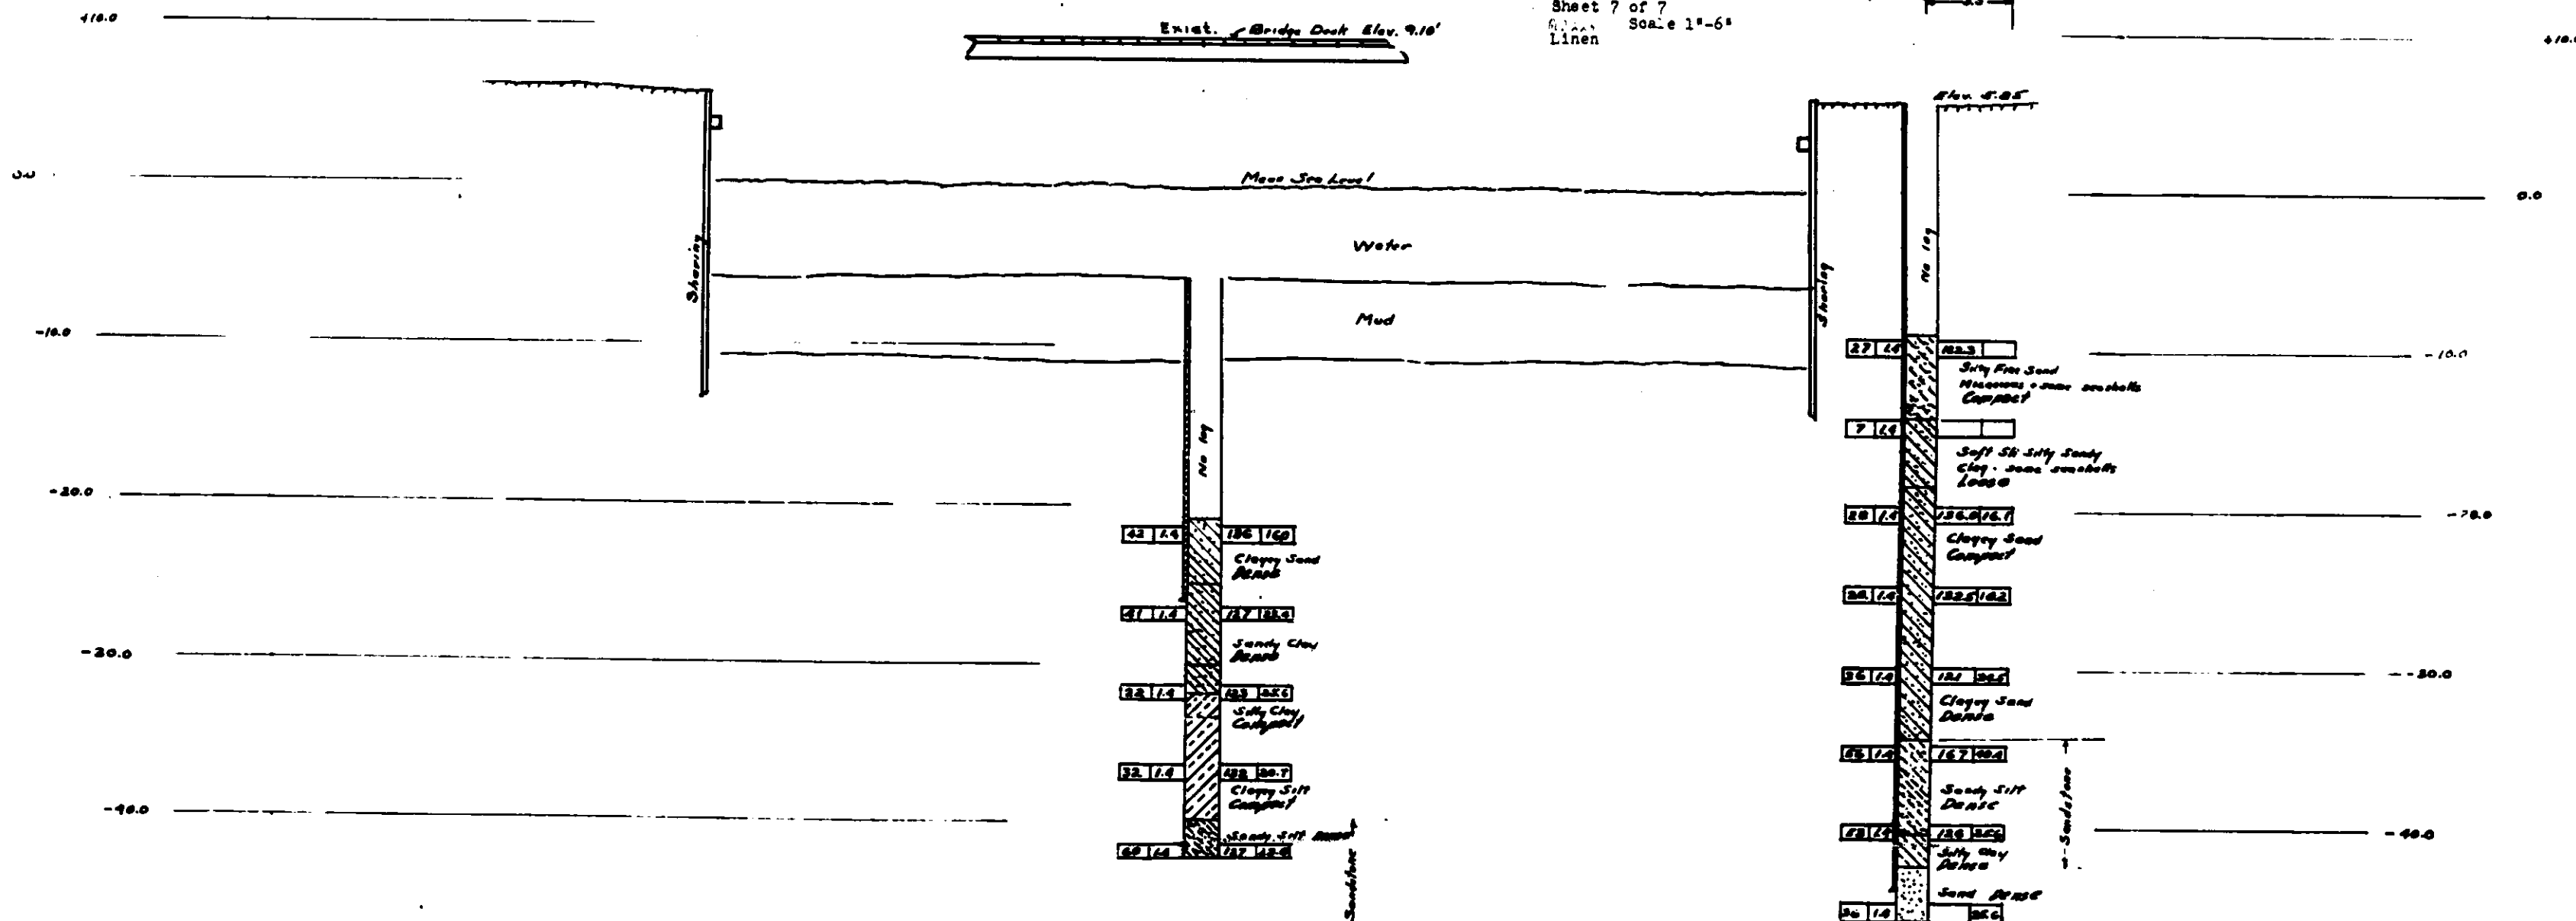
Bench Mark Int. Hwy 101 & Broadway, E. Signal  
Light Base, 30' NE & Hwy 101, 30' SE & Broadway  
Elevation 6.13'

Bridge #AN-2  
Broadway Bridge  
Across Bolsa Chica  
Inlet Channel  
Sheet 7 of 7  
Scale 1" = 6'
