# Bridge Inspection Records Information System

Bridge Number : 55C0561  
Facility Carried: ISLAND WAY  
Location : 0.1 MI S DANA PT HRBR DR  
City :  
Inspection Date : 14-AUG-01

**Bridge Inspection Report**

Description of Structure : Simply supported 4-span PC/PS concrete box girder (8 units) with a continuous RC deck and RC single column bents and RC closed end strutted abutments, all supported upon spread footings.

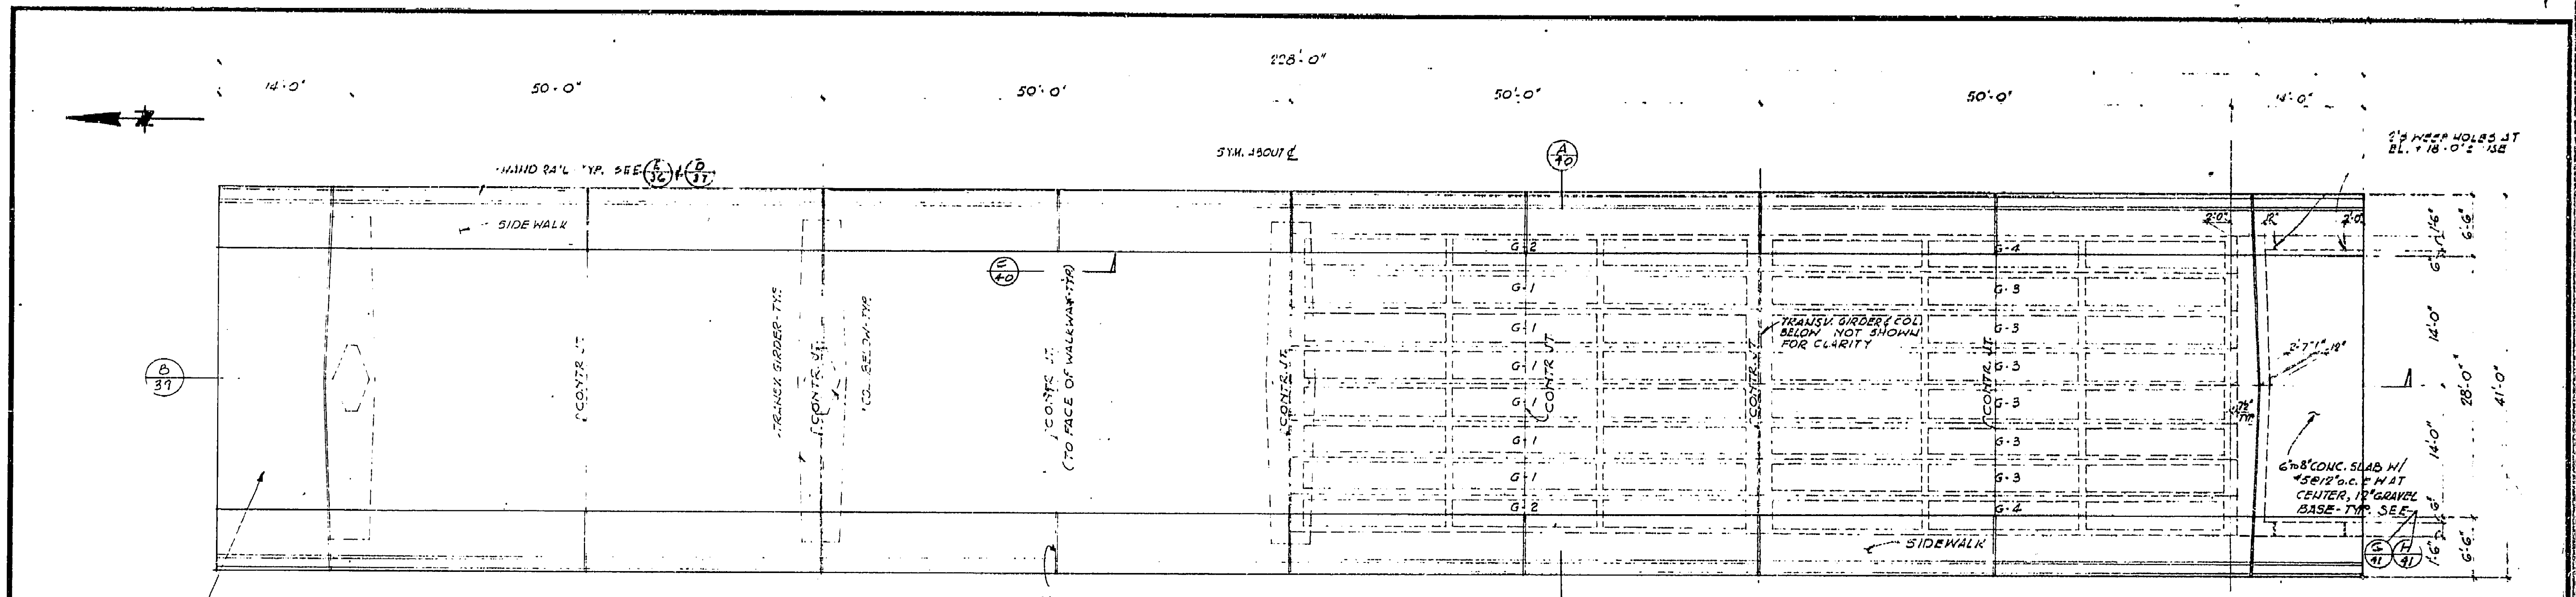
PLAN A SEE PARTIAL PLAN A

NOTE: APPROACH STRUCTURES TO BE CONSTRUCTED SIX MONTHS AFTER COMPLETION OF FILL. MODIFIED BY CONTRACTOR REQUEST

NOTE: SEE SH. 37 FOR PLAN OF REVETTED SLOPE & BRIDGE SUPPORT.

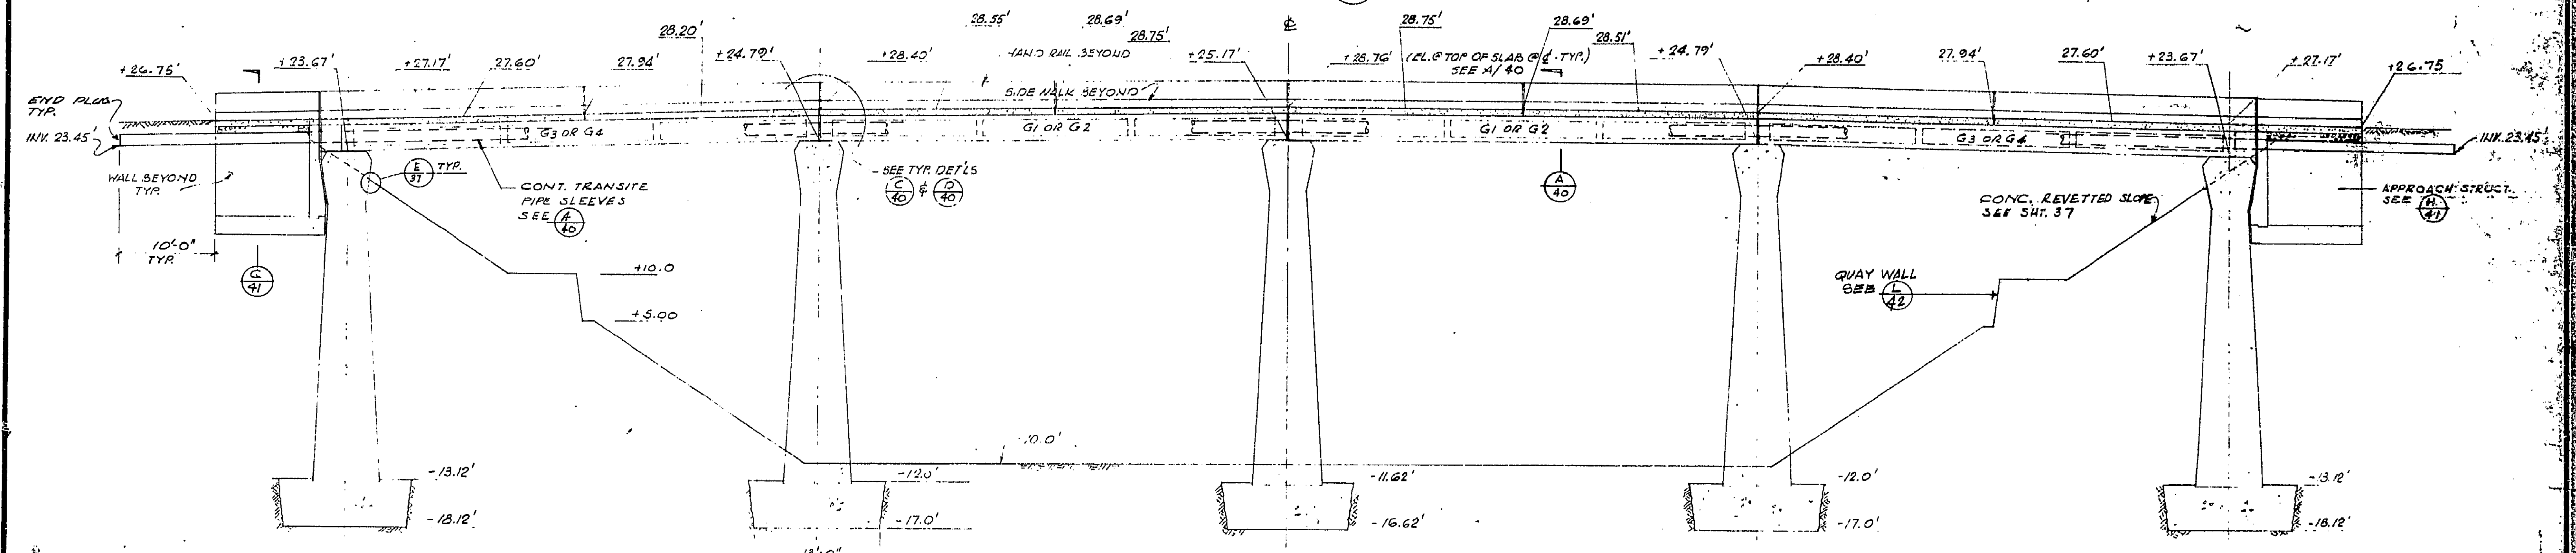
SECTION B

NOTE: CONCRETE FOOTINGS PLACED AGAINST CUT BANK

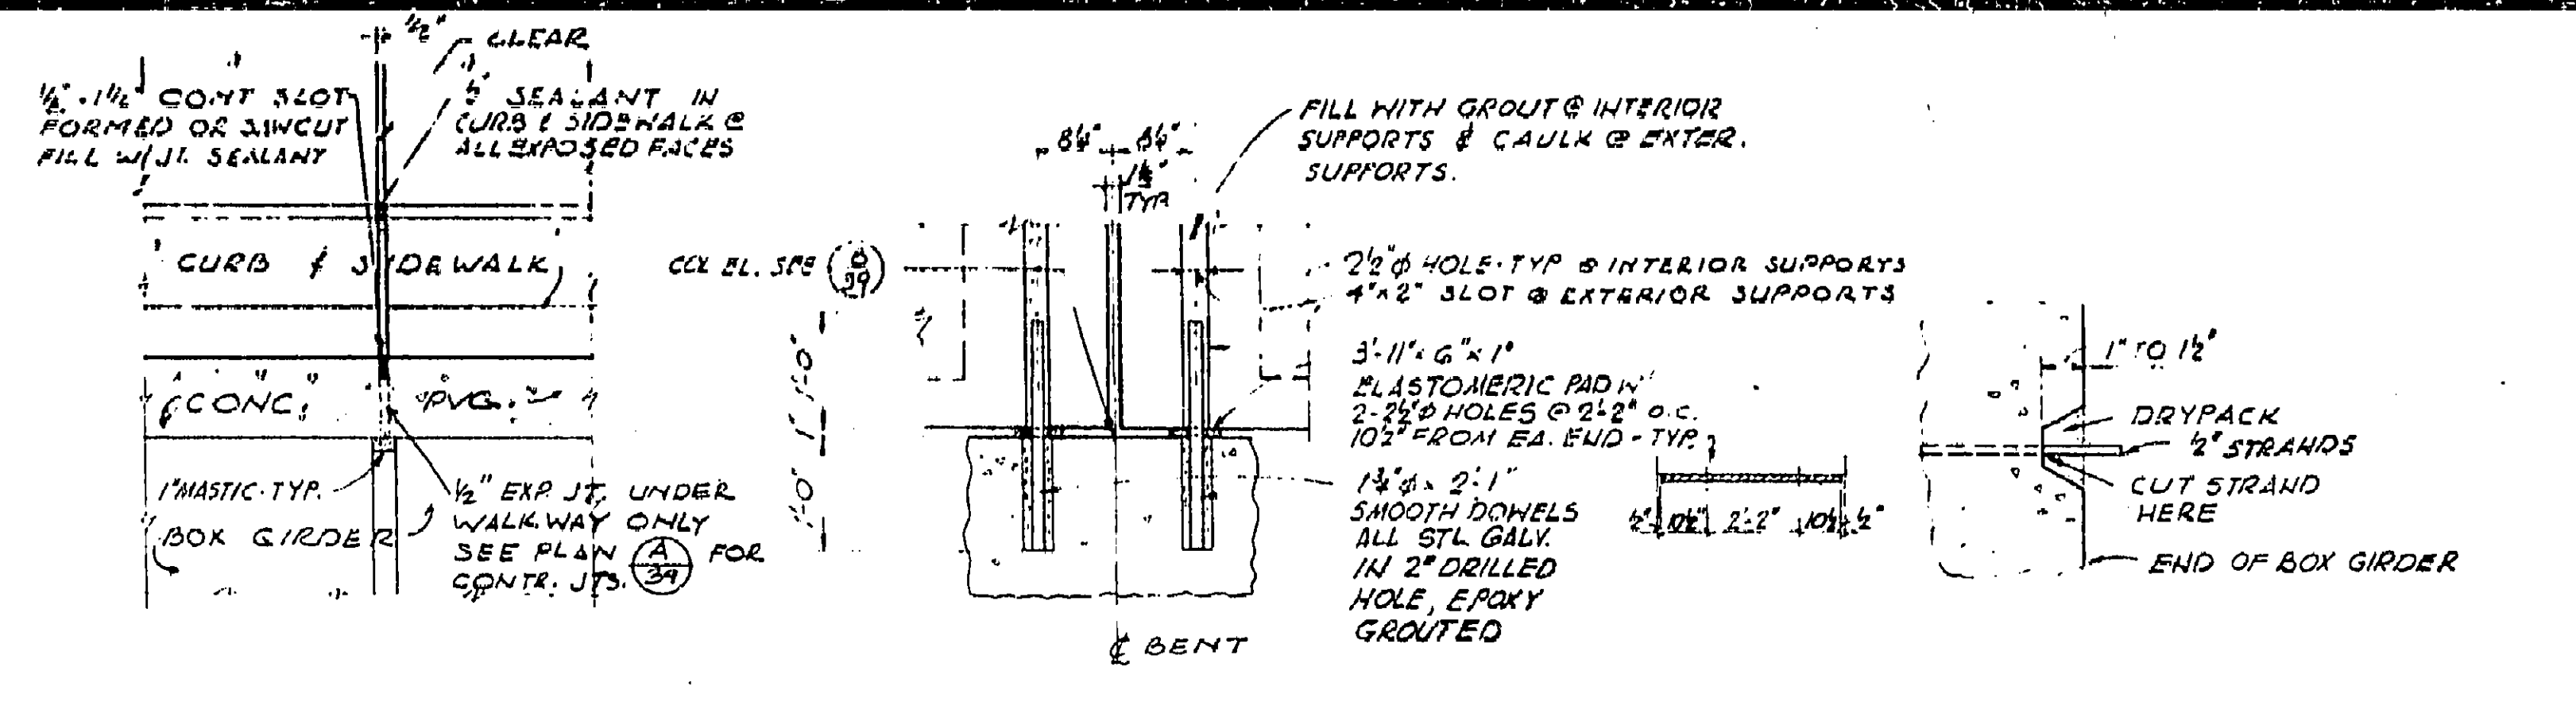
DET. @ ENDS OF PRESTRESSING

5 STRANDS NO SCALE

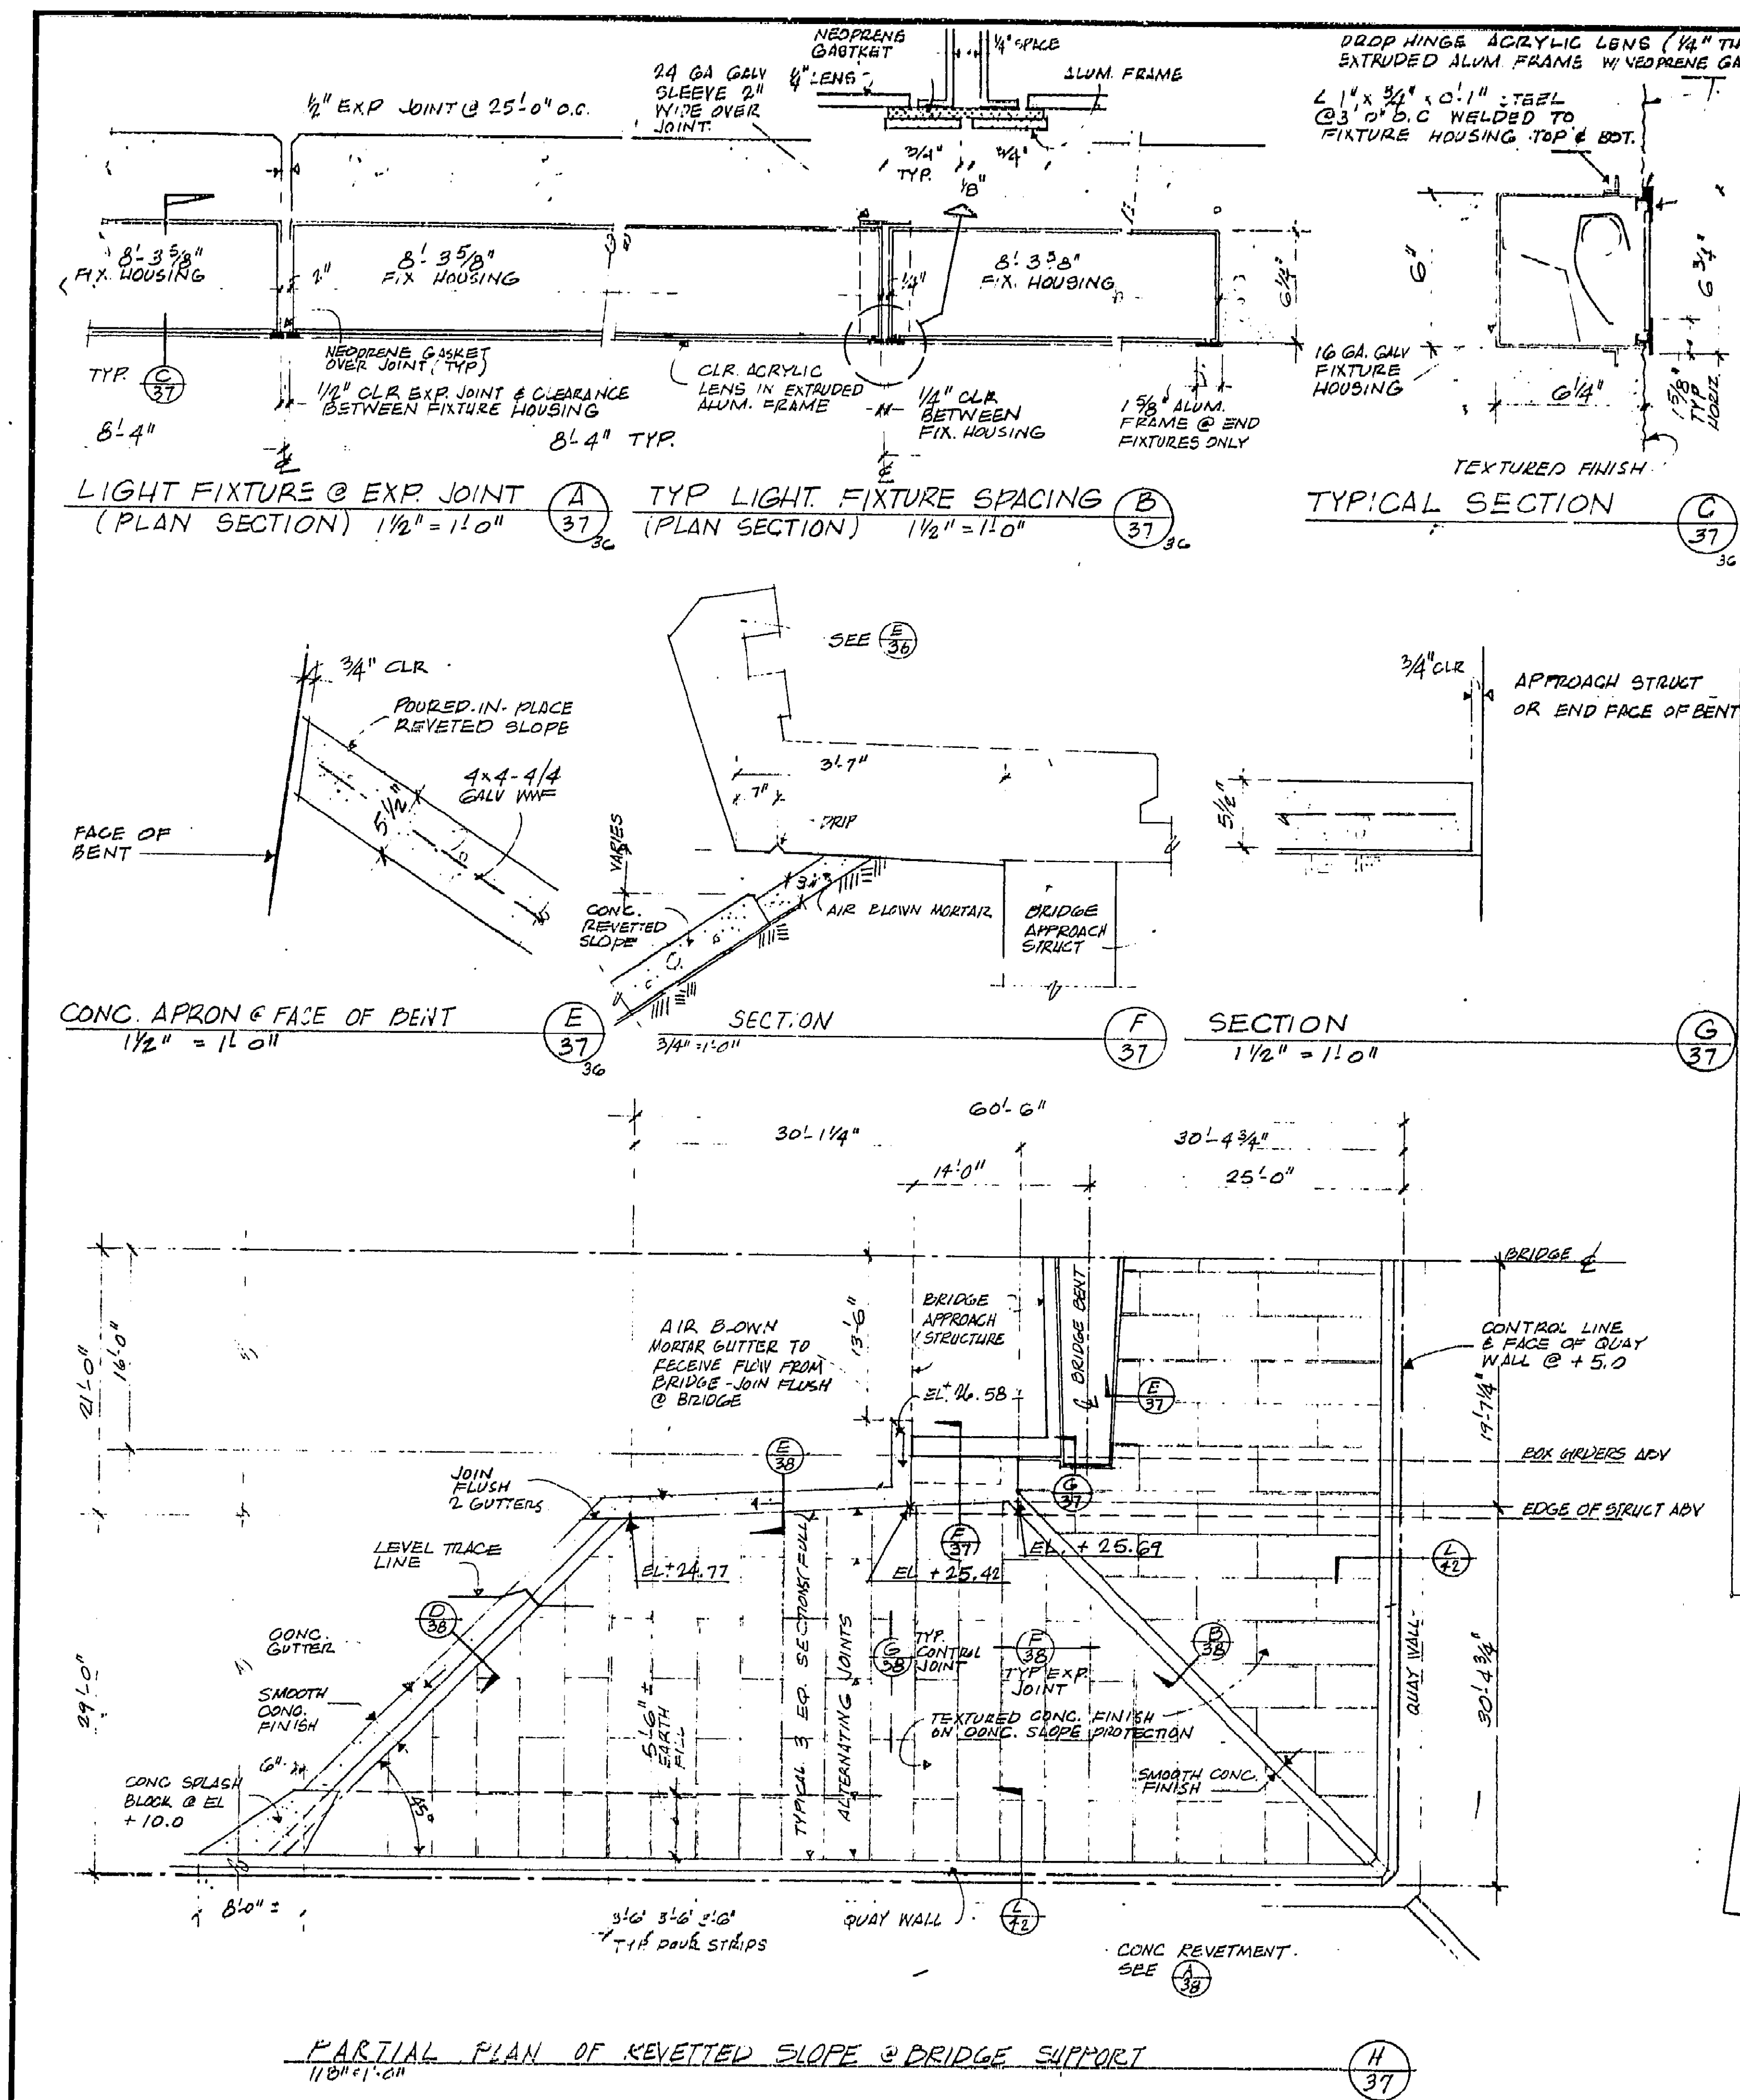
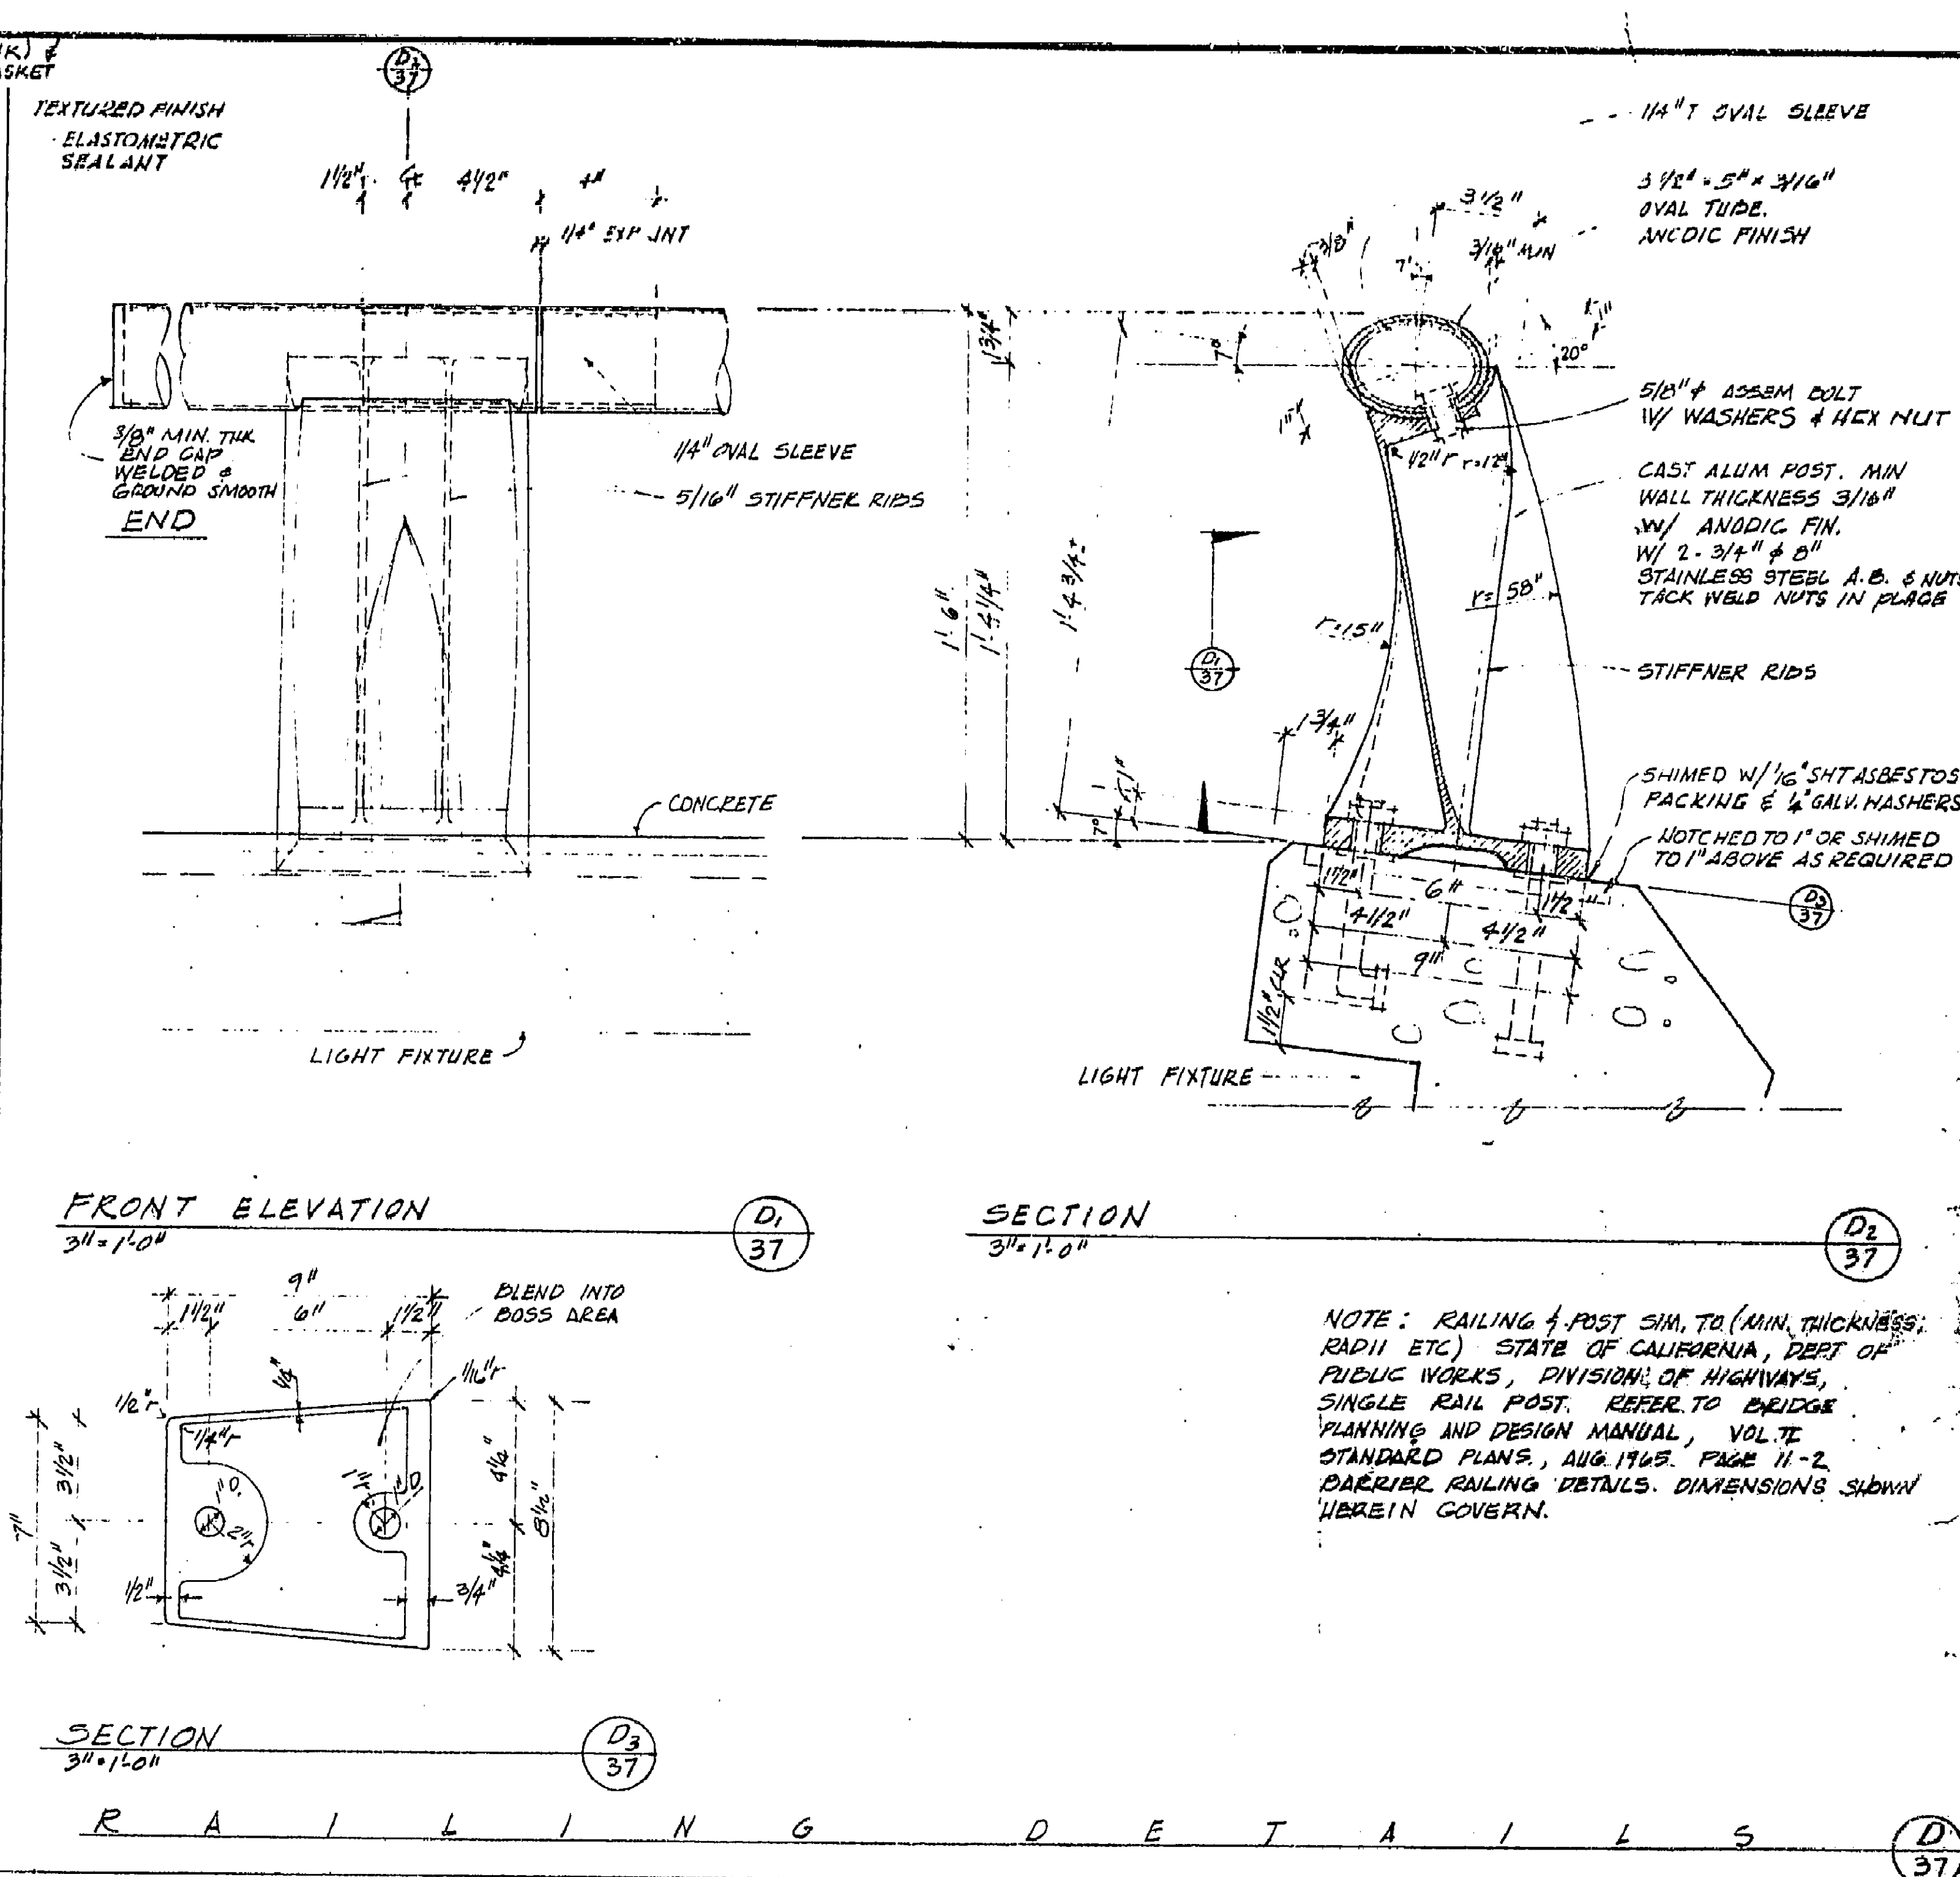
NOTE: RAILING & POST SIM. TO (MIN. THICKNESS, RADIUS ETC.) STATE OF CALIFORNIA, DEPT OF PUBLIC WORKS, DIVISION OF HIGHWAYS, SINGLE RAIL POST. REFER TO BRIDGE PLANNING AND DESIGN MANUAL, VOL. 2, STANDARD PLANS, AUG 1963, PAGE 11-2. RAILING RAILING DETAILS. DIMENSIONS SHOWN HEREIN GOVERN.
