| CALLE DE LOS MOLINOS RCB<br>PREVENTATIVE MAINTENANCE<br>Br. No. 55C0399 | PLOT DATE: 4/4/19<br>SCALE: AS SHOWN |

| GENERAL PLAN |

CALLE DE LOS MOLINOS RCB  
PREVENTATIVE MAINTENANCE  
Br. No. 55C0399

**MISCELLANEOUS  
DETAILS**

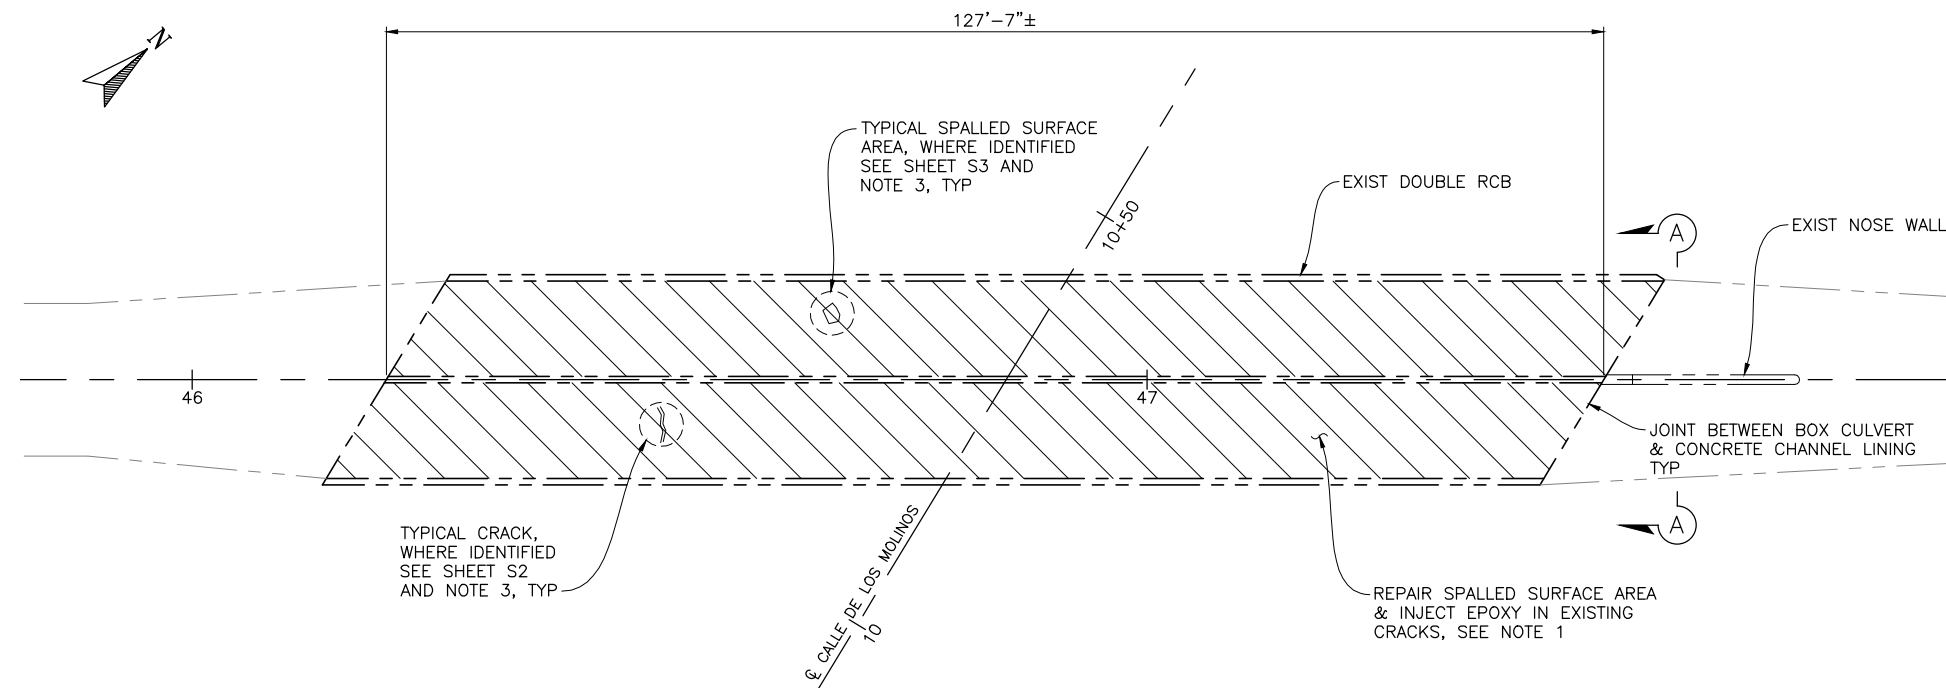
**PLAN - RCB**  
SCALE: 1"=10'

- REPAIR SPALLED SURFACE AREAS AND INJECT EPOXY IN EXISTING CRACKS WITHIN THE LIMITS OF EXISTING BOX CULVERT SOFFIT SLAB.
- INJECT CONCRETE SEALANT CAULKING IN ALL CRACKS 0.050" WIDE OR GREATER WITHIN THE LIMITS OF EXISTING CONCRETE SLOPE PAVING. SEE SPECIFICATIONS SECTION F-46.
- FINAL LIMITS OF REPAIR SPALLED SURFACE AREA, INJECT CRACK (EPOXY) AND INJECT CRACK (SEALANT) TO BE ESTABLISHED DURING CONSTRUCTION.
- FOR VIEW A-A, SEE SHEET S2.
- FOR SPALL REPAIR DETAILS, SEE SHEET S3.
- FOR INJECT CRACK DETAILS, SEE SHEET S2.
- PROVIDE TRAFFIC CONTROL PER SPECIFICATION F-3.

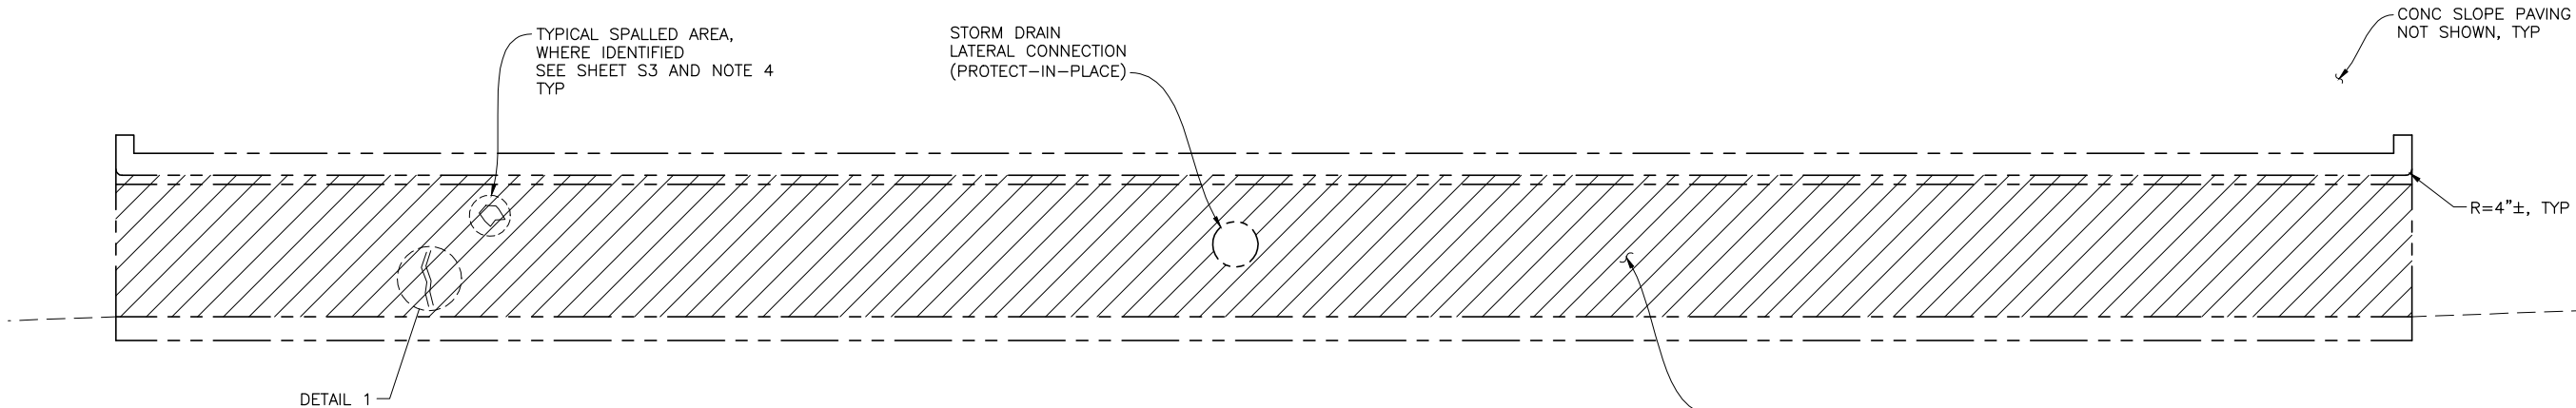
### LONGITUDINAL VIEW INSIDE RCB

SCALE: 1"=5'  
LEFT WALL SHOWN, CENTER & RIGHT WALL SIMILAR)

REPAIR SPALLED SURFACE AREA & INJECT EPOXY IN EXISTING CRACKS, SEE NOTES 2 & 3.

1. REPAIR SPALLED SURFACE AREA & INJECT EPOXY IN EXISTING CRACKS WITHIN THE LIMITS OF EXISTING BOX CULVERT WALL FACE & EXISTING CONCRETE BOX CULVERT TOP SLAB FACE.
2. INJECT EPOXY INTO CRACKS HAVING A CRACK WIDTH OF 0.050" OR GREATER. IF CRACKS HAVE A CRACK WIDTH 0.050" OR GREATER AND ALSO HAVE PORTIONS LESS THAN 0.050" IN WIDTH, INJECT EPOXY IN ALL PORTIONS OF THE CRACK DOWN TO 0.010" IN WIDTH. SEE SPECIFICATION F-45.
3. FOR CRACKS GREATER THAN 0.250" IN WIDTH, CONSIDER AS A SPALL AND REPAIR PER DETAILS ON "SPALL REPAIR DETAILS" SHEET.
4. FINAL LIMITS OF REPAIR SPALLED SURFACE AREA AND INJECT CRACK (EPOXY) TO BE ESTABLISHED DURING CONSTRUCTION.

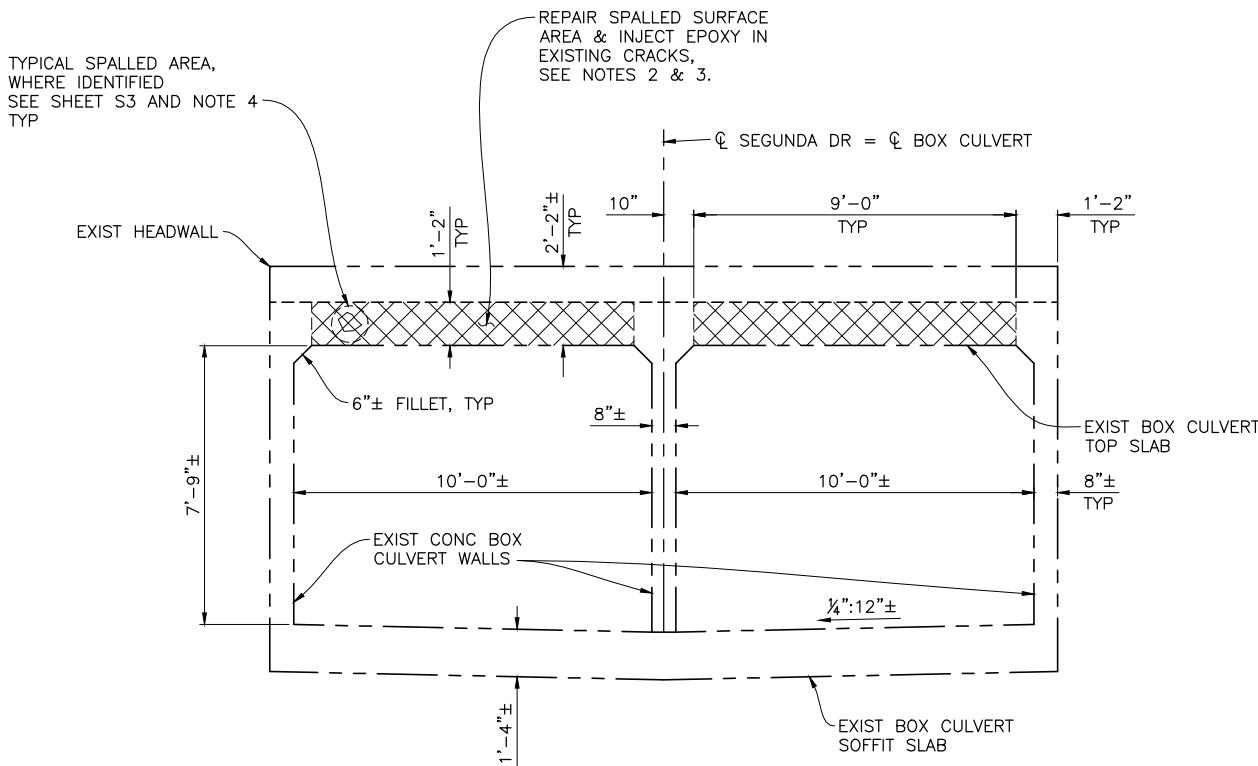
**VIEW A-A**  
**RCB NORTH SECTION**  
SCALE: 3/8"=1'-0"  
(NOSE WALL NOT SHOWN FOR CLARITY)

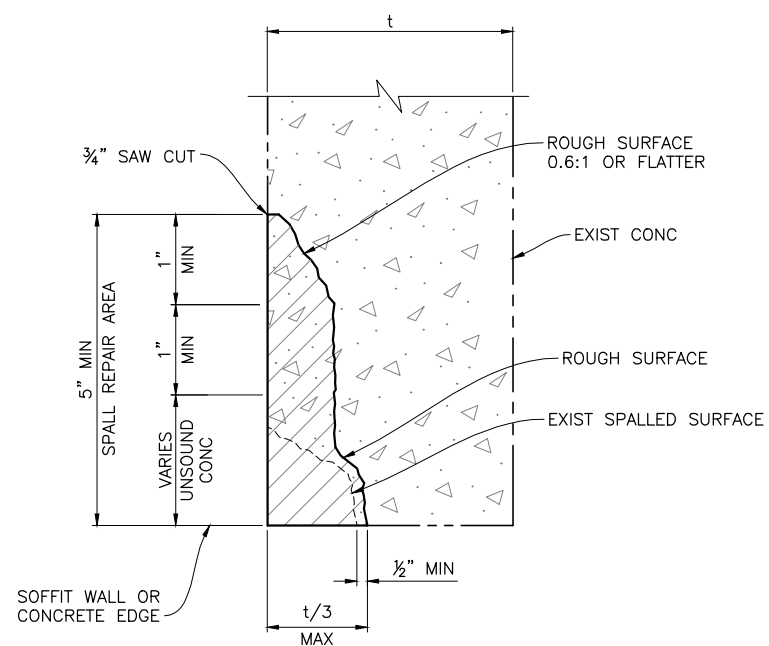
**SECTION A-A**  
**JOINT, CRACK OR EDGE OF CONCRETE REPAIR**  
NO SCALE

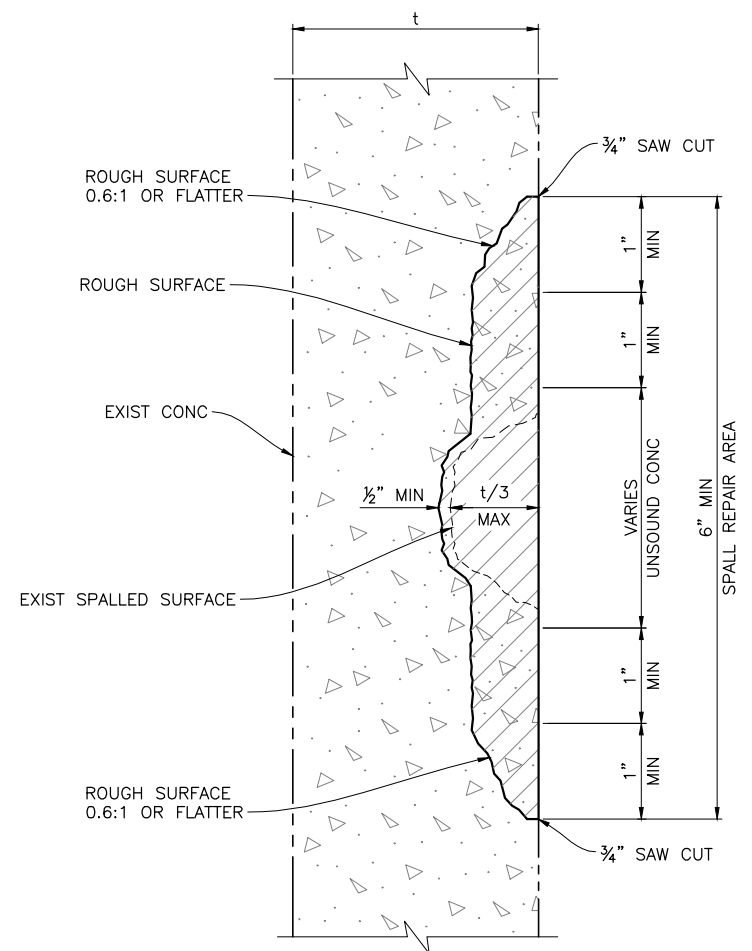
**SECTION B-B**  
**MISCELLANEOUS SPALL REPAIR**  
NO SCALE

- SEE "GENERAL PLAN" SHEET FOR SPALL REPAIR LOCATIONS. SEE SPECIFICATION F-47.
- IF SPALL REPAIR AREA IS LESS THAN 4" FROM AN EDGE, EXTEND THE REPAIR TO THE JOINT.
- PROTECT EXISTING REINFORCING IN-PLACE. WHEN DAMAGED REINFORCEMENT IS FOUND, REPLACE AS SHOWN IN "TYPICAL SPALL REPAIR WITH BAR REINFORCEMENT REPLACEMENT" DETAIL.
