# Access Compliance Report Public Rights-of-Way (Curb Ramps)

| Main Street: ESPERANZA_RD | | Cross Street: N/A | | Location: SW | |
| ADA ID: RPAT220221122942 | Ramp Type: Type 4 - Parallel | Initial Pass/Fail: Pass | Overall Compliance: Yes | Severity Score: | 0 |

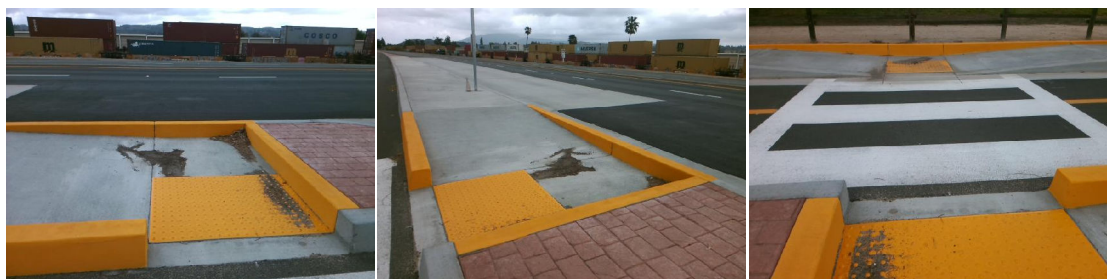
| Compliance | Description | Data | Compliance | Description | Data |
| N/A | Ramp Length LT (in) | 119 | N/A | Ramp Length RT (in) | -9999 |
| Yes | Ramp Width LT (in) | 85 | N/A | Ramp Width RT (in) | -9999 |
| Yes | Ramp Run Slope LT (%) | 6.8 | N/A | Ramp Run Slope RT (%) | -9999 |
| Yes | Ramp Cross Slope LT (%) | 1.5 | N/A | Ramp Cross Slope RT (%) | -9999 |
| N/A | Landing Present | Yes | Yes | DWS Provided | Yes |
