SCUPPER DRAIN DETAILS ON BRIDGE

AS BUILT

ORANGE COUNTY RESOURCES & DEVELOPMENT MANAGEMENT DEPT		ANTONIO PARKWAY WILDLIFE UNDERCROSSING (WIDEN)		SHEET 65 OF 72	
SIDEWALK DETAILS					
DESIGNED: <u>J. WANG</u>					
DRAWN: <u>J. WANG</u> CHECKED: <u>F. JIANG</u>					
SCALE: <u>AS SHOWN</u> DATE: <u>9/19/08</u> DRAWING NO.:

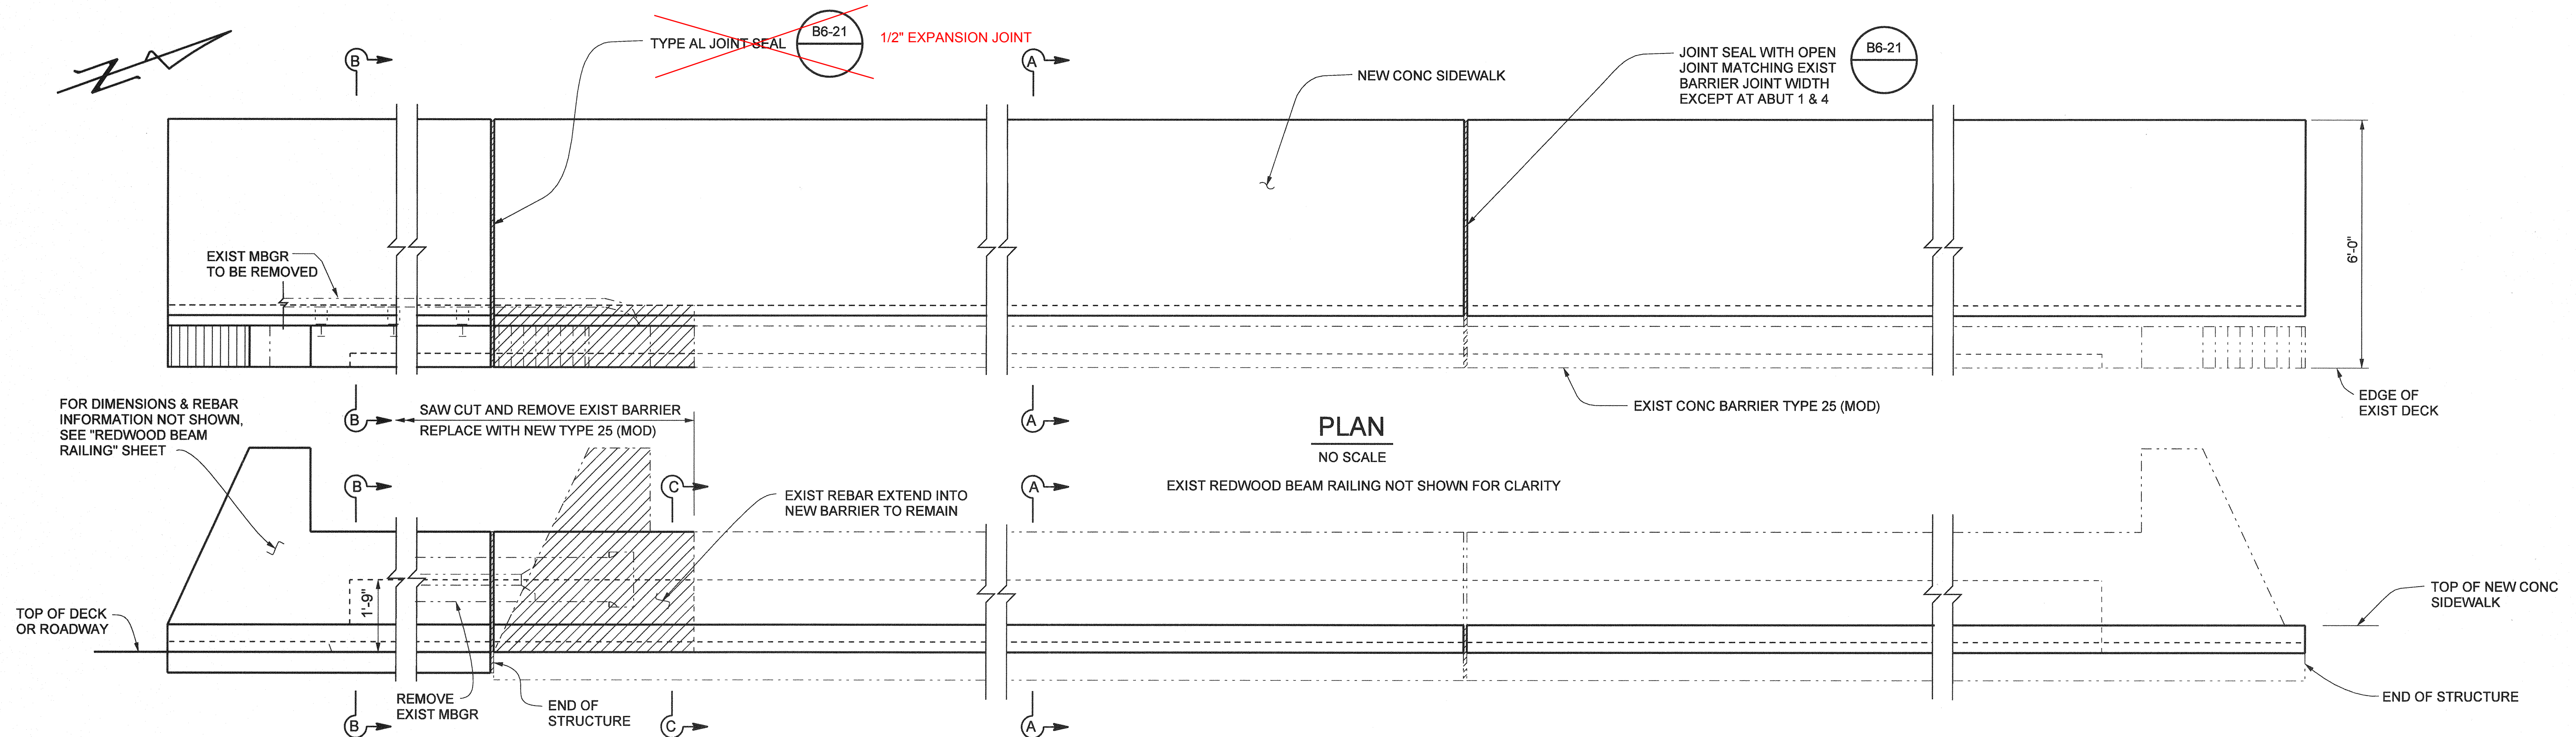
MIRRORED ELEVATION

NO SCALE
EXIST REDWOOD BEAM RAILING NOT SHOWN FOR CLARITY

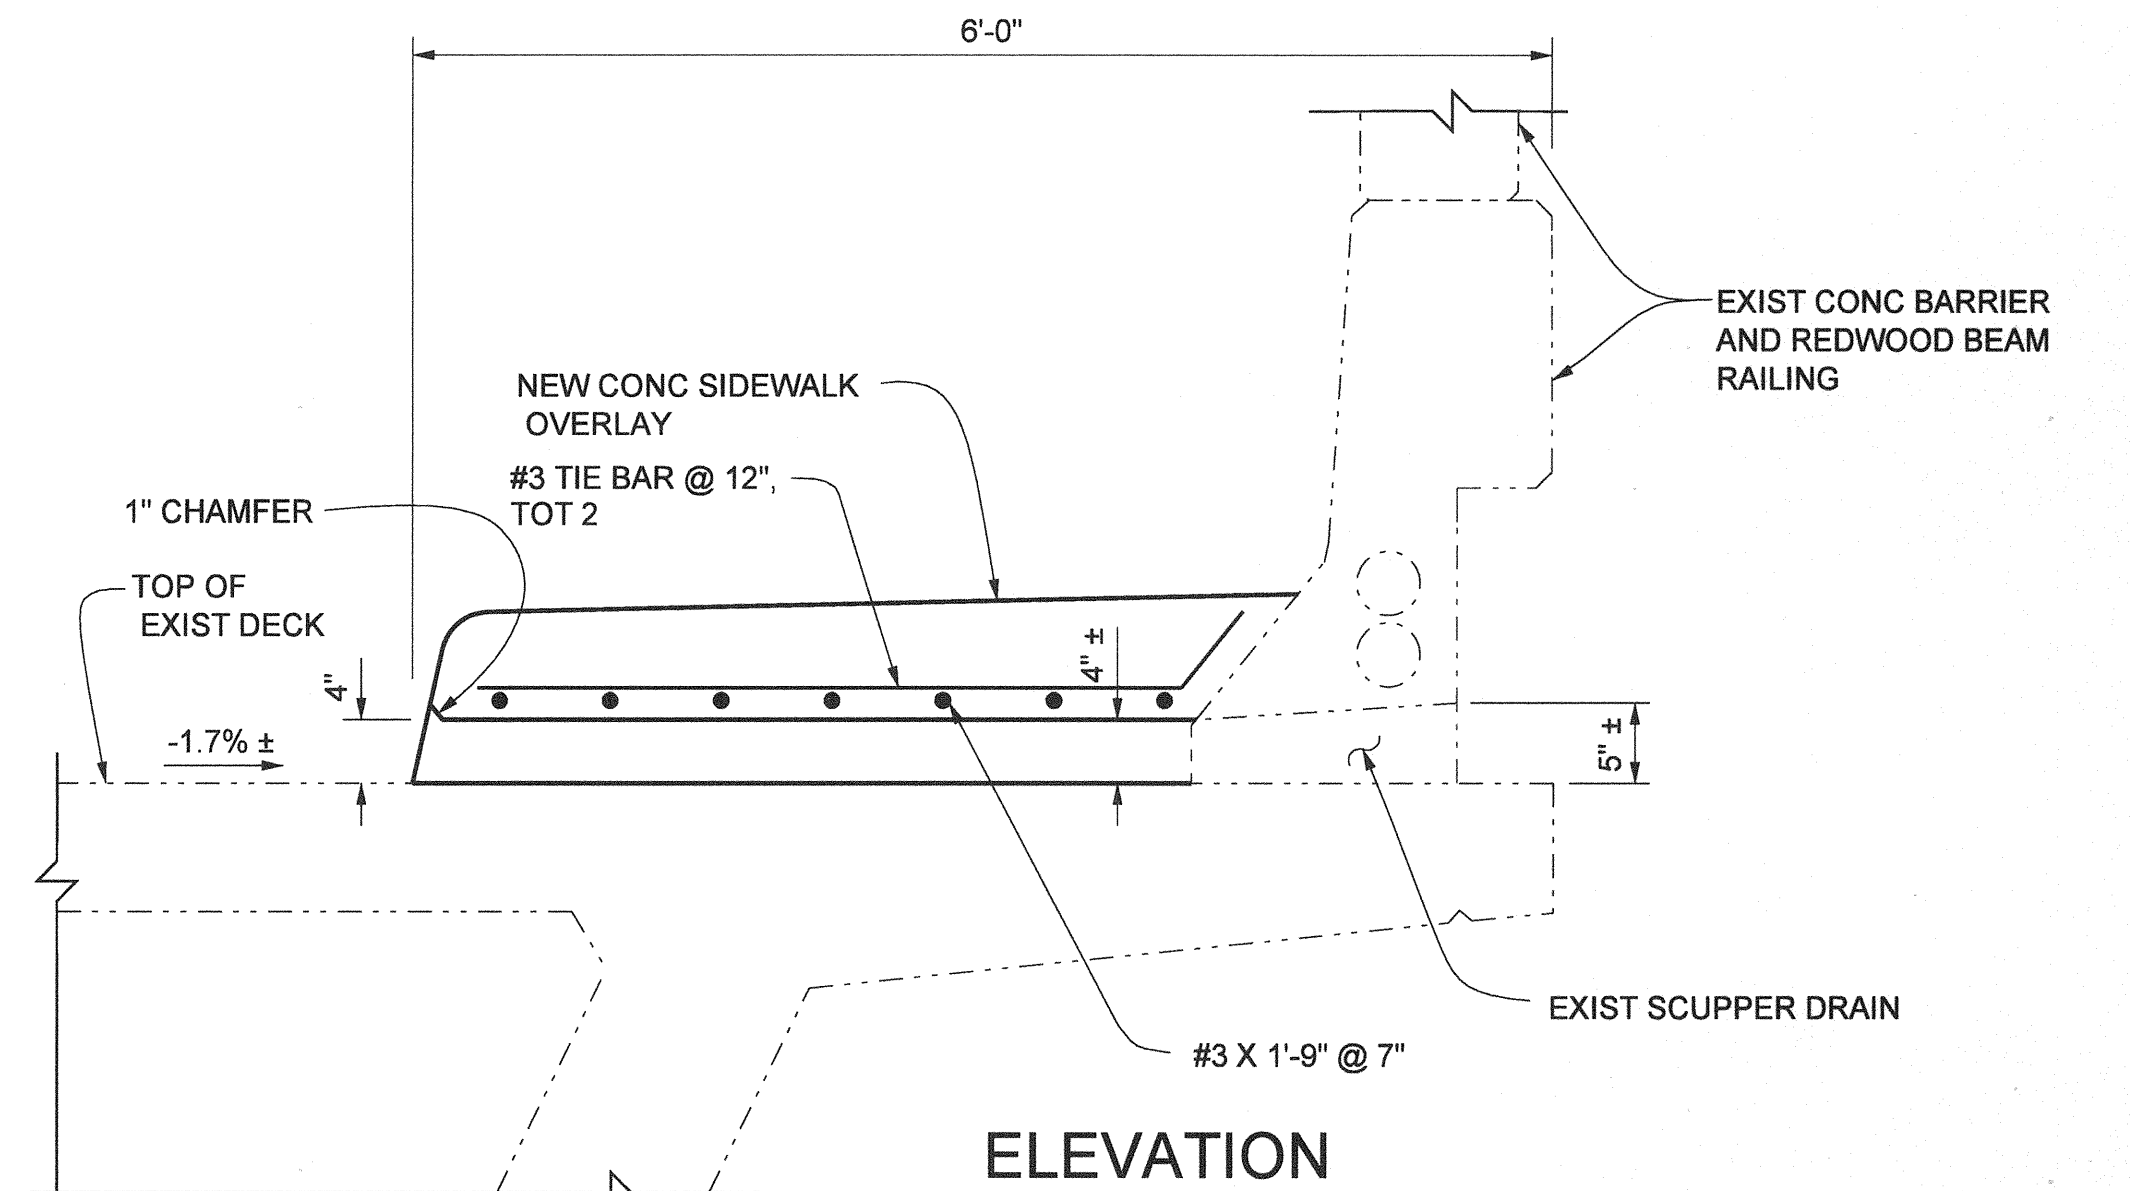
ELEVATION

FOR SIDEWALK REINF, SEE SECTION A-A
