| ORANGE COUNTY<br>ENVIRONMENTAL MANAGEMENT AGENCY | | BRE A BLVD. BRIDGE | |
| BR. 55-37. | | CHANNEL CROSS SECTIONS. | |

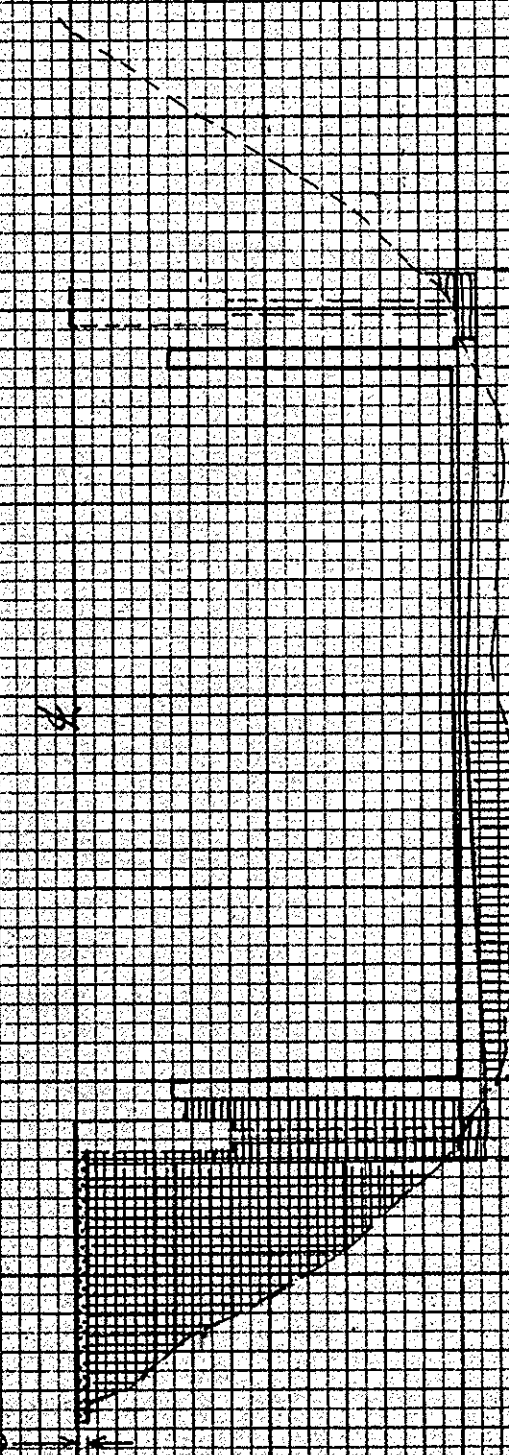
Wing Wall No. 1  
Excavation for rock mass (included in grouted rock mass)

THIS SECTION SHOWS  
POSITION OF BACK AND  
FRONT OF EMBANKMENT  
ELEVATION AND WING WALL  
SLOPE

WING WALL NO. 1  
OF THIS SECTION IS SHOWN DASHED  
STA 9+18  
END WING WALL
