Orange County Bridge Review Summary

Bridge Number: 55C0404

Bridge Name: Anaheim-Barber City Channel **Year Built:** 1959

Facility Carried: Dale Street

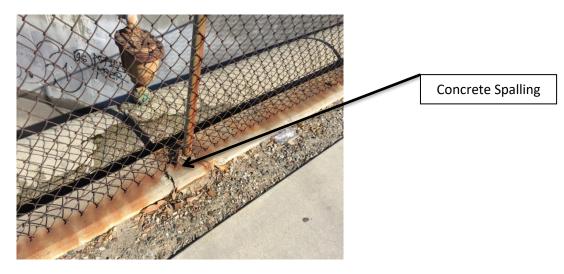
Photo 3: Railing Curb

- Spalled post pocket on east side (photo 3).
- Utility on the west side dripping water (photo 4), constantly keeping concrete wet.
- Minor soffit spall at east abutment/headwall (photo 4).
- Minor efflorescence visible on soffit (photo 5).

There are 2 incipient spalls 300 mm x 200mm at the inside face of headwall under posts 2 & 3. There is a spall 100 mm x 100 mm x 25 mm with exposed rebar at the bottom of east headwall of barrel #1 (south).

- Recommend patching spalled concrete. No immediate actions required since not a high priority.
- Efflorescence likely from water penetrating through deck. Not significant problem at this time. To repair will require deck AC removal, deck treatment, and grinding approach AC to conform to lower deck elevation.
- Recommend contacting utility owner to repair water drip problem.

- Repair Spalls < \$10,000 (includes engineering, mobilization and contingency)
- Utility repair should be funded by utility company

Repair the $\,$ spall 100 mm x 100 mm x 25 mm $\,$ with exposed rebar at the bottom of east headwall of barrel #1 (south) and the 2 incipient spalls 300 mm x 200mm at the inside face of headwall under posts 2 &

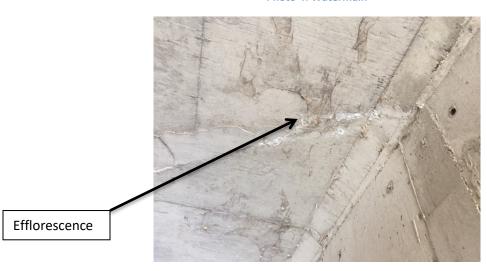
Photo 5: Bridge Soffit

There is white efflorescence at the soffit along the construction joint.
