Orange County Bridge Review Summary

Bridge Number: 55C0628

Bridge Name: San Juan Creek

Facility Carried: Antonio Parkway

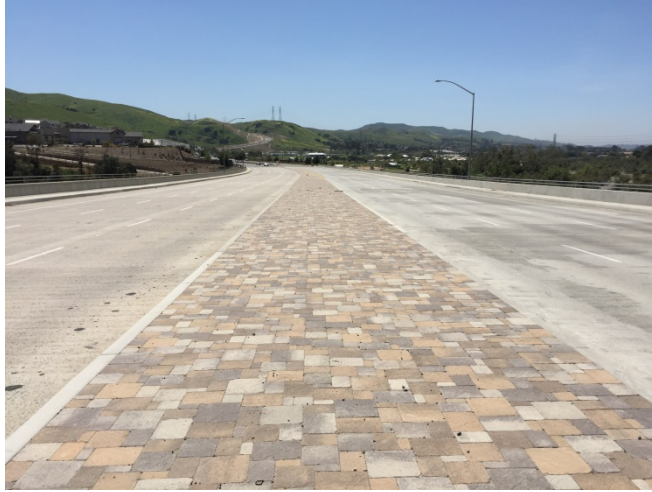
Photo 1:

- Expansion joints and deck drains are full of dirt.
- Sand is piling up on the northeast side of sidewalk.

- Clean deck drains and remove sand from sidewalk.

- Unplug deck drains ≈ \$10,000, includes traffic control and assumes pipes clogged
