# Access Compliance Report Public Rights-of-Way (Island Curb Cuts)

| Main Street: ETHEREAL_RD | | Cross Street: ETHEREAL_RD | | Location: | N |
| ADA ID: CCRK211104123357 | Curb Cut Type: MedianRefuge2 | Initial Pass/Fail: Pass | Overall Compliance: No | Severity Score: | 15 |

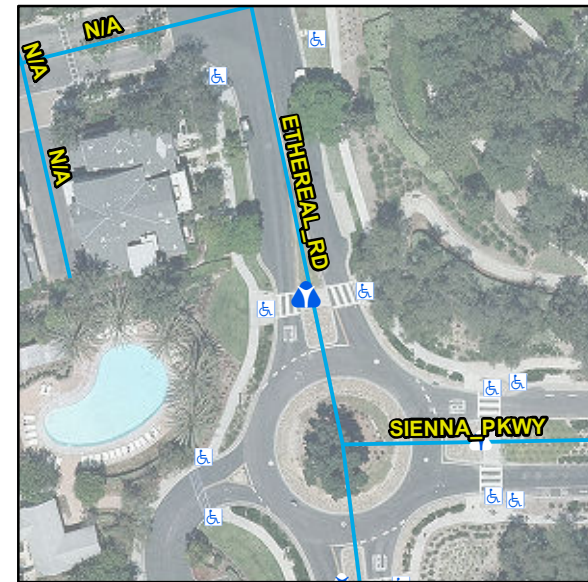
| Compliance | Description | Data | Compliance | Description | Data |
|---|---|---|---|---|---|
| N/A | Painted Cross Walk 1 | Yes | No | DWS 1 Provided | No |
| Yes | Refuge 2 Cross Slope (%) | 4.6 | No | Gutter 2 Cross Slope (%) | 3.3 |
| N/A | Painted Cross Walk 2 | Yes | No | DWS 2 Provided | No |

Possible Solutions:

Install Detectable Warning System. Remove & Replace Gutter.

R305, R304.5.3, STD 1115
