# Access Compliance Report Public Rights-of-Way (Island Curb Cuts)

| Main Street: ETHEREAL_RD | | Cross Street: ETHEREAL_RD | | Location: | N |
| ADA ID: CCRK211104124924 | Curb Cut Type: MedianRefuge2 | Initial Pass/Fail: Pass | Overall Compliance: No | Severity Score: | 15 |

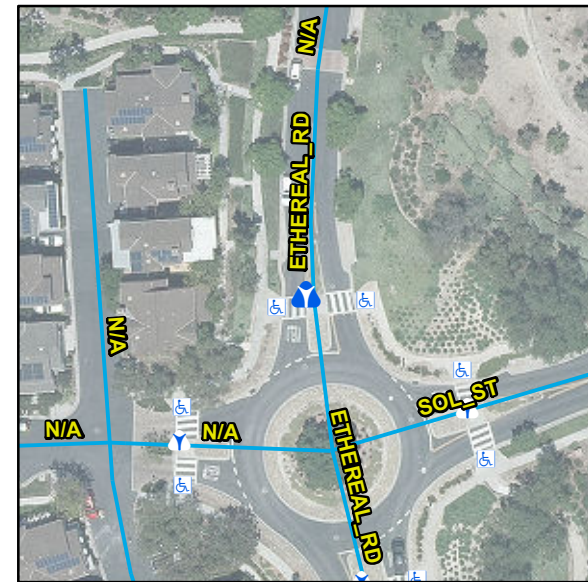
| Compliance | Description | Data | Compliance | Description | Data |
|---|---|---|---|---|---|
| Yes | Refuge 1 Cross Slope (%) | 4.6 | No | Gutter 1 Cross Slope (%) | 4.7 |
| N/A | Painted Cross Walk 1 | Yes | No | DWS 1 Provided | No |
| Yes | Refuge 2 Cross Slope (%) | 4.8 | No | Gutter 2 Cross Slope (%) | 4.3 |
| N/A | Painted Cross Walk 2 | Yes | No | DWS 2 Provided | No |

Possible Solutions:

**Install Detectable Warning System. Remove & Replace Gutter.**

**R305, R304.5.3, STD 1115**
