# Access Compliance Report Public Rights-of-Way (Island Curb Cuts)

| Main Street: ETHEREAL_RD | | Cross Street: ETHEREAL_RD | | Location: | S |
| ADA ID: CCRK211104132719 | Curb Cut Type: MedianRefuge2 | Initial Pass/Fail: Pass | Overall Compliance: No | Severity Score: | 15 |

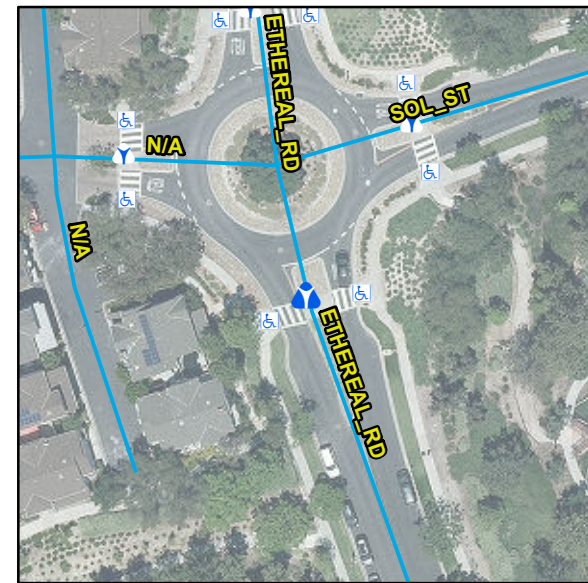
| Compliance | Description | Data | Compliance | Description | Data |
|---|---|---|---|---|---|
| N/A | Painted Cross Walk 1 | Yes | No | DWS 1 Provided | No |
| Yes | Refuge 2 Cross Slope (%) | 2.6 | No | Gutter 2 Cross Slope (%) | 2.8 |
| N/A | Painted Cross Walk 2 | Yes | No | DWS 2 Provided | No |

Install Detectable Warning System. Remove & Replace Gutter.
