# Access Compliance Report Public Rights-of-Way (Island Curb Cuts)

| Main Street: SIENNA_PKWY | | Cross Street: SIENNA_PKWY | | Location: | NE |
| ADA ID: CCRK211111130501 | Curb Cut Type: MedianRefuge2 | Initial Pass/Fail: Pass | Overall Compliance: No | Severity Score: | 7.5 |

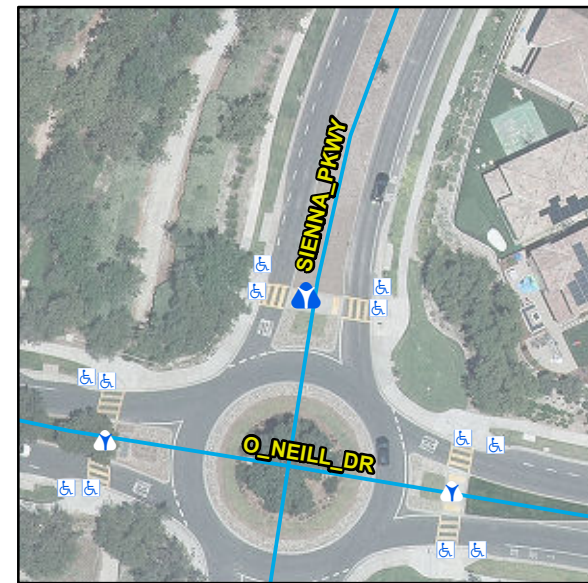
| Compliance | Description | Data | Compliance | Description | Data |
|---|---|---|---|---|---|
| Yes | Refuge Inside Cross Walk 1 | Yes | No | DWS 1 Full Width | No |
| | Road 1 Slope (%) | 4.2 | No | DWS 1 Offset (In) | 27 |
| Yes | Refuge Inside Cross Walk 2 | Yes | No | DWS 2 Full Width | No |
| | Road 2 Slope (%) | 2.1 | No | DWS 2 Offset (In) | 38 |

**Remove & Replace Detectable Warning System.**

**R305.1.4, R305.2, STD 1115**

Total Cost: \$ 1600
