# Access Compliance Report Public Rights-of-Way (Island Curb Cuts)

| Main Street: NARROW_CANYON_RD | | Cross Street: NARROW_CANYON_RD | | Location: | N |
| ADA ID: CCRK211115125606 | Curb Cut Type: MedianRefuge2 | Initial Pass/Fail: Pass | Overall Compliance: No | Severity Score: | 15 |

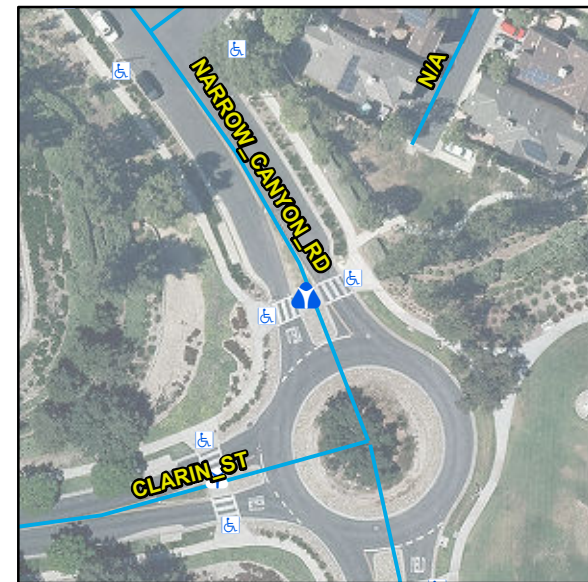
| Compliance | Description | Data | Compliance | Description | Data |
|---|---|---|---|---|---|
| N/A | Painted Cross Walk 1 | Yes | No | DWS 1 Provided | No |
| Yes | Refuge 2 Cross Slope (%) | 5 | No | Gutter 2 Cross Slope (%) | 5 |
| N/A | Painted Cross Walk 2 | Yes | No | DWS 2 Provided | No |

Possible Solutions:

Install Detectable Warning System. Remove & Replace Gutter.
