# Access Compliance Report Public Rights-of-Way (Island Curb Cuts)

Main Street: ESENCIA\_DR Cross Street: ESENCIA\_DR Location: NW

ADA ID: CCRK211129123300 Curb Cut Type: MedianRefuge2 Initial Pass/Fail: Pass Overall Compliance: Yes Severity Score: 0

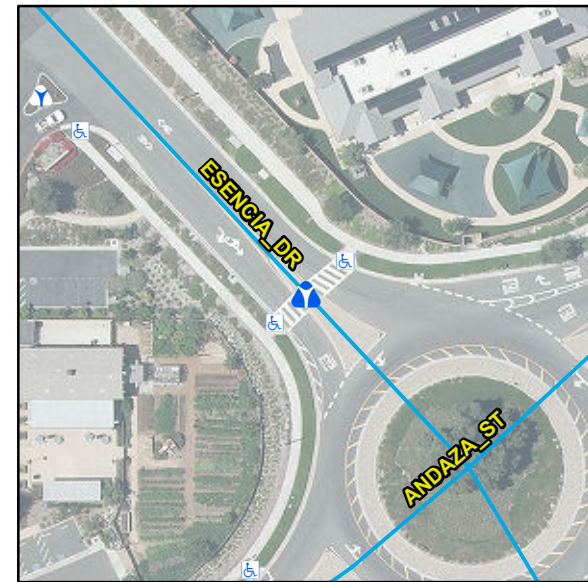
| Compliance | Description | Data | Compliance | Description | Data |
|---|---|---|---|---|---|
| Yes | Overall Surface Condition: | Acceptable | | | |
