# Access Compliance Report Public Rights-of-Way (Island Curb Cuts)

| Main Street: ANDAZA_ST | | Cross Street: ANDAZA_ST | | Location: | W |
| ADA ID: CCRK211129133111 | Curb Cut Type: MedianRefuge2 | Initial Pass/Fail: Pass | Overall Compliance: Yes | Severity Score: | 0 |

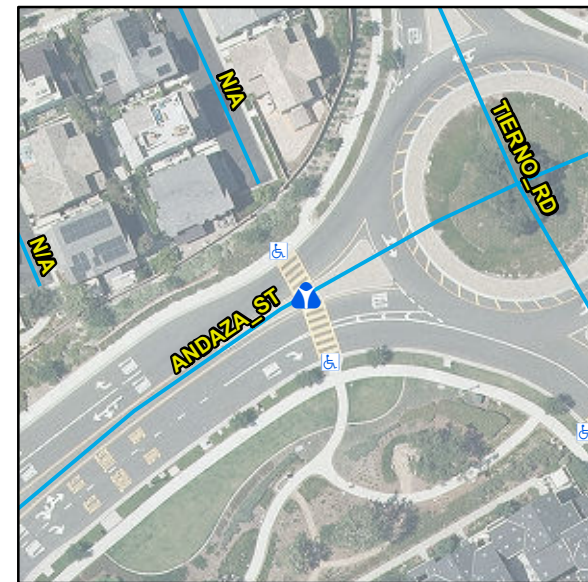
| Compliance | Description | Data | Compliance | Description | Data |
|---|---|---|---|---|---|
| Yes | Overall Surface Condition: Acceptable | | | | |
