# Access Compliance Report Public Rights-of-Way (Island Curb Cuts)

| Main Street: ESENCIA_DR | | Cross Street: ESENCIA_DR | | Location: | SE |
| ADA ID: CCRK211201125725 | Curb Cut Type: MedianRefuge2 | Initial Pass/Fail: Pass | Overall Compliance: No | Severity Score: | 10 |

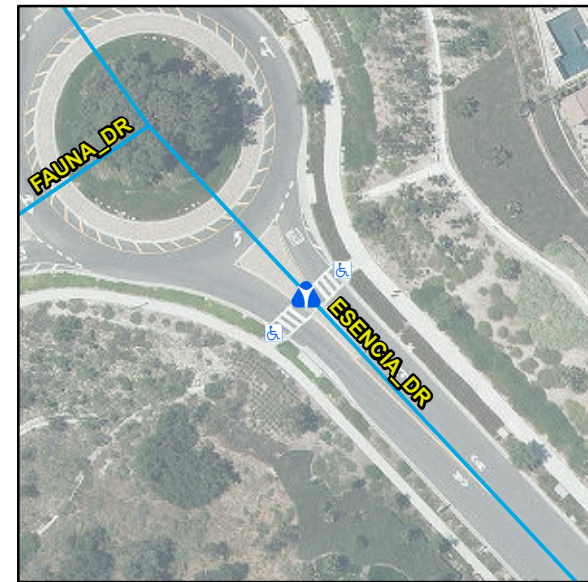
| Compliance | Description | Data | Compliance | Description | Data |
|---|---|---|---|---|---|
| Yes | Refuge 2 Slope (%) | 0.3 | No | Gutter 2 Slope (%) | 6.8 |

Possible Solutions:

**Remove & Replace Gutter.**

**R304.5.4, STD 1115**

**\$ 252**
