Main Street: **ENDRY\_ST** Cross Street: **CANTON\_AVE** Location: **NE**

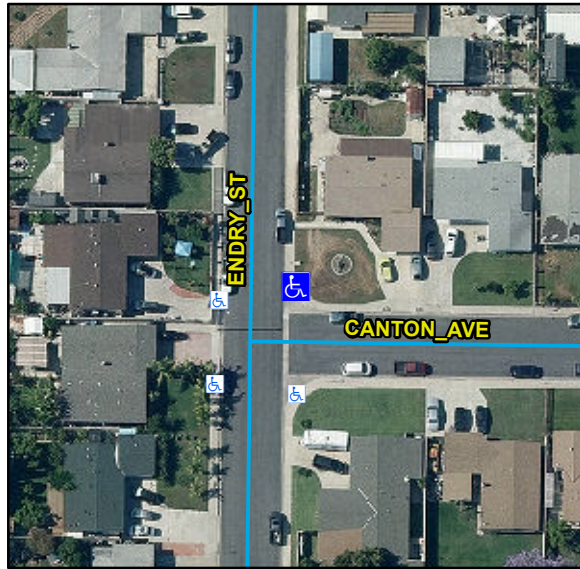
| Compliance | Description | Data | Compliance | Description | Data |
|---|---|---|---|---|---|
| <b>No</b> | Landing Width (in) | <b>46</b> | <b>Yes</b> | DWS Length (in) | <b>36</b> |

**Remove & Replace Landing.**
