# Access Compliance Report Public Rights-of-Way (Curb Ramps)

Main Street: **DECKER\_AVE** Cross Street: **FRALEY\_ST** Location: **SE**

ADA ID: **RPAT210916131918** Ramp Type: **Type 4 - Parallel** Initial Pass/Fail: **Pass** Overall Compliance: **Yes** Severity Score: **0**

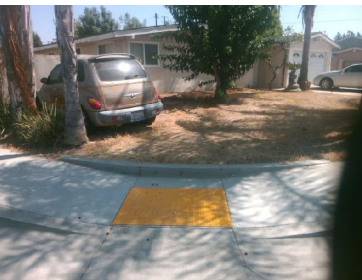
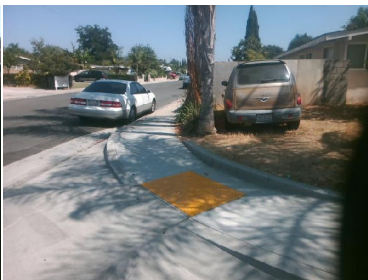
| Compliance | Description | Data | Compliance | Description | Data |
|---|---|---|---|---|---|
| <b>Yes</b> | Overall Surface Condition | <b>Acceptable</b> | | | |
