# Access Compliance Report Public Rights-of-Way (Curb Ramps)

Main Street: JEAN\_ST Cross Street: CANTON\_AVE Location: SW

ADA ID: RPAT210916144202 Ramp Type: Type 4 - Parallel Initial Pass/Fail: Pass Overall Compliance: No Severity Score: 5

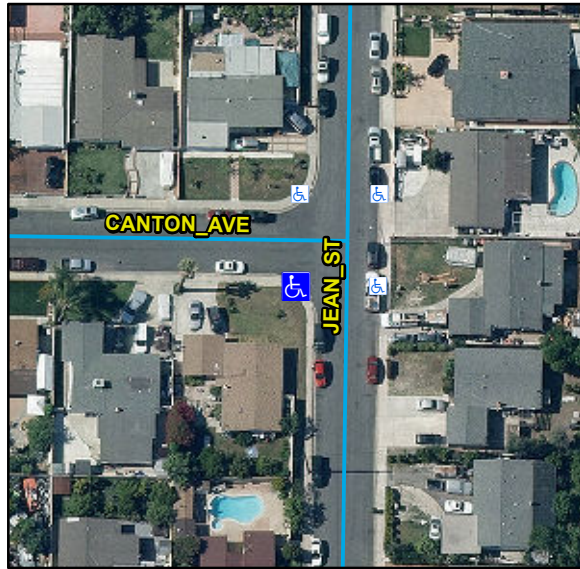
| Compliance | Description | Data | Compliance | Description | Data |
|---|---|---|---|---|---|
| No | Gutter Run Slope (%) | 5.5 | | Road Cross Slope (%) | 3.9 |

Remove & Replace Gutter.

R304.5.4, STD 1115
