# Access Compliance Report Public Rights-of-Way (Curb Ramps)

Main Street: CRESTWOOD\_LN Cross Street: JEAN\_ST Location: SE

ADA ID: RPAT210916151455 Ramp Type: Type 4 - Parallel Initial Pass/Fail: Pass Overall Compliance: Yes Severity Score: 0

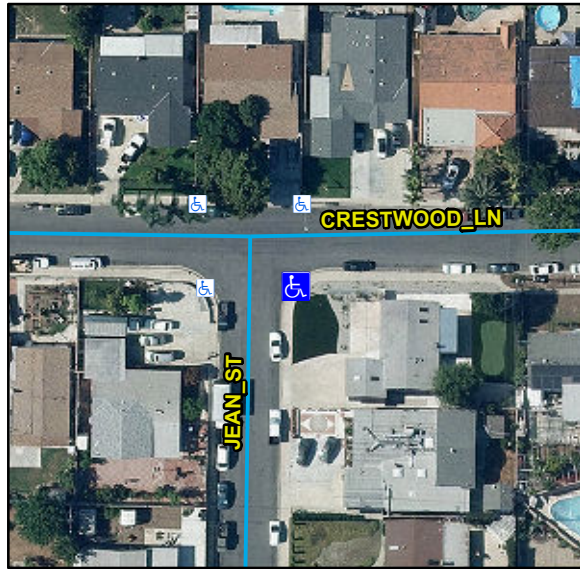
| Compliance | Description | Data | Compliance | Description | Data |
|---|---|---|---|---|---|
| Yes | Overall Surface Condition | Acceptable | | | |

N/A
