# Access Compliance Report Public Rights-of-Way (Curb Ramps)

Main Street: ROCKAWAY\_DR Cross Street: ROXBOROUGH\_DR Location: NW

ADA ID: RPAT210917090446 Ramp Type: Type 1 - Perpendicular Diagonal Initial Pass/Fail: Pass Overall Compliance: No Severity Score: 4

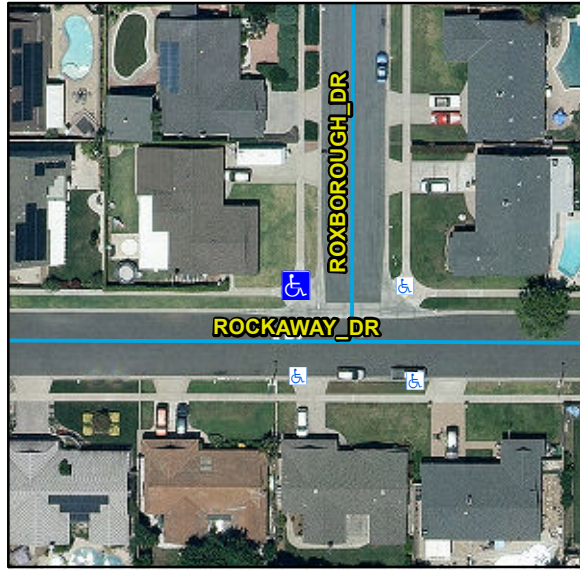
| Compliance | Description | Data | Compliance | Description | Data |
|---|---|---|---|---|---|
| Yes | Gutter Ponding | No | No | Curb Slope | 9.7 |

**Remove & Replace Curb Ramp With Two New Directional Ramps or Equivalent.**

**R304.2.2, R304.2.1, STD 1115**

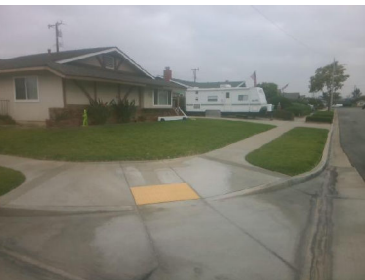
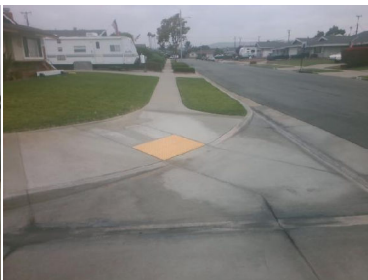
| Compliance | Description | Data | Compliance | Description | Data |
|---|---|---|---|---|---|
| Yes | Overall Surface Condition: <b>Acceptable</b> | | Yes | Perp Joint Present | Yes |
