# Access Compliance Report Public Rights-of-Way (Curb Ramps)

Main Street: TABAH\_LN Cross Street: CARTLEN\_DR Location: SE

ADA ID: RPAT210917130515 Ramp Type: Type 1 - Perpendicular Diagonal Initial Pass/Fail: Pass Overall Compliance: No Severity Score: 0

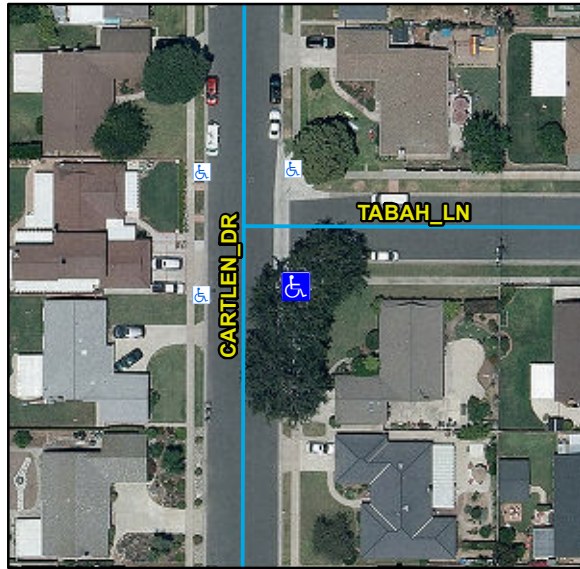
## Field Measurements/Component Compliance

| Compliance | Description | Data | Compliance | Description | Data |
|---|---|---|---|---|---|
| Yes | Gutter Ponding | No | No | Curb Slope | 12.1 |

### Possible Solutions:

Remove & Replace Curb Ramp With Two New Directional Ramps or Equivalent.

R304.2.2, R304.2.1, STD 1115
