# Access Compliance Report Public Rights-of-Way (Curb Ramps)

Main Street: ASHGROVE\_DR Cross Street: N/A Location: NW

ADA ID: RPAT210921101028 Ramp Type: Type 4 - Parallel Initial Pass/Fail: Pass Overall Compliance: Yes Severity Score: 0

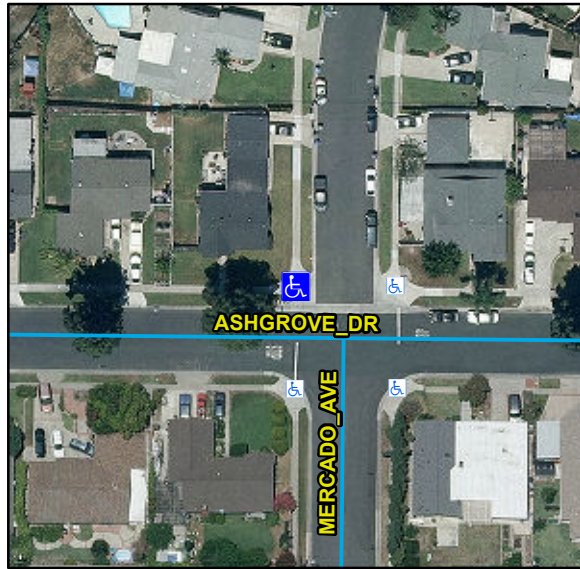
| Compliance | Description | Data | Compliance | Description | Data |
|---|---|---|---|---|---|
| N/A | Ramp Length LT (in) | 90 | N/A | Ramp Length RT (in) | 88 |
| Yes | Ramp Width LT (in) | 120 | Yes | Ramp Width RT (in) | 122 |
| Yes | Ramp Run Slope LT (%) | 6.5 | Yes | Ramp Run Slope RT (%) | 7.6 |
| Yes | Ramp Cross Slope LT (%) | 0.9 | Yes | Ramp Cross Slope RT (%) | 0.3 |
| Yes | Landing Width (in) | 48 | Yes | DWS Length (in) | 36 |
| Yes | Landing Run Slope (%) | 1.4 | Yes | DWS Full Width | Yes |
| Yes | Landing Cross Slope (%) | 1 | | DWS Offset Type | Single |

Possible Solutions:

N/A

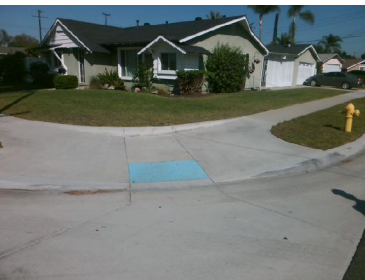
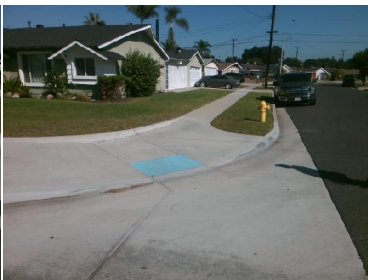
| Compliance | Description | Data | Compliance | Description | Data |
|---|---|---|---|---|---|
| Yes | Overall Surface Condition | Acceptable | | | |
