# Access Compliance Report Public Rights-of-Way (Curb Ramps)

Main Street: **KELLOGG\_DR** Cross Street: **MOUNTAIN\_VIEW\_AVE** Location: **E**

ADA ID: **RPAT210922123233** Ramp Type: **Type 4 - Parallel** Initial Pass/Fail: **Pass** Overall Compliance: **No** Severity Score: **0**

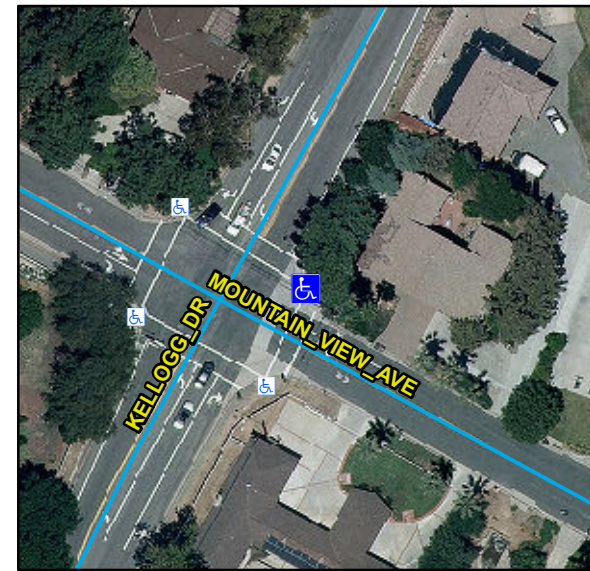
| Compliance | Description | Data | Compliance | Description | Data |
|---|---|---|---|---|---|
| <b>Yes</b> | Gutter Ponding | <b>No</b> | <b>No</b> | Curb Slope | <b>9.4</b> |

Possible Solutions:  
**Remove & Replace Curb Slope.**

OC Std/PROW:  
**R304.2.2, STD 1115**

Total Cost: \$ **252**

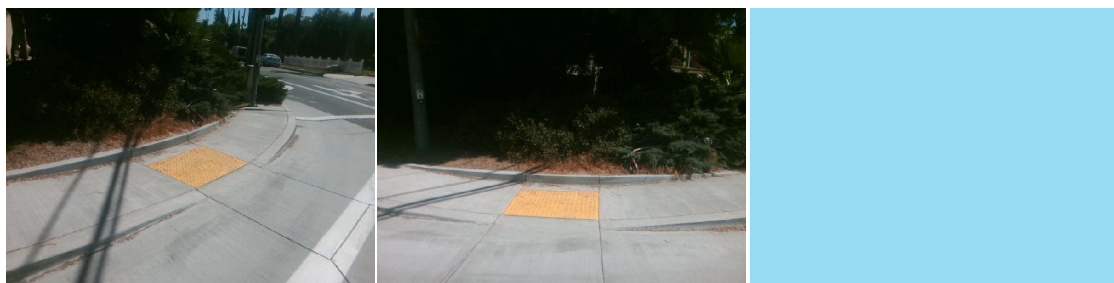
| Compliance | Description | Data | Compliance | Description | Data |
|---|---|---|---|---|---|
| <b>N/A</b> | Ramp Length LT (in) | <b>112</b> | <b>N/A</b> | Ramp Length RT (in) | <b>107</b> |
| <b>Yes</b> | Ramp Width LT (in) | <b>48</b> | <b>Yes</b> | Ramp Width RT (in) | <b>48</b> |
| <b>Yes</b> | Ramp Run Slope LT (%) | <b>5.9</b> | <b>Yes</b> | Ramp Run Slope RT (%) | <b>6.4</b> |
| <b>Yes</b> | Ramp Cross Slope LT (%) | <b>0.6</b> | <b>Yes</b> | Ramp Cross Slope RT (%) | <b>0.5</b> |
