# Access Compliance Report Public Rights-of-Way (Curb Ramps)

Main Street: N/A Cross Street: WOODGATE\_DR Location: SW

ADA ID: RPAT210923124124 Ramp Type: Type 6 - Directional 1 Initial Pass/Fail: Pass Overall Compliance: No Severity Score: 5

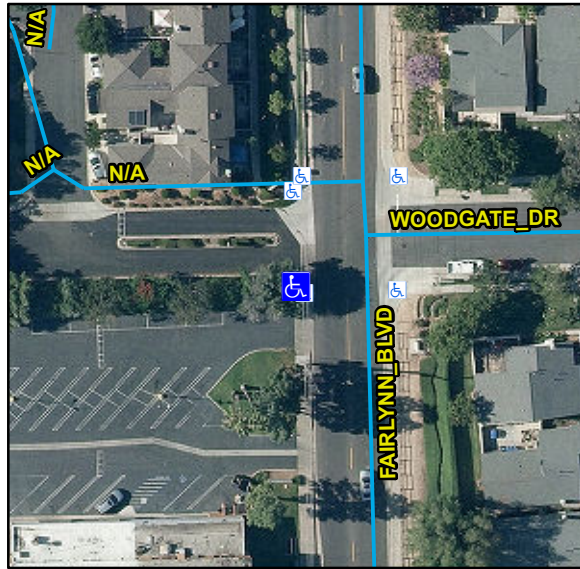
| Compliance | Description | Data | Compliance | Description | Data |
|---|---|---|---|---|---|
| No | Landing Run Slope (%) | 5.2 | | DWS Offset Type | Multiple |
| No | Landing Cross Slope (%) | 2.4 | Yes | DWS Left Offset (in) | 0 |
| No | Gutter Cross Slope (%) | 6.9 | | Parallel Ramp Side | N/A |

Remove & Replace Entire Ramp. Remove & Replace Gutter.
