# Access Compliance Report Public Rights-of-Way (Curb Ramps)

Main Street: N/A Cross Street: ESPERANZA\_RD Location: NW

ADA ID: RPAT210923135710 Ramp Type: Type 7 - Directional 2 Initial Pass/Fail: Pass Overall Compliance: No Severity Score: 6

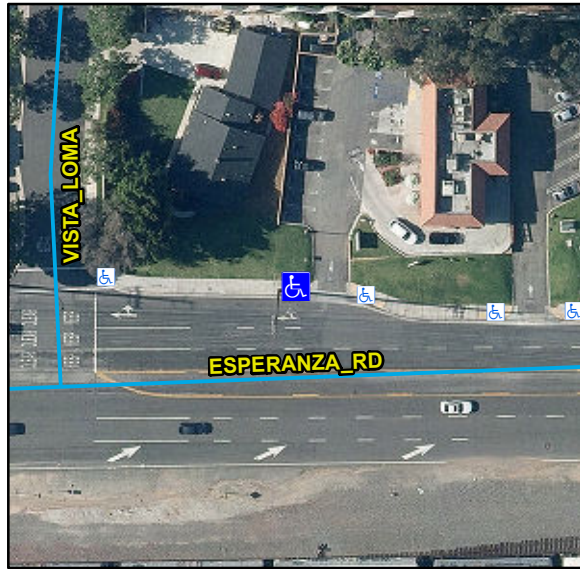
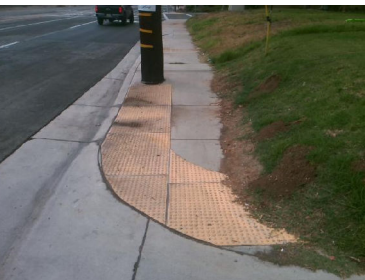
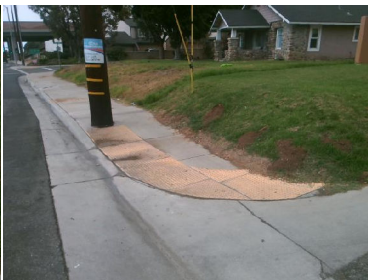
| Compliance | Description | Data | Compliance | Description | Data |
|---|---|---|---|---|---|
| No | Grade Break Cross Slope (%) | 2.1 | N/A | Flare Slope RT (%) | N/A |
| Yes | Gutter Ponding | No | No | Curb Slope | 15.8 |
| No | Gutter Run Slope (%) | 9.7 | | Road Cross Slope (%) | 0.4 |
| No | Gutter Cross Slope (%) | 5.8 | | Parallel Ramp Side | Right |

Remove & Replace Entire Ramp. Remove & Replace Gutter. Utility Present.

R304.2.2, R304.5.3, R304.5.4, STD 1115
