# Access Compliance Report Public Rights-of-Way (Curb Ramps)

| Main Street: E_CENTER_ST | | Cross Street: S_ESPLANADE_ST | | Location: | SE |
| ADA ID: RPAT210927120152 | Ramp Type: Type 4 - Parallel | Initial Pass/Fail: Fail | Overall Compliance: No | Severity Score: | 15 |

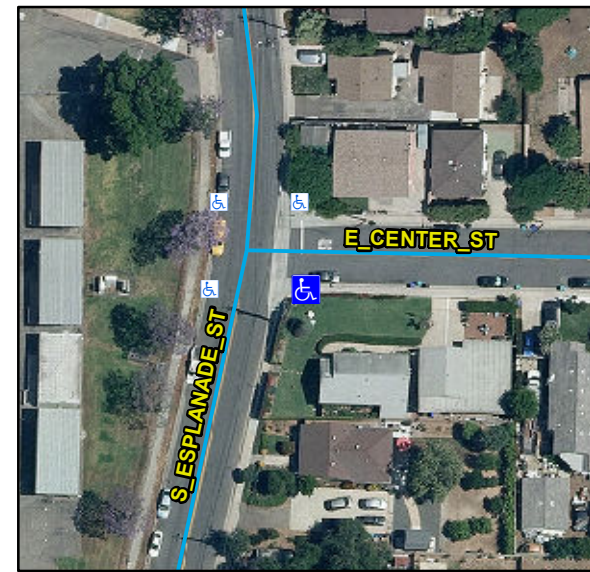
| Compliance | Description | Data | Compliance | Description | Data |
|---|---|---|---|---|---|
| No | Ramp Run Slope LT (%) | 9.5 | Yes | Ramp Run Slope RT (%) | 2.8 |

**Remove & Replace Curb Ramp With Two New Directional Ramps or Equivalent.**

**R304.3.2, STD 1115**

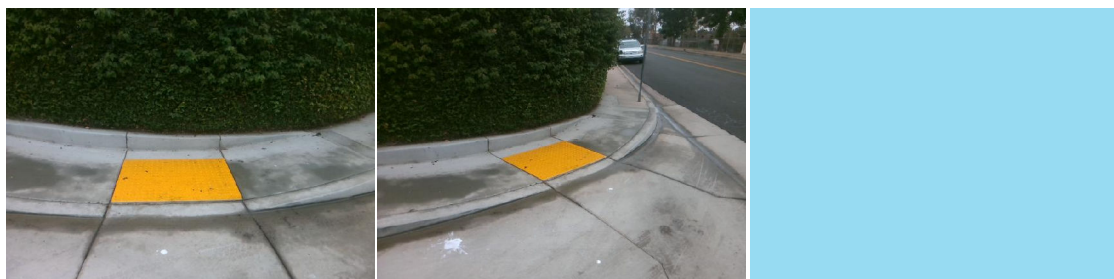
| Compliance | Description | Data | Compliance | Description | Data |
|---|---|---|---|---|---|
| N/A | Ramp Length LT (in) | 122 | N/A | Ramp Length RT (in) | 66 |
| Yes | Ramp Width LT (in) | 48 | Yes | Ramp Width RT (in) | 48 |
