# Access Compliance Report Public Rights-of-Way (Curb Ramps)

Main Street: HEWES\_ST Cross Street: CENTER\_ST Location: NE

ADA ID: RPAT210929095311 Ramp Type: Type 4 - Parallel Initial Pass/Fail: Pass Overall Compliance: No Severity Score: 20

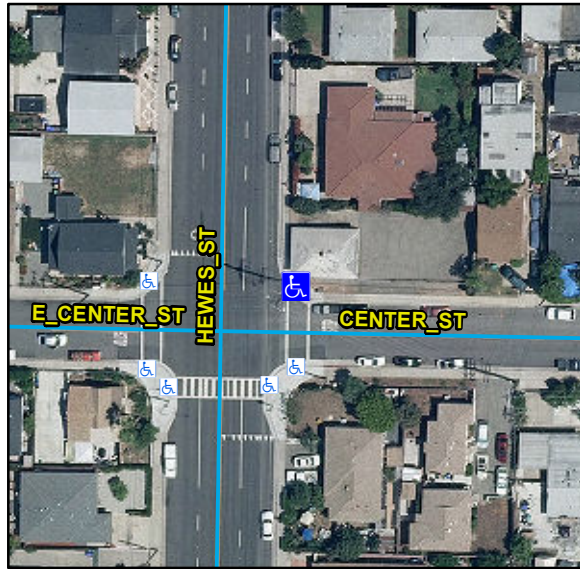
| Compliance | Description | Data | Compliance | Description | Data |
|---|---|---|---|---|---|
| No | Obstructions Present? | Yes | N/A | Utilities Present? | No |
| | Obstruction Types | Power Pole | | Utility Types | |

Possible Solutions:

Relocate Obstruction.
