# Access Compliance Report Public Rights-of-Way (Curb Ramps)

| Main Street: E_CHAPMAN_AVE | | Cross Street: S_HEWES_ST | | Location: | SE |
| ADA ID: RPAT210929131351 | Ramp Type: Type 4 - Parallel | Initial Pass/Fail: Fail | Overall Compliance: No | Severity Score: | 15 |

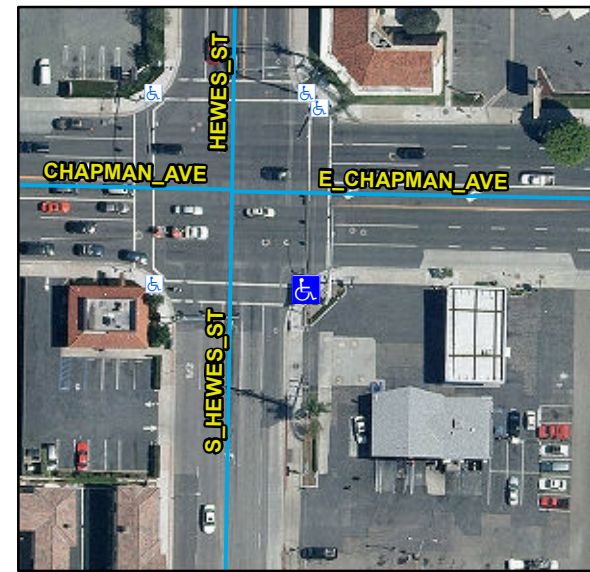
| Compliance | Description | Data | Compliance | Description | Data |
|---|---|---|---|---|---|
| No | Ramp Run Slope LT (%) | 9.8 | Yes | Ramp Run Slope RT (%) | 3.8 |

**Remove & Replace Curb Ramp With Two New Directional Ramps or Equivalent.**

**R304.3.2, STD 1115**

Total Cost: \$ 4000

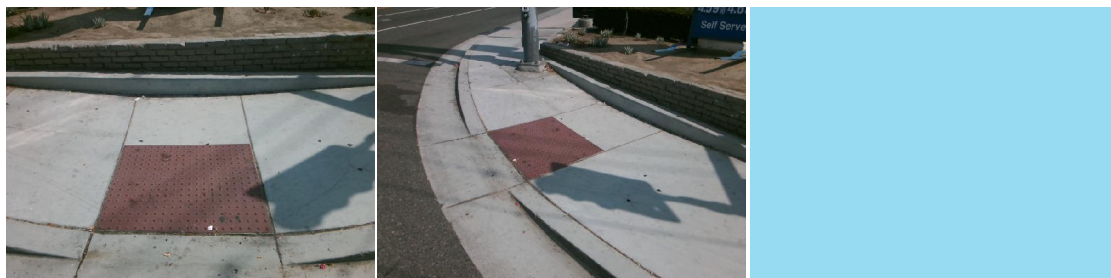
| Compliance | Description | Data | Compliance | Description | Data |
| N/A | Ramp Length LT (in) | 56 | N/A | Ramp Length RT (in) | 114 |
| Yes | Ramp Width LT (in) | 75 | Yes | Ramp Width RT (in) | 76 |
