# Access Compliance Report Public Rights-of-Way (Curb Ramps)

Main Street: EARLHAM\_ST Cross Street: E\_CHAPMAN\_AVE Location: SW

ADA ID: RPAT210929144048 Ramp Type: Type 4 - Parallel Initial Pass/Fail: Pass Overall Compliance: No Severity Score: 0

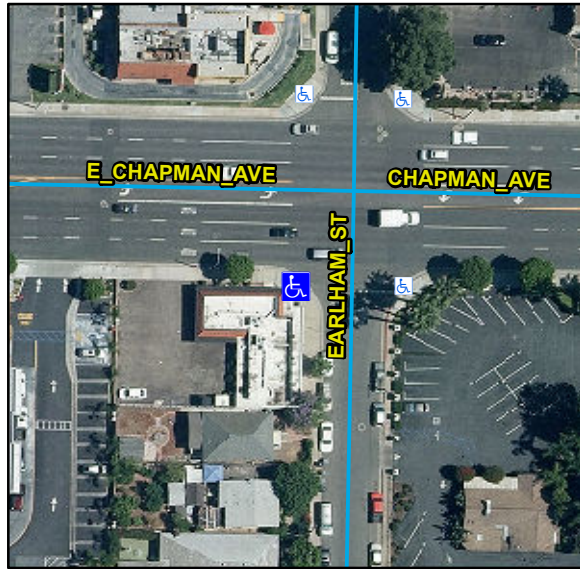
| Compliance | Description | Data | Compliance | Description | Data |
|---|---|---|---|---|---|
| Yes | Gutter Ponding | No | No | Curb Slope | 15.4 |

Remove & Replace Curb Slope.

R304.2.2, STD 1115

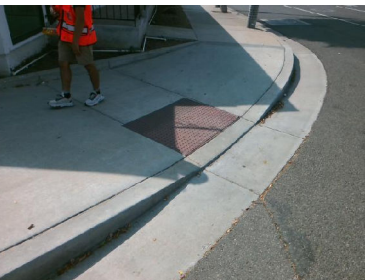
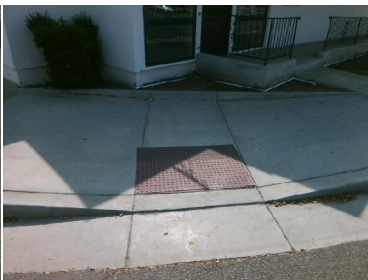
| Compliance | Description | Data | Compliance | Description | Data |
|---|---|---|---|---|---|
| Yes | Overall Surface Condition | Acceptable | | | |
