# Access Compliance Report Public Rights-of-Way (Curb Ramps)

Main Street: ETHELBEE\_WAY Cross Street: CALVO\_DR Location: SW

ADA ID: RPAT210930083835 Ramp Type: Type 1 - Perpendicular Diagonal Initial Pass/Fail: Pass Overall Compliance: No Severity Score: 22

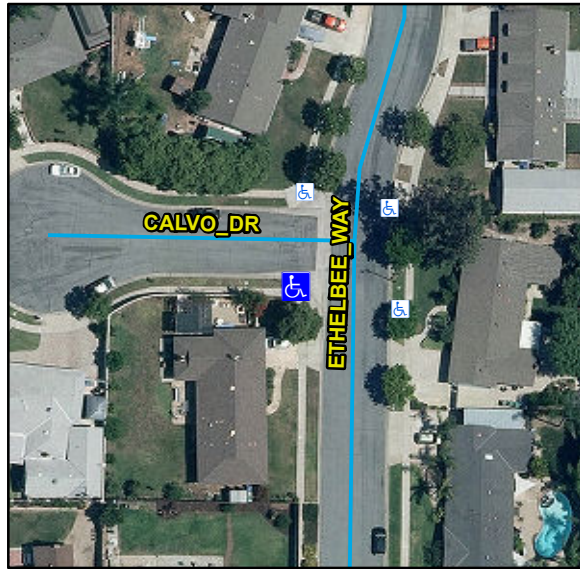
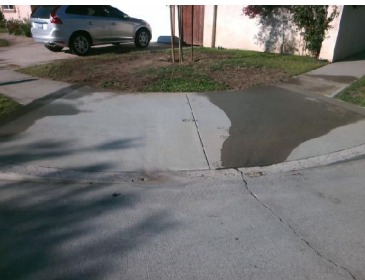
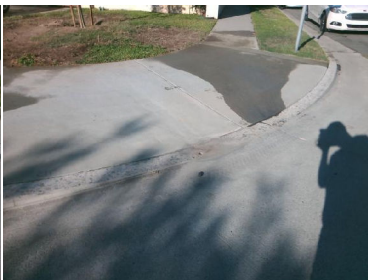
| Compliance | Description | Data | Compliance | Description | Data |
|---|---|---|---|---|---|
| N/A | Ramp Length (in) | 109 | N/A | Flare Type LT | |
| Yes | Ramp Width (in) | 69 | | | Sloped |
| Yes | Ramp Run Slope (%) | 7.1 | N/A | Flare Slope LT (%) | 4.6 |
| Yes | Ramp Cross Slope (%) | 1.7 | N/A | Flare Traversable LT | No |
| N/A | Landing Present | No | N/A | Flare Type RT | |
| No | Landing Width (in) | N/A | N/A | Flare Slope RT (%) | 7.4 |
| No | Landing Run Slope (%) | N/A | N/A | Flare Traversable RT | No |
| No | Landing Cross Slope (%) | N/A | No | DWS Provided | No |

Remove & Replace Curb Ramp With Two New Directional Ramps or Equivalent.
